**RESERVE FUND STUDY  
CARLETON CONDOMINIUM CORPORATION  
# 286**

**PREPARED FOR: CARLETON CONDOMINIUM CORPORATION #286**

**PREPARED BY: Newbridge Engineering Inc.**

**DATE: February 18, 2020**

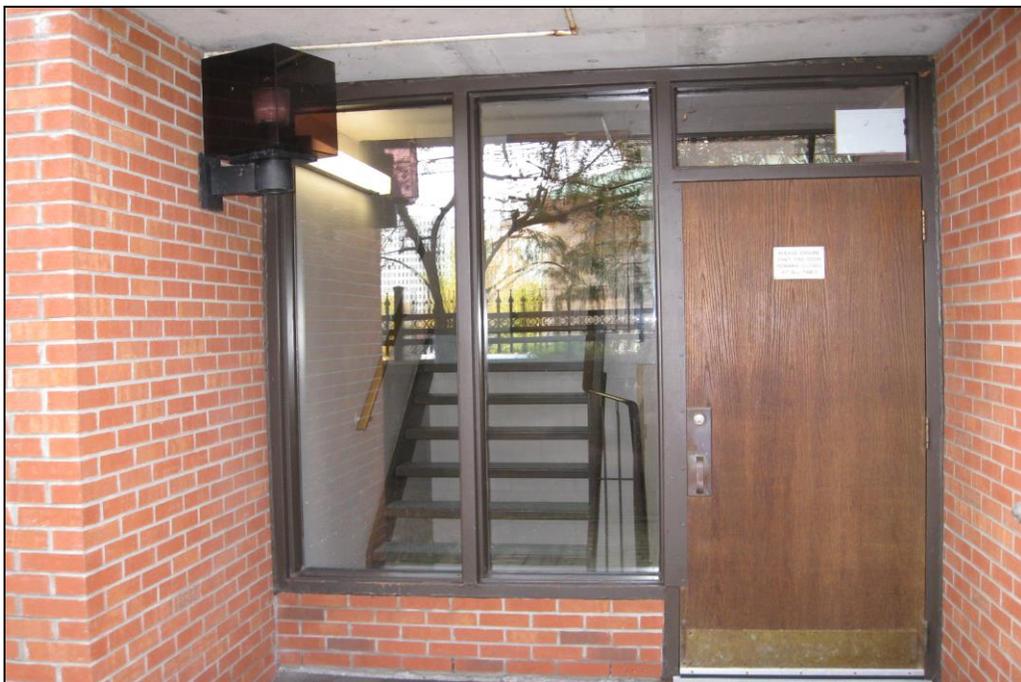
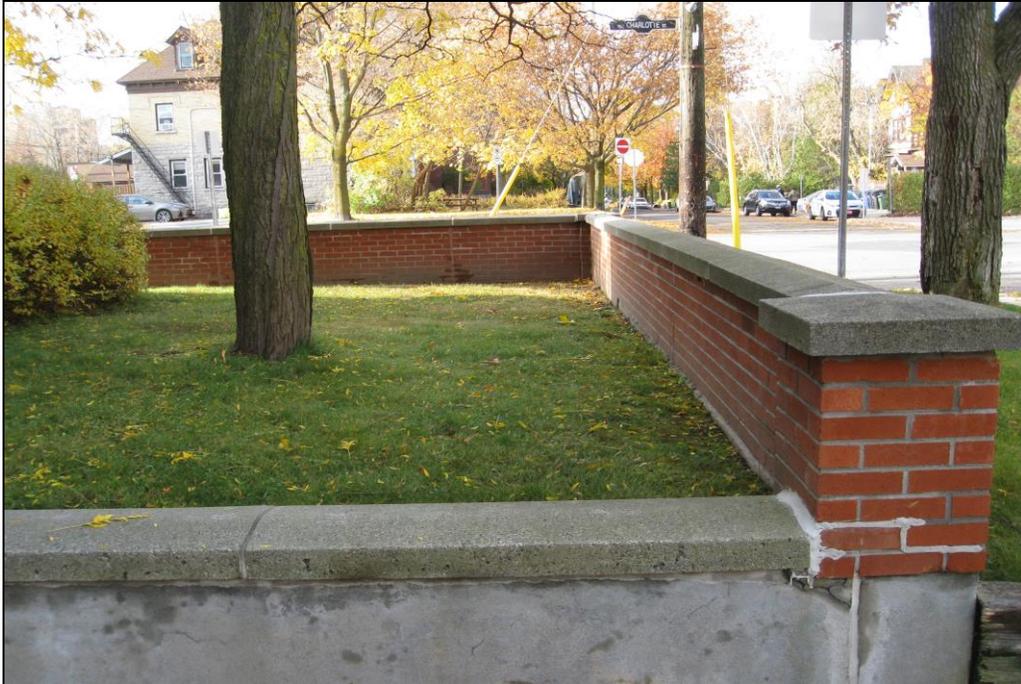
There are also brick faced retaining walls located along the north and west property lines as well as outside the front entry. These walls are generally in satisfactory condition but will need periodic repairs. The most southerly section of these walls along the west property line is tilted towards the street, but it has been stabilized with cables and ground anchors. It is our understanding that this section will be removed and not replaced if it deteriorates any further.

**ABOVE:** Brick retaining walls on northwest corner.  
**BELOW:** Brick retaining walls on northwest corner.

An allowance of four thousand five hundred dollars (\$4,500) has been made every five years for future masonry repairs. This allowance is carried in the year(s) 2025/26, 2030/31, 2035/36, 2040/41 and 2045/46.

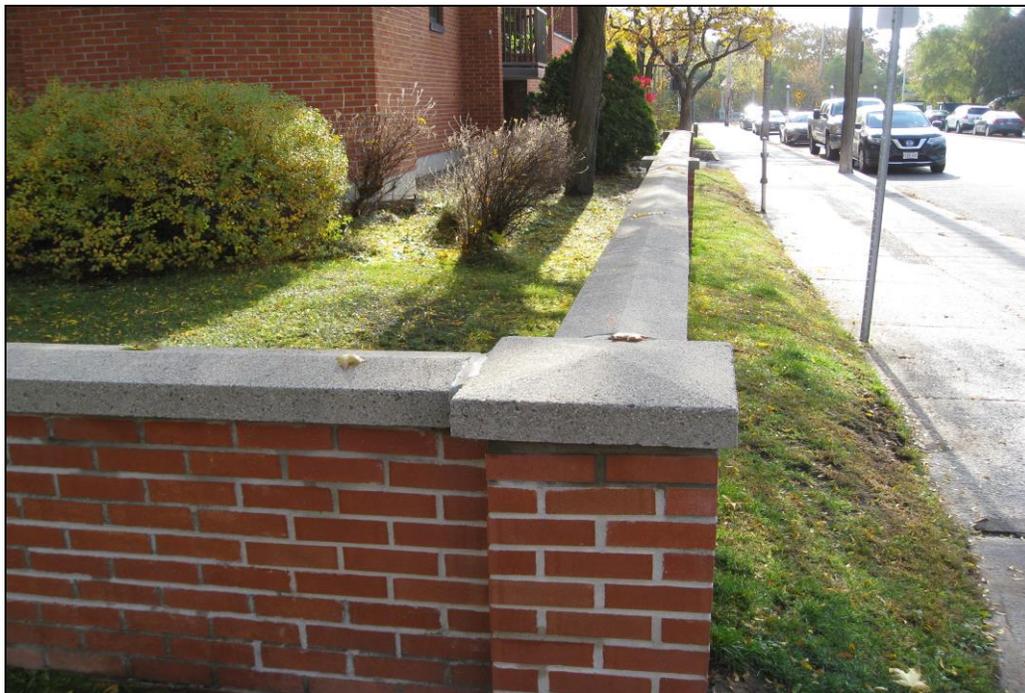
**ABOVE:** Tilting retaining wall on southwest corner.

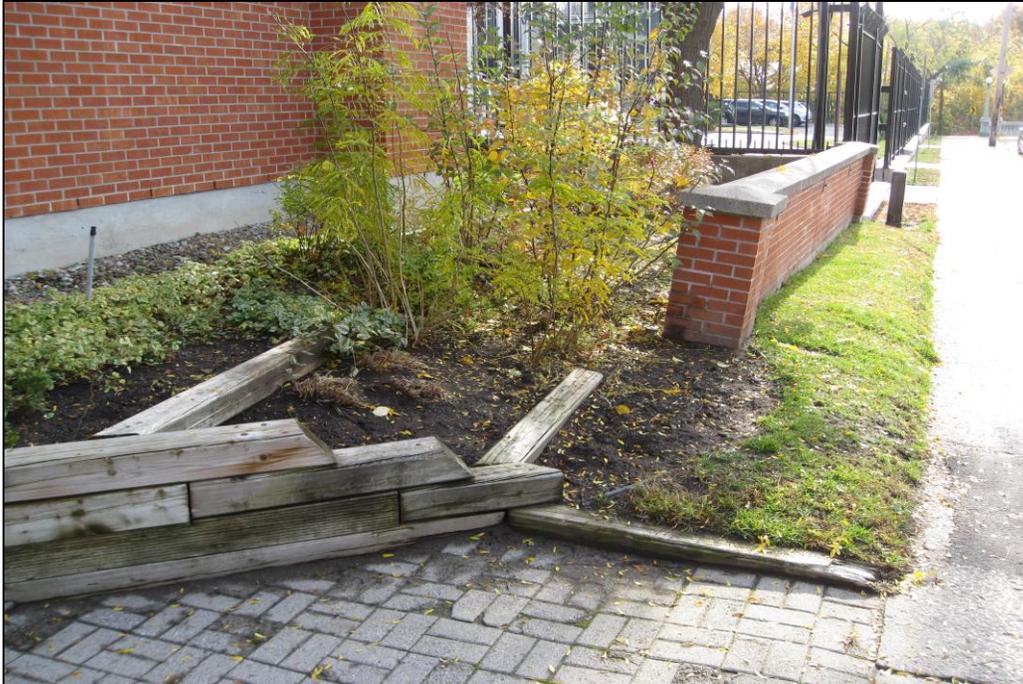
**BELOW:** Support anchors on southwest corner retaining wall.

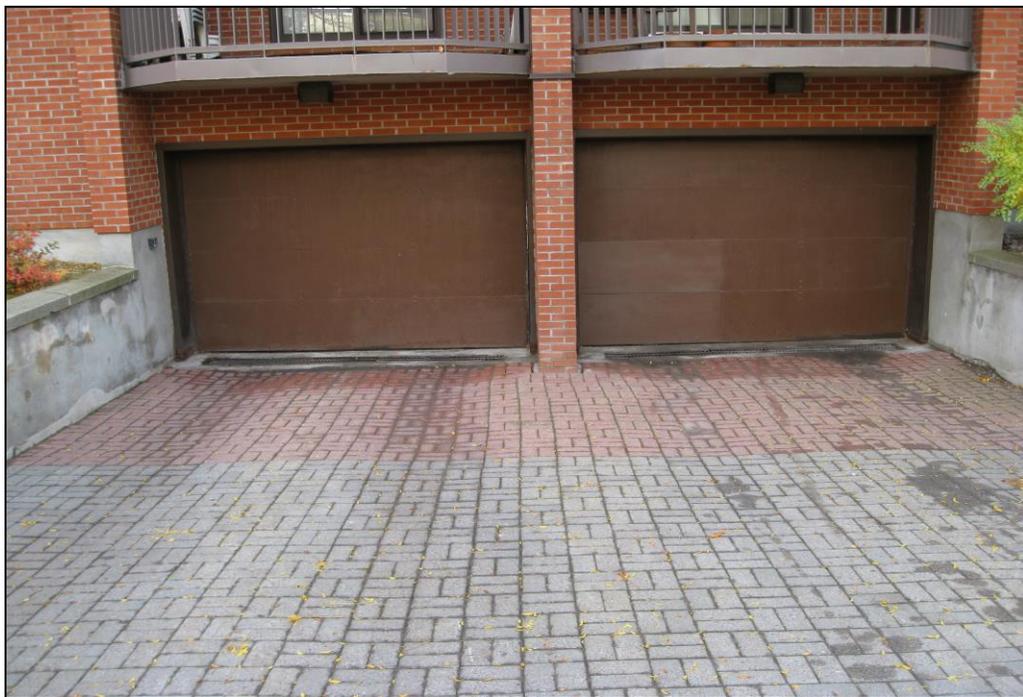
Cast-in-place concrete retaining walls run along each side of the parking garage entrance ramp. They are in satisfactory condition but will need periodic repairs to the concrete and parging. If the walls are well maintained, complete replacement should not be required during the study period.

**ABOVE:** Concrete retaining wall along garage ramp.  
**BELOW:** Storm drain at bottom of garage ramp.

Parging repairs on the retaining walls have been included in the brick masonry repair allowance of \$6,000 in 2020/21.

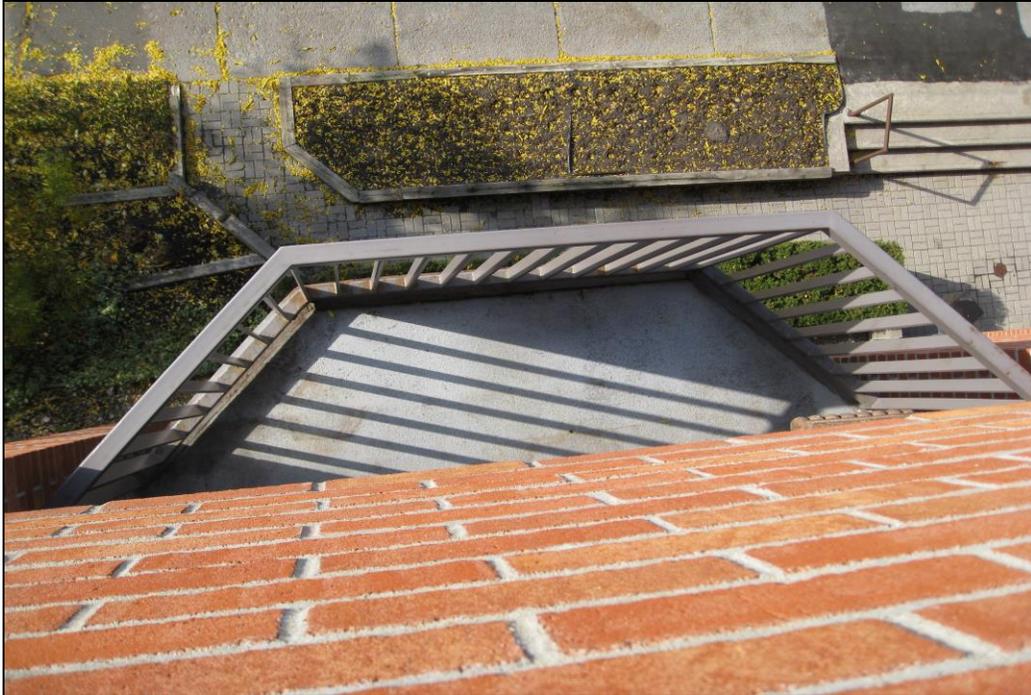
The balcony railings have been refinished in the past and will need to be refinished again in the future before they are eventually replaced. The current condition of the railings varies from balcony to balcony. The railings on the balconies that are more exposed to the elements, i.e., the balconies facing Charlotte St. and Wilbrod St., appear to have the most deterioration on their surface.

**ABOVE:** Typical balcony from above.  
**BELOW:** Rust on a balcony railing.

Refinishing of the railings has also been scheduled in the year(s) 2036/37 and 3046/47 at an estimated cost of five thousand dollars (\$5,000) each year. The refinishing allowances are lower in these years because the railings are scheduled for replacement in 2026/27 and will require minimum refinishing for a number of years thereafter.

Replacement of the railings has been scheduled in the year(s) 2026/27 at an estimated cost of twenty-five thousand three hundred dollars (\$25,300).

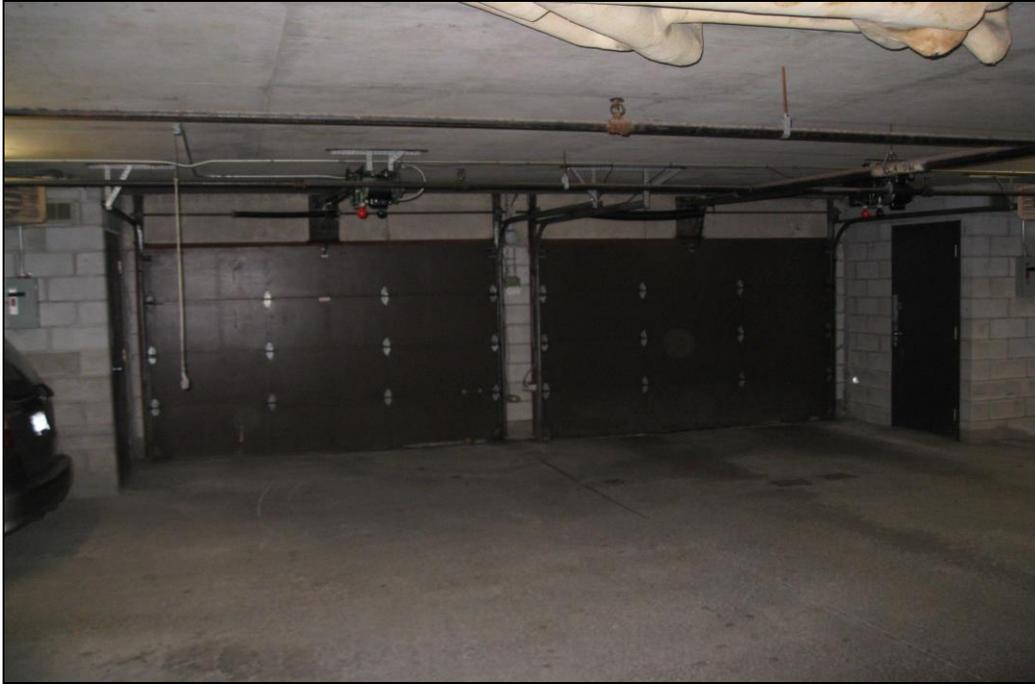
Each of the overhead garage doors has an electric door opener. The normal life expectancy of this type of opener is 5-10 years. These openers like the doors have out performed their life expectancy because of limited usage. We have therefore only budgeted for their replacement three times over the length of the study period.

**ABOVE:** Garage overhead doors.  
**BELOW:** Electric garage door opener.

Replacement of the electric door openers has been scheduled in the year(s) 2022/23, 2031/32 and 2046/47 at an estimated cost of four thousand four hundred and seventy-two dollars (\$4,472) each year.
