RESERVE FUND STUDY UPDATE WITH SITE VISIT CARLETON CONDOMINIUM CORPORATION No. 34 OTTAWA, ONTARIO

File # 19543
February 27, 2020

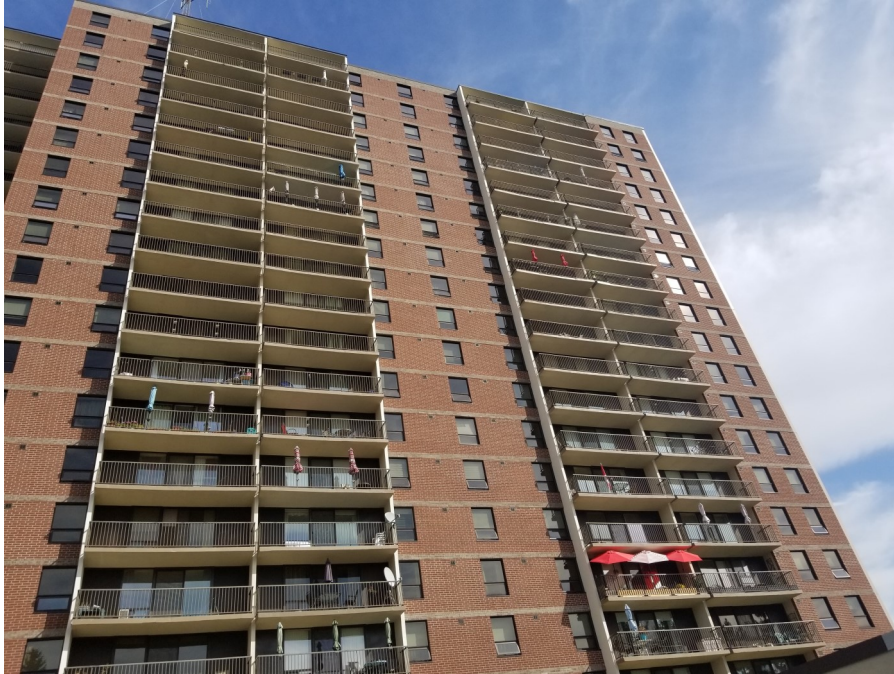
- 1 General view of masonry veneer, punched windows and balconies on west elevation

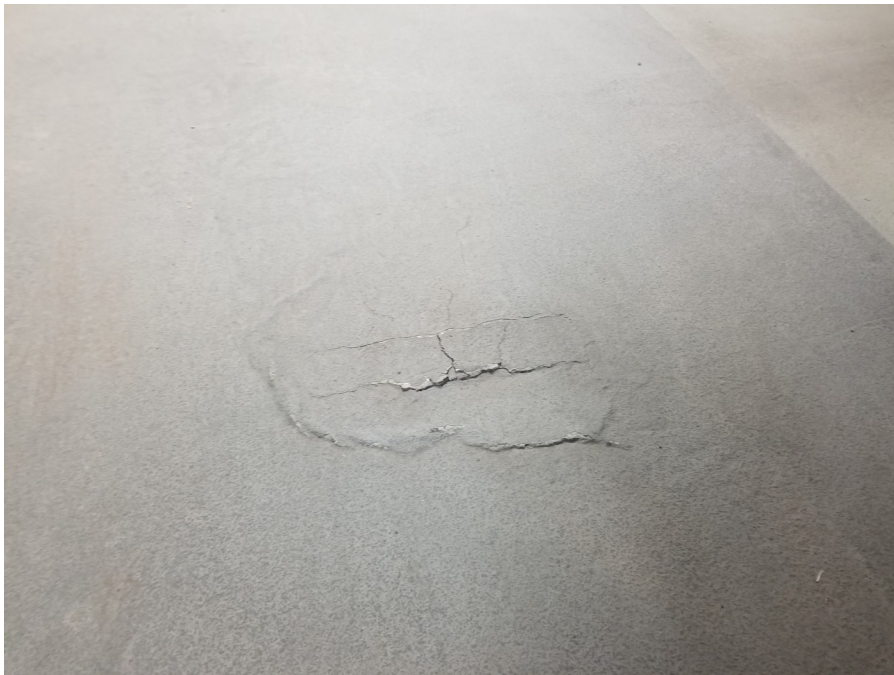
The traffic bearing membrane was replaced in 2005; however repairs were performed in 2014. The traffic bearing membrane varies from fair-to-satisfactory condition with moderate delamination and surface deterioration observed. We estimate repairs will be required in the next 5 years. A subsequent replacement will be required in the next 5-10 years.

- 2 Close-up view of membrane and concrete delamination on parking garage intermediate slab

- .F In order to ensure funds are available to perform localized repairs to the traffic bearing waterproofing on suspended slab when required, an allowance of **\$30,000** has been made in fiscal year **2021 and every 12 years thereafter**
- .G Replacement of the traffic bearing membrane on the suspended slab is estimated to cost **\$400,000** and this work has been budgeted in fiscal year **2025 and every 20 years** thereafter.
- .H Minor repairs of the traffic bearing membrane should be performed, as required, using funds from the operating budget.

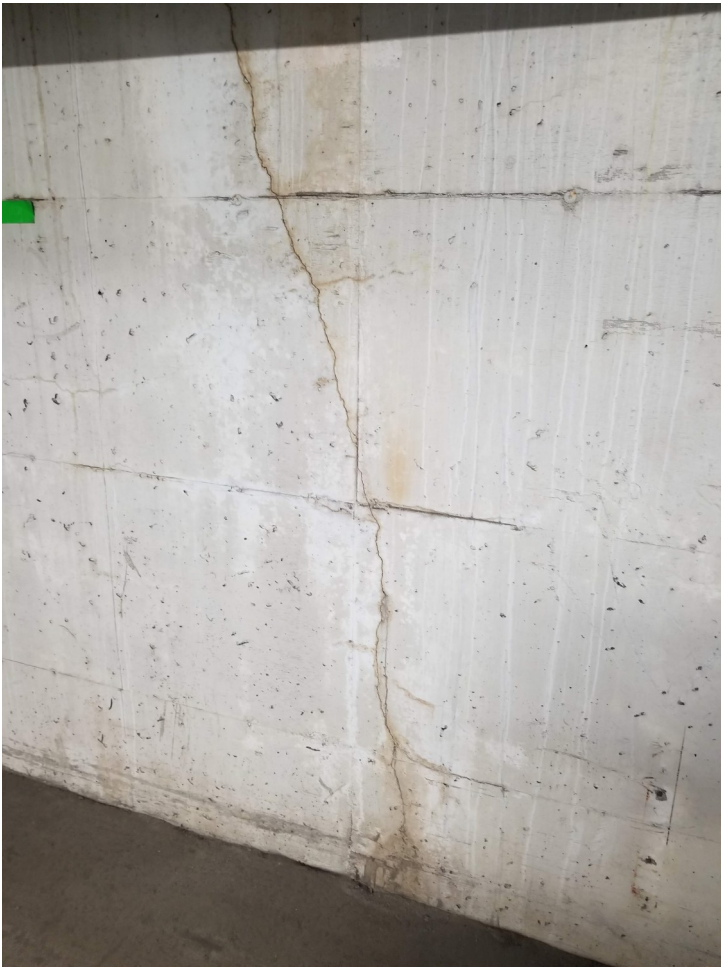
3 Showing crack in north garage foundation wall

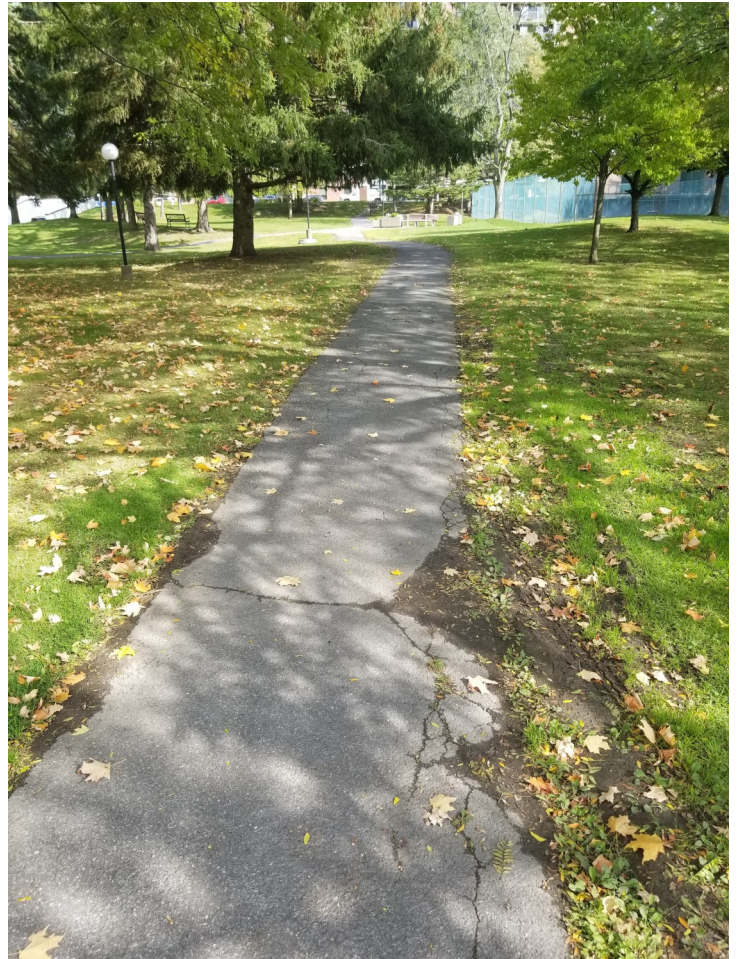
The asphalt walkways are suspected to have been replaced in fiscal year 2000; as such are 20 years old. The asphalt pavement is in fair condition with moderate cracking, settlement and heaving observed. We estimate replacement of the walkways will be required in the next 5 years. A subsequent replacement will be required in 15 years, following the initial replacement.

4 Typical cracking of asphalt walkways

- .F Replacement of the asphalt walkways is estimated to cost **\$20,000** and this work has been budgeted fiscal year **2020 and every 15 years** thereafter
- .G To maintain the condition of the asphalt walkways between resurfacing cycles, crack and rut repairs and asphalt patching should be performed on a regular basis using funds from the operating budget.

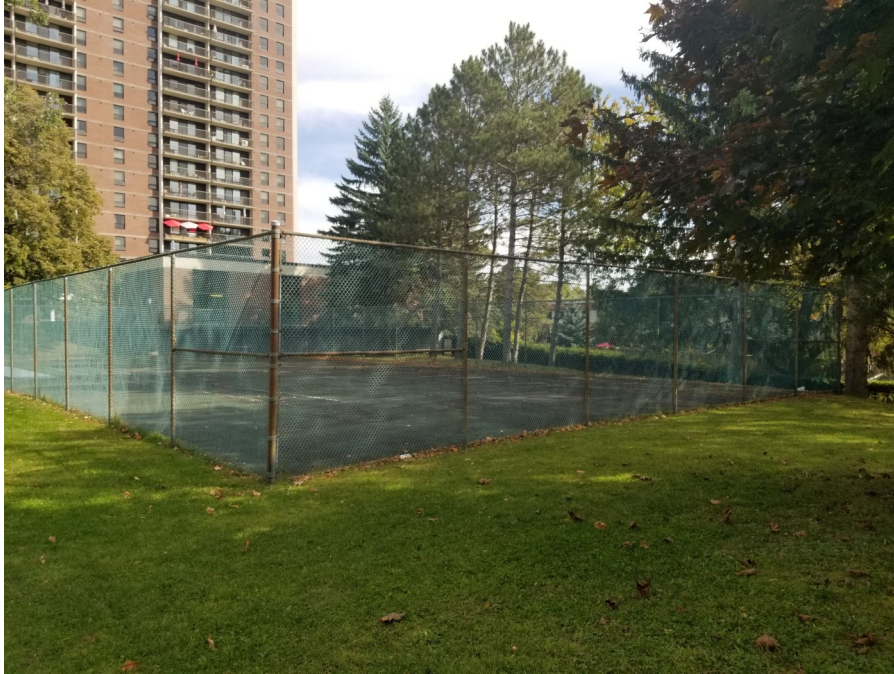
5 Condition of tennis court fencing

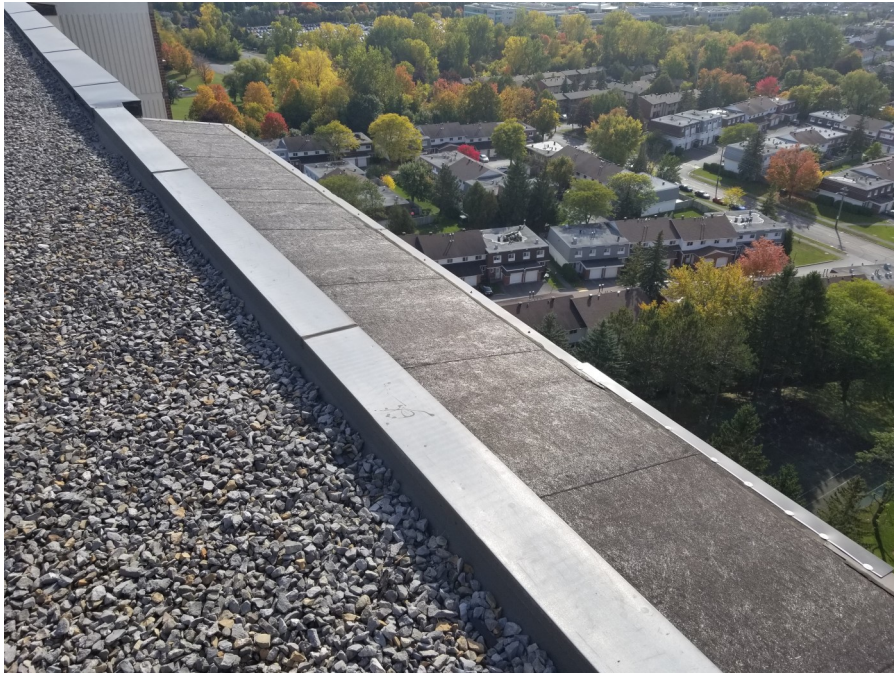
6 Recently replaced conventional balcony canopy roof

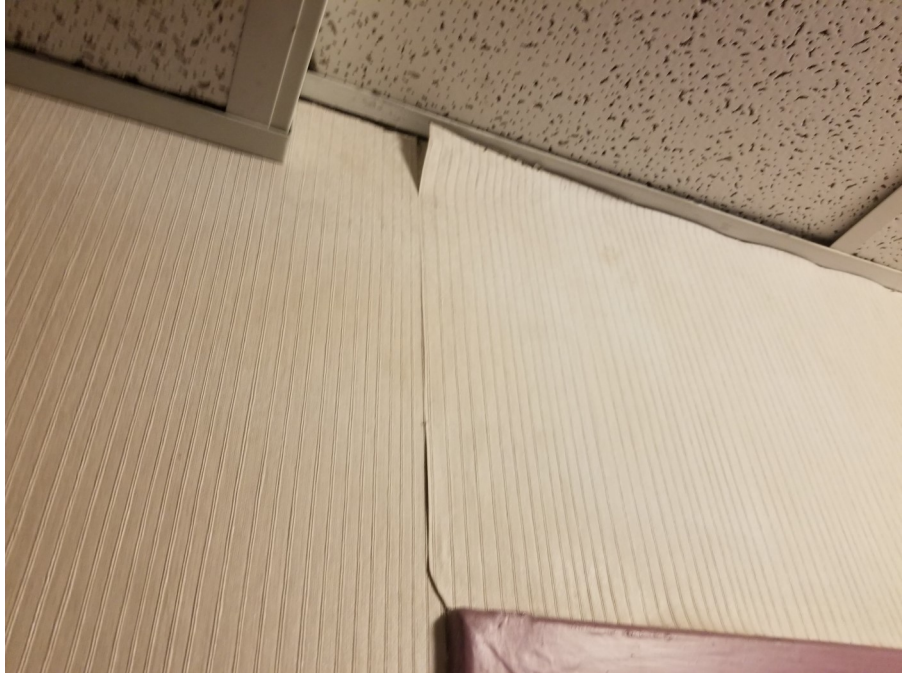
7 Typical deterioration of corridor wallpaper

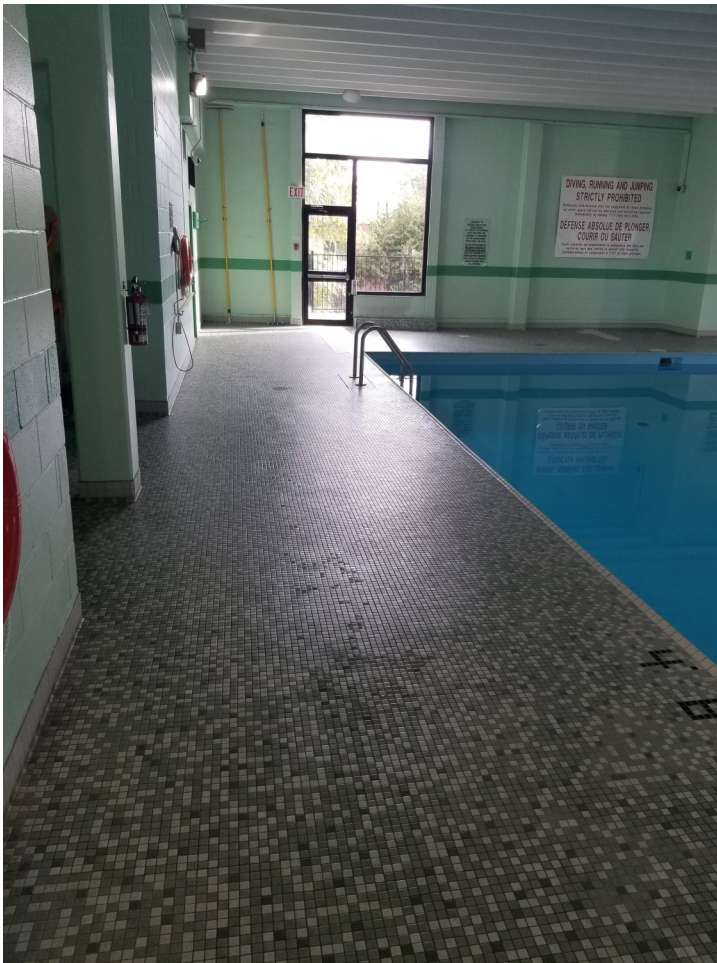
8 General view of pool deck
