Comprehensive Reserve Fund Study

Carleton Condominium Corporation No.339

November 20, 2020

C2997-REP.01

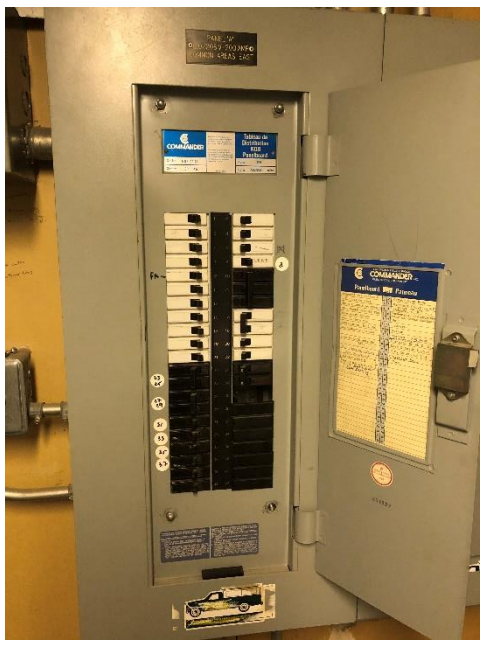
Photograph No. 18

Date: 5/25/2020	
Description Common element electrical "Panel A" is missing knock out breaker cover plate.

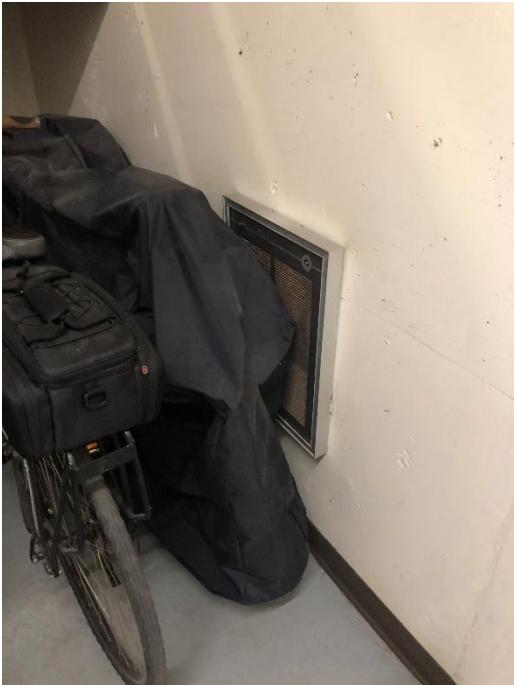
Photograph No. 36

Date: 5/25/2020	
Description Typical electrical force flow heating located in stairwell. It was noted that storage of bicycle leaning on force flow heater is creating a potential fire hazard. Area in front of heater should be clear of any obstructions.

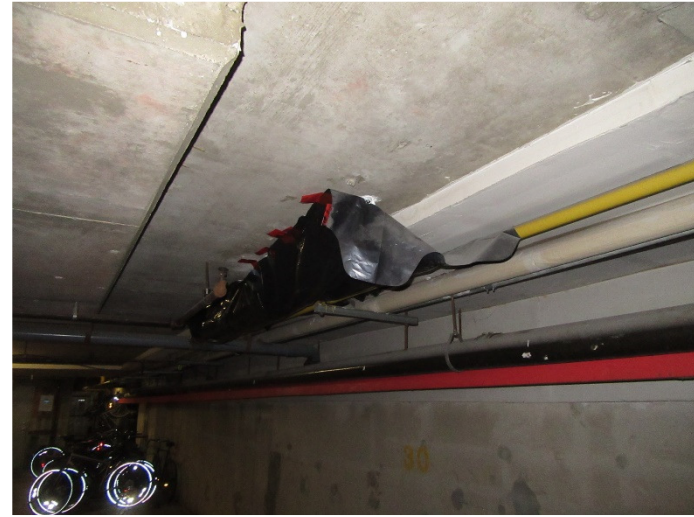
Photo D.2 – Example of a leak through the podium deck membrane into the parking garage.

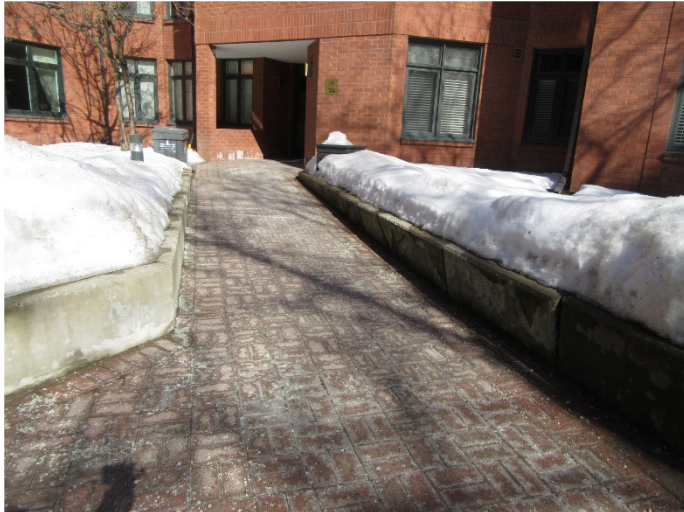
Retaining walls at the front of the building consist of a combination of precast concrete units, cast-in-place concrete, and natural stone. The cast-in-place concrete walls appear to be in satisfactory condition and should provide many more years of reliable service. However, the precast concrete and stone retaining walls are only in fair condition. The precast concrete walls are leaning, while the stone retaining walls have many loose and/or missing stones. Therefore, in conjunction with replacement of the podium deck membrane in 2022, we budgeted \$70,000 to replace the precast concrete and stone retaining walls.

Photo D.3 – Showing precast concrete retaining walls that are leaning.

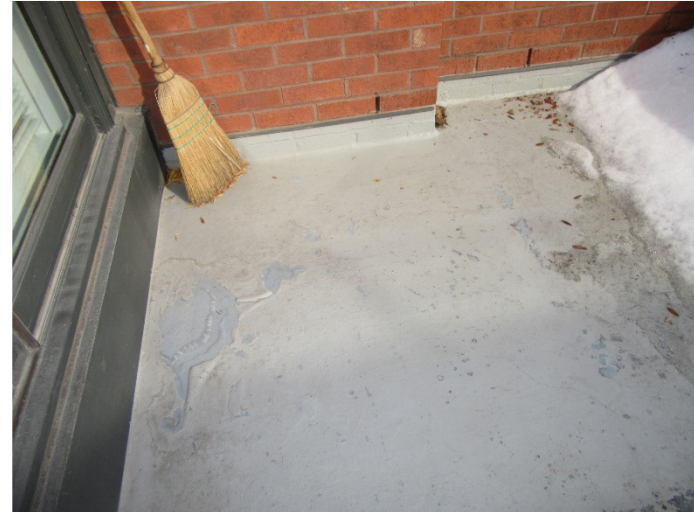
The elastomeric waterproofing membrane on balcony slabs is in fair condition and should be replaced soon. Therefore, we budgeted \$20,000 to replace balcony waterproofing membranes in 2023. Elastomeric membranes should provide fifteen years of service before replacement is again required. Therefore, \$20,000 is budgeted to replace balcony waterproofing membrane a second time in 2038.

Photo D.4 – Showing balcony waterproofing membrane that is peeling.

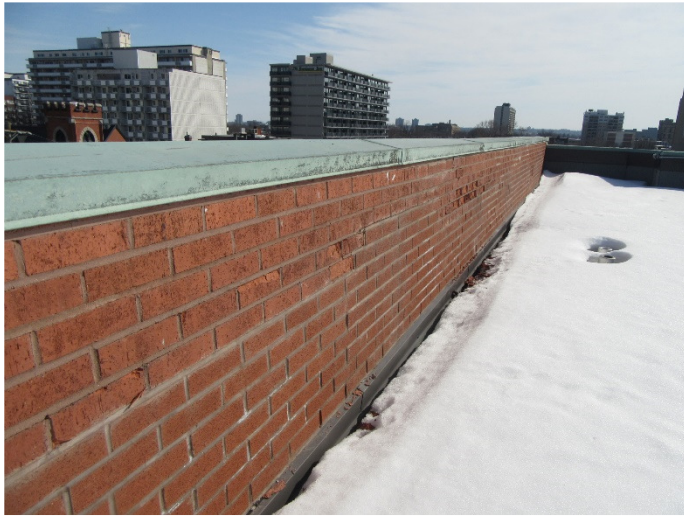
The brick masonry veneer is mostly in satisfactory condition. However, several areas of spalled bricks were observed, including at parapet walls, near balcony scuppers, and at balcony privacy walls. In addition, extensive brick spalling was observed at the east façade, though the full extent of brick deterioration could not be determined without conducting a full investigation. Therefore, we recommend a detailed brick masonry assessment be conducted in 2020, with engineering fees estimated to be around \$8,000. Upon completion of the assessment, brick repairs should be completed in 2021 to address deficiencies. Since the extent of required brick repairs cannot be fully determined until the condition of the brick masonry is further assessed, an allowance of \$40,000 is provided for brick repairs. In the end, repair costs could end up being higher or lower, depending on the findings. Furthermore, since the brick masonry veneer will require on-going maintenance repairs throughout the lifetime of the complex, we budgeted allowances of \$15,000 for further as-required brick masonry repairs in 2031 and 2041.

Photo D.5 – Showing numerous spalled brick at a parapet wall.

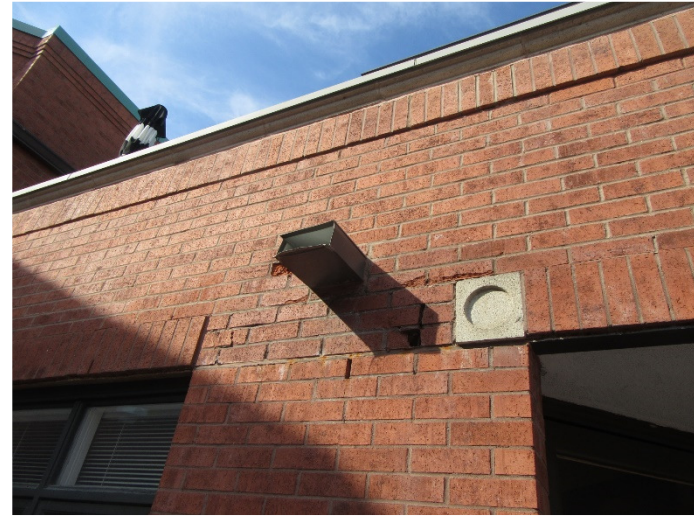
Photo D.6 – Showing spalled bricks near a balcony scupper.

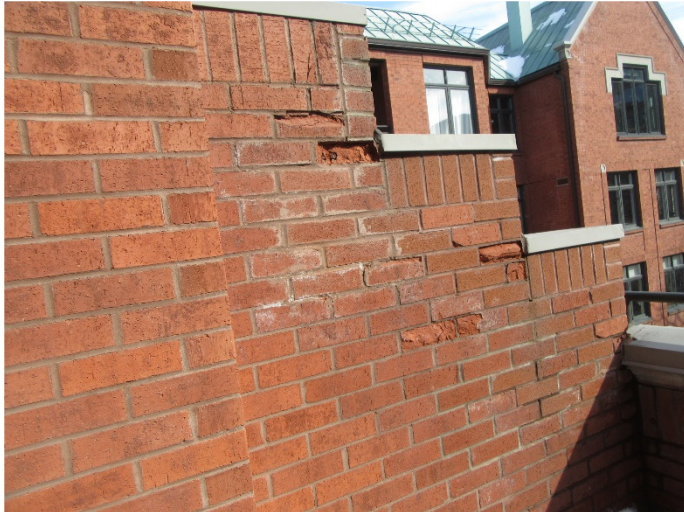
Photo D.7 – Showing a spalled bricks at a balcony privacy wall.

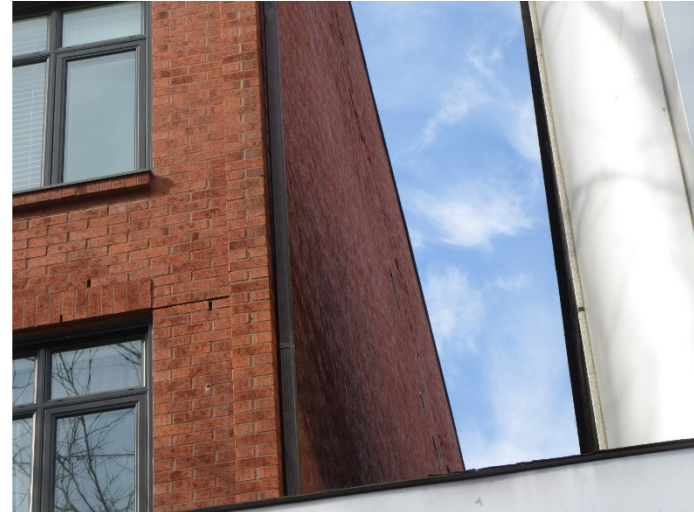
Photo D.8 – Showing numerous spalled bricks at the east elevation.
