FINAL REPORT

Comprehensive Reserve Fund Study with Site Inspection

Carleton Condominium Corporation No. 634

95 Beech Street

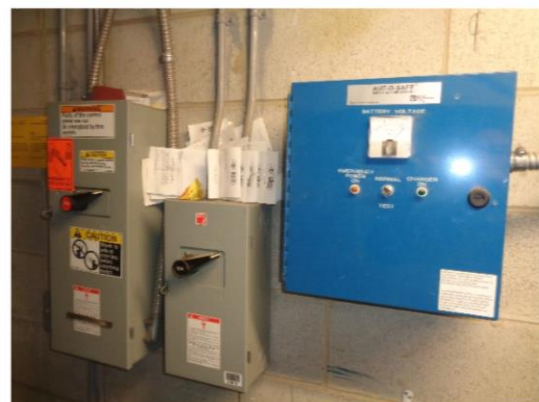
Image 1

Battery Lowering device

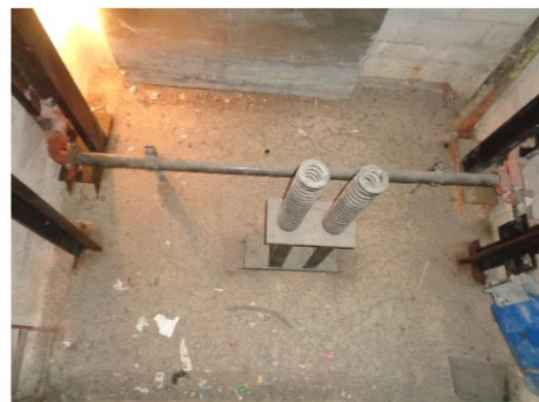
Image 2

Pit

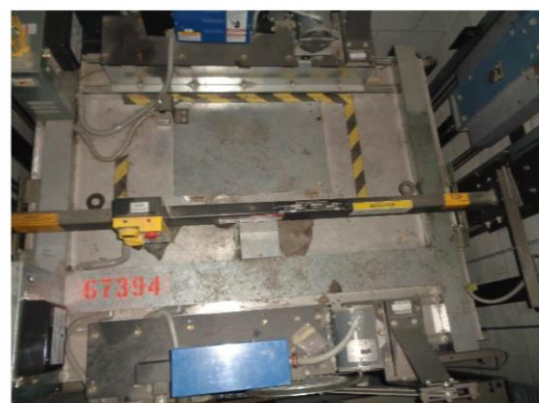
Image 3

Car top
