**Comprehensive Reserve Fund Study**  
**Carleton Condominium Corporation No. 60**

333 Chapel Street, Ottawa, Ontario

Report No. 2150111.00

March 21, 2016

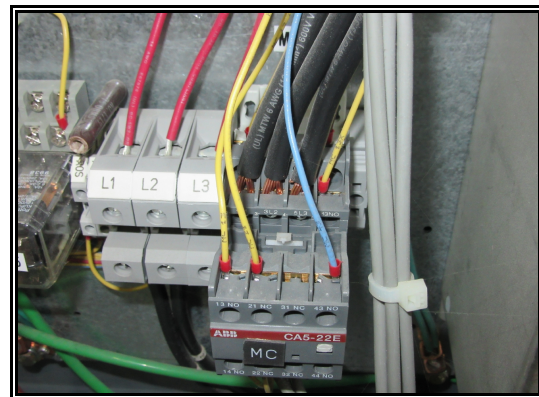
**Elevator 1 Deficiencies**

7. Minimize exposed conductors of high power connections at MC relay and L1, L2, L3.
