Reference: **Elevator Maintenance Audit**  
**324 Laurier Avenue West, Ottawa ON**  
File 226004 - Letter O107568c.wpd

Elevator Maintenance Audit

OCSCC No. 829 - 324 Laurier Avenue West, Ottawa ON

2018-06-07

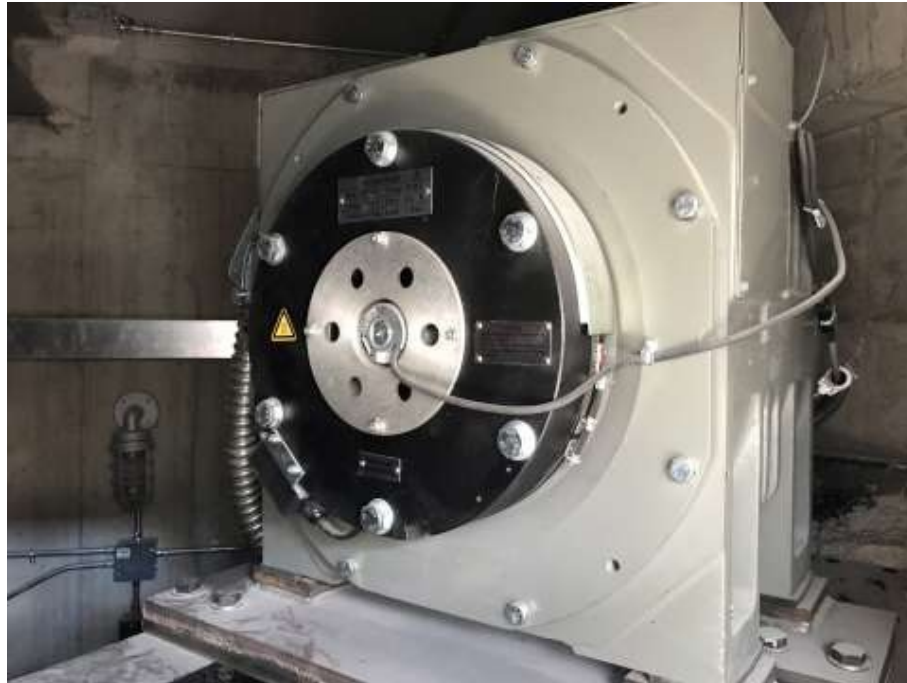
Photo 1: Machine (#3)

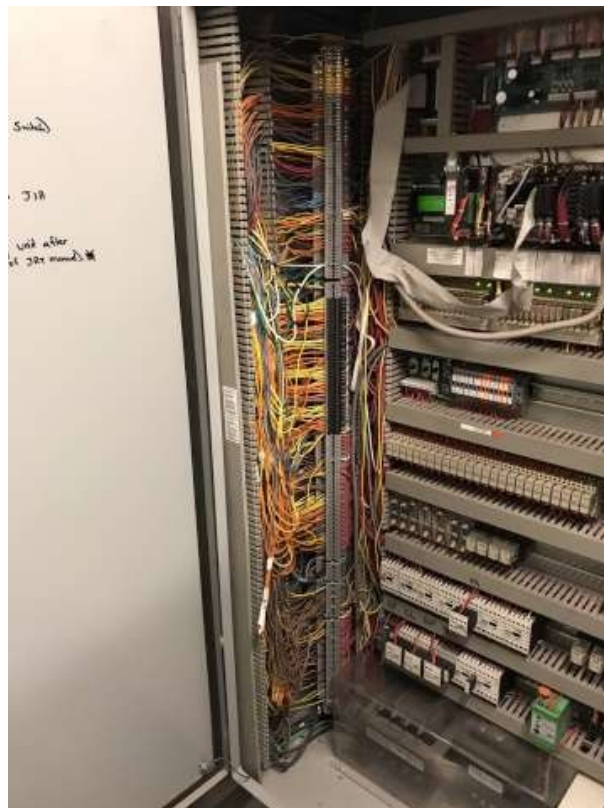
Photo 2: Controller (#2) - install raceway cover

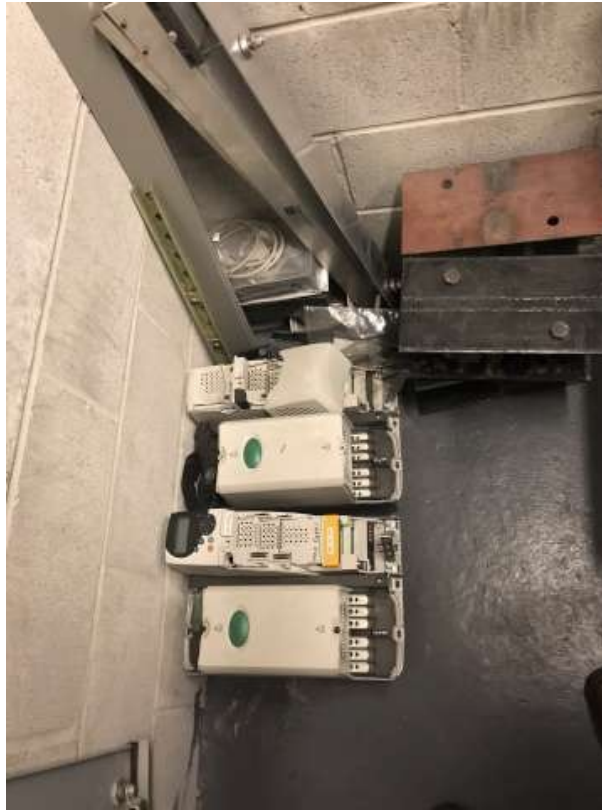
Photo 3: Spare parts in machine room - store properly

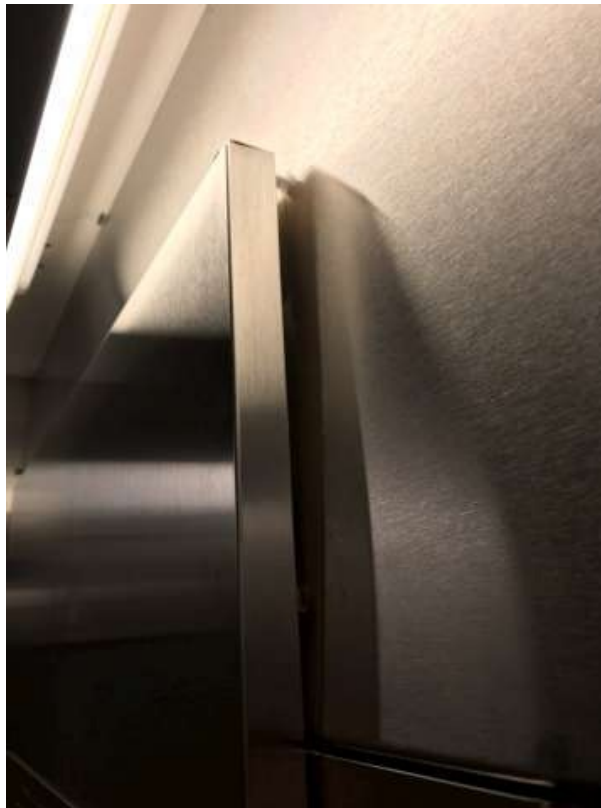
Photo 4: Applied car operating panel (#1) - properly align

10	Diagnose and eliminate cause for irregular arrival signals (gongs).	3
11	Render in-car passing tone operative.	3
12	Adjust applied COP so that the rear is flush, assembly is presently located outside of the alignment stud exposing wiring.	1
<b>Machine room</b>		
13	Close and secure controller cabinet doors.	All
14	Install spare parts cabinet in the machine room. Do not store spare / old parts (drives) on the machine room floor.	1
15	Tidy wiring inside the dispatch controller.	All (Dispatch)
16	Remove jumper stored in dispatch controller cabinet.	All (Dispatch)
17	Re-install raceway cover in controller.	2
18	Confirm completion of outstanding Firefighters' Emergency Operation Category 1 tests (overdue since January 2018) and update the logbook accordingly.	All
19	Confirm completion of outstanding Standby or Emergency Power or Emergency Lowering Operation Category 1 tests (overdue since December 2017) and update the logbook accordingly.	All

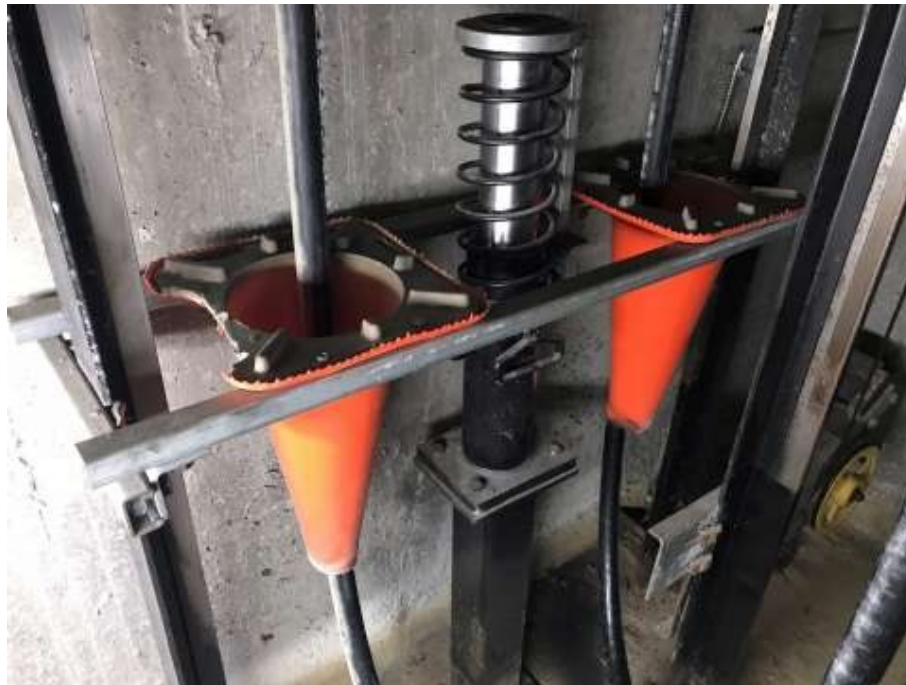
Photo 5: Compensation cable stabilizer (#1) - provide sufficient means

#	Deficiency	Unit
21	Monitor and remove corrosion as required currently present on pit steel.	All
22	Adjust roller guide assembly on underside of cab presently producing uneven wear between rollers.	1
23	Provide suitable means for compensating cable stabilization in pit such as nylon roller assembly. Pylon currently used does not sufficiently control movement and is wearing into cable coating.	All
24	Clean door operator.	1, 2
25	Replace worn hall door pickup roller @ floors 8, 9, 11.	1
26	Replace worn hall door pickup roller @ floors 8, 9 (car clipping roller assemblies during operation).	2
27	Replace worn hall door pickup roller @ floors 9, 13, 15, 18, PH.	3
28	Clean the car top, remove rags.	All
29	Eliminate exposed wire currently present at governor, provide conduit as needed.	2

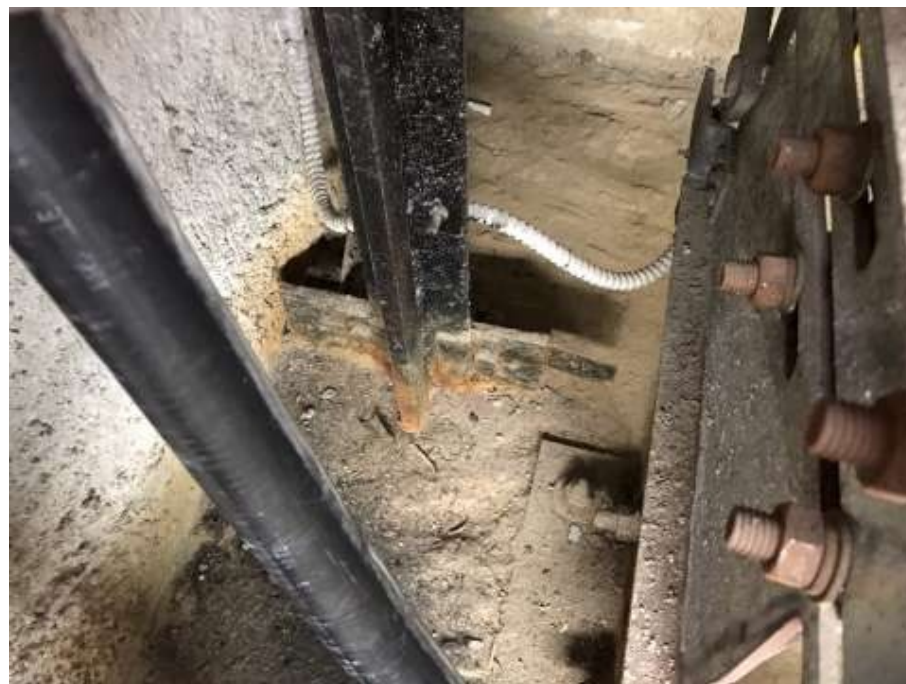
Photo 6: Counterweight pit steel (#1) - scrape and paint

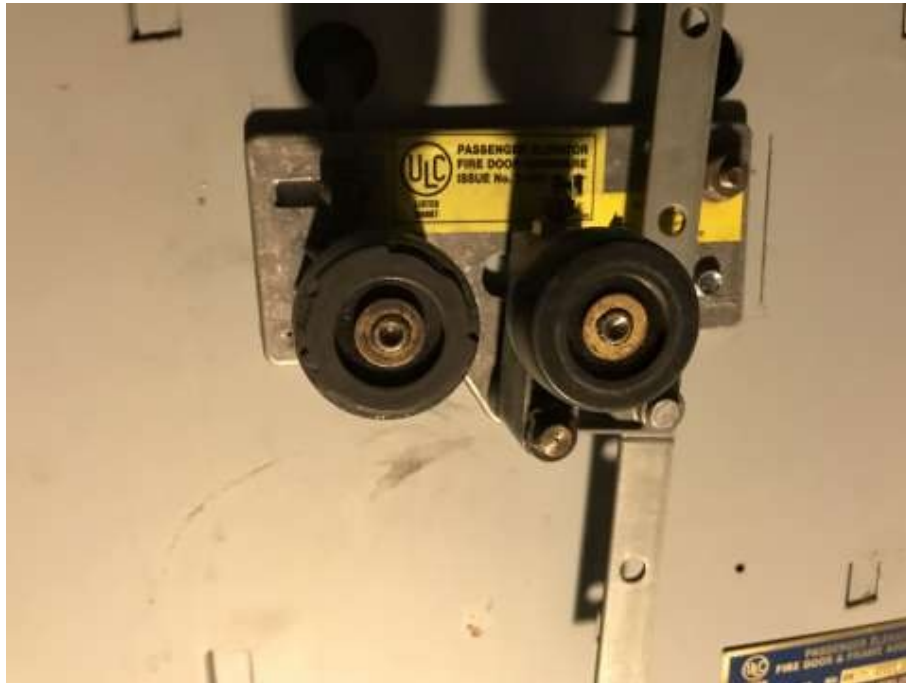
Photo 7: Hall pickup roller (#1) - replace

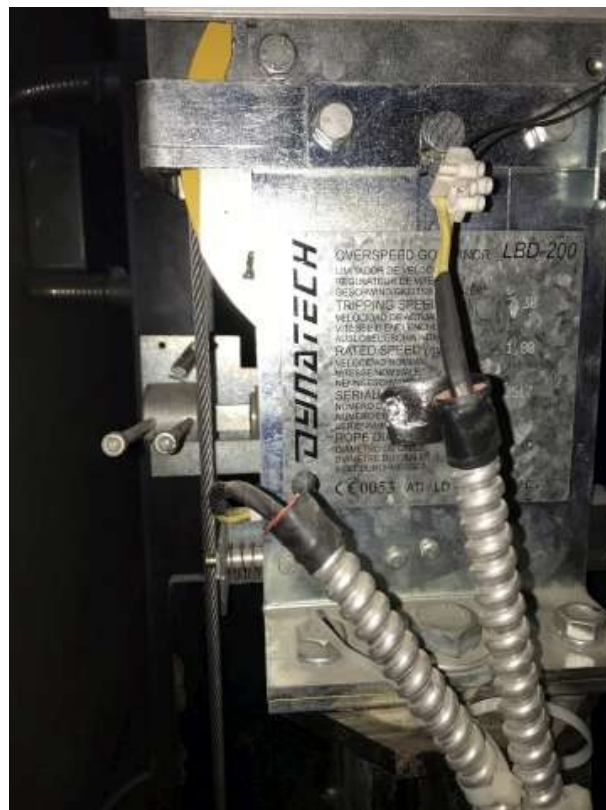
Photo 8: Governor (#2) - provide conduit
