## **BOARD of DIRECTORS - OCSCC1009**

#### **APPENDIX D: DEFICIENCIES TRACKING SUMMARY**

The purpose of the performance audit is to identify performance deficiencies of the common elements of the Condominium that may give rise to a warranty claim under the builder's warranty.

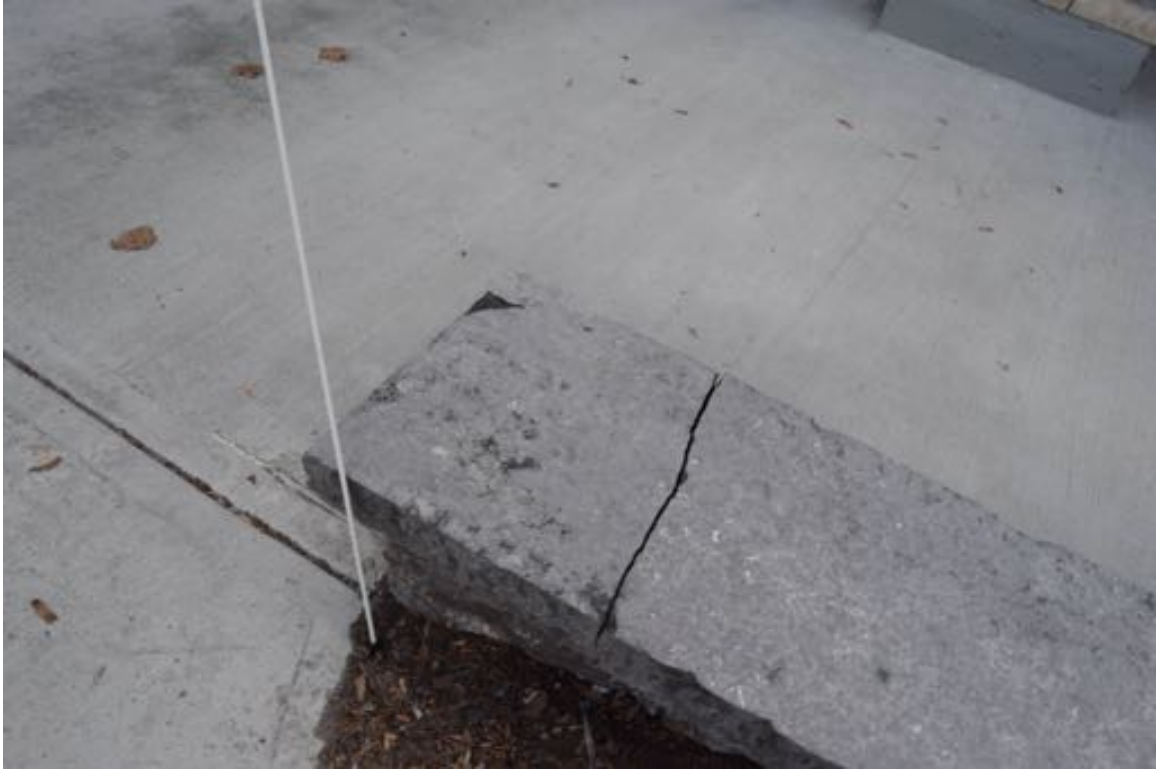
(3) For the small retaining wall leading up to the ramp entrance, the top masonry cap has a large crack, and a chipped corner, refer to Photo 1.

*Photo 1: For the small retaining wall leading up to the ramp entrance, the top masonry cap has a large crack, and a chipped corner.*

The builder will review the above noted deficiencies and make any required repairs to the masonry items under the requirements of the first year warranty.

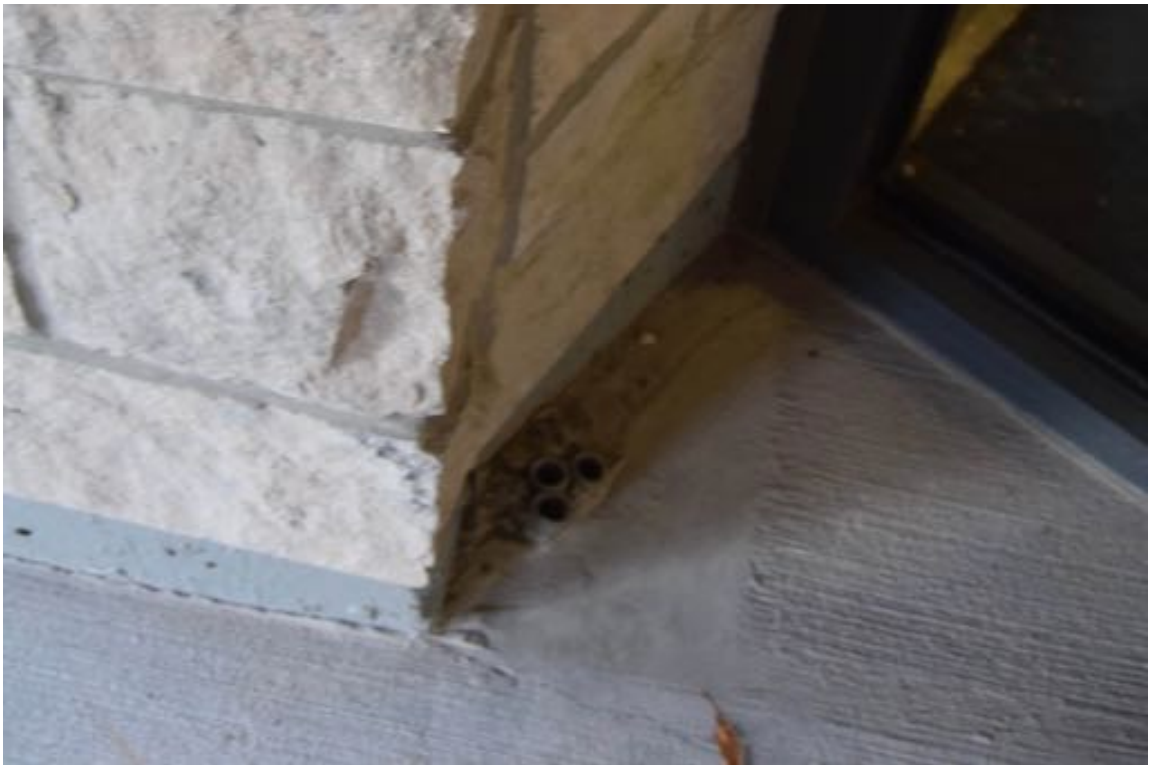
*Photo 2: There are excess conduits visible in the concrete, near the left building entrance.*

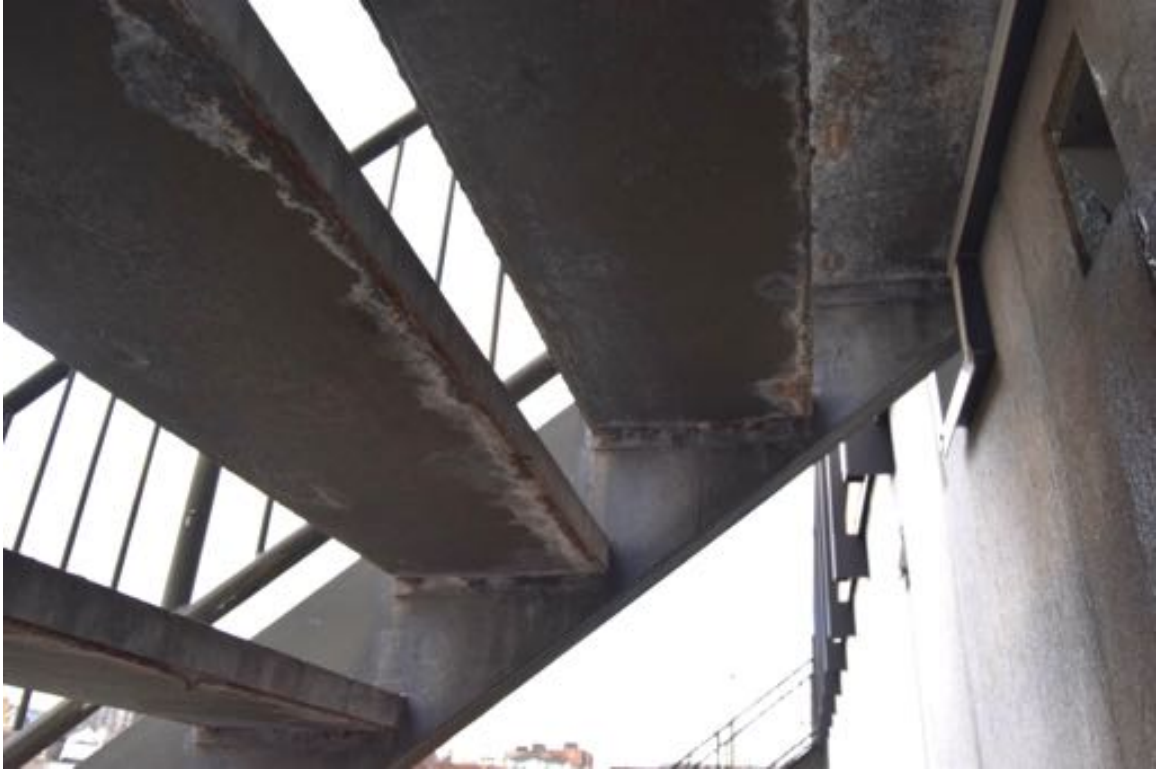
*Photo 3: South staircase is rusting at the bottom.*

The builder will review the above deficiencies and repair the metal items under the requirements of the first year warranty.

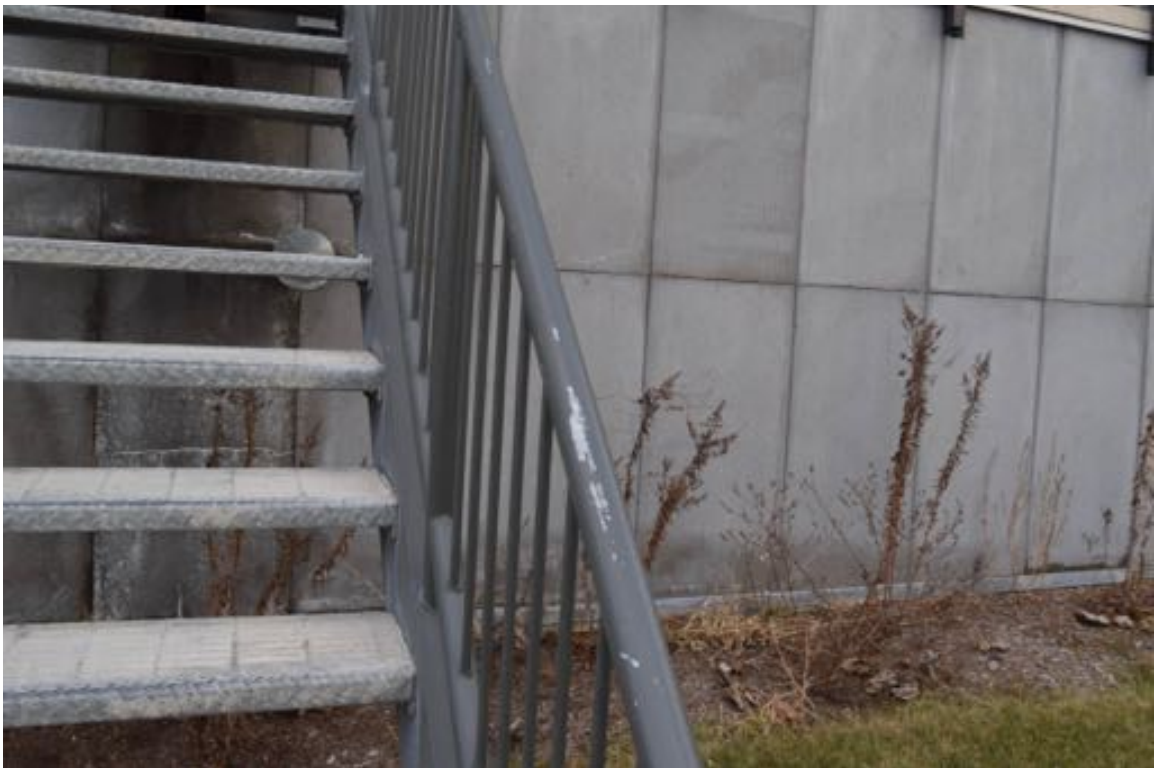
*Photo 4: Paint is peeling on the south staircase.*

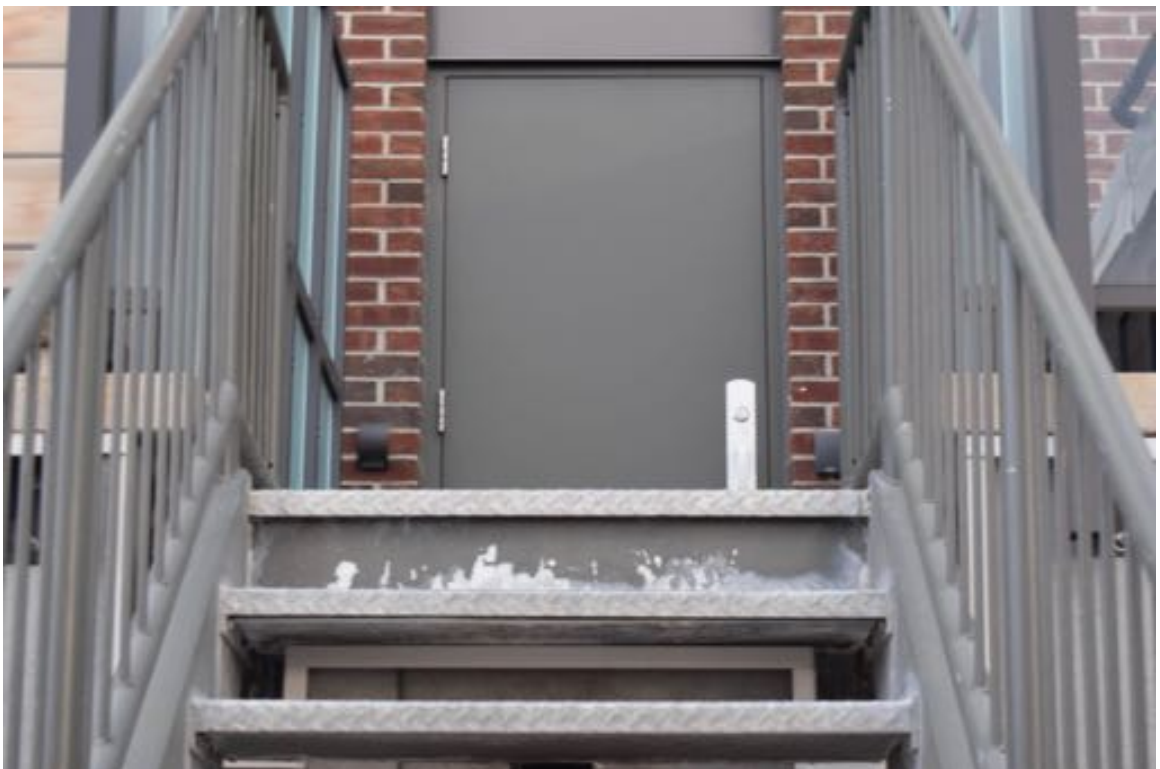
*Photo 6: South staircase top riser is severely rusted*

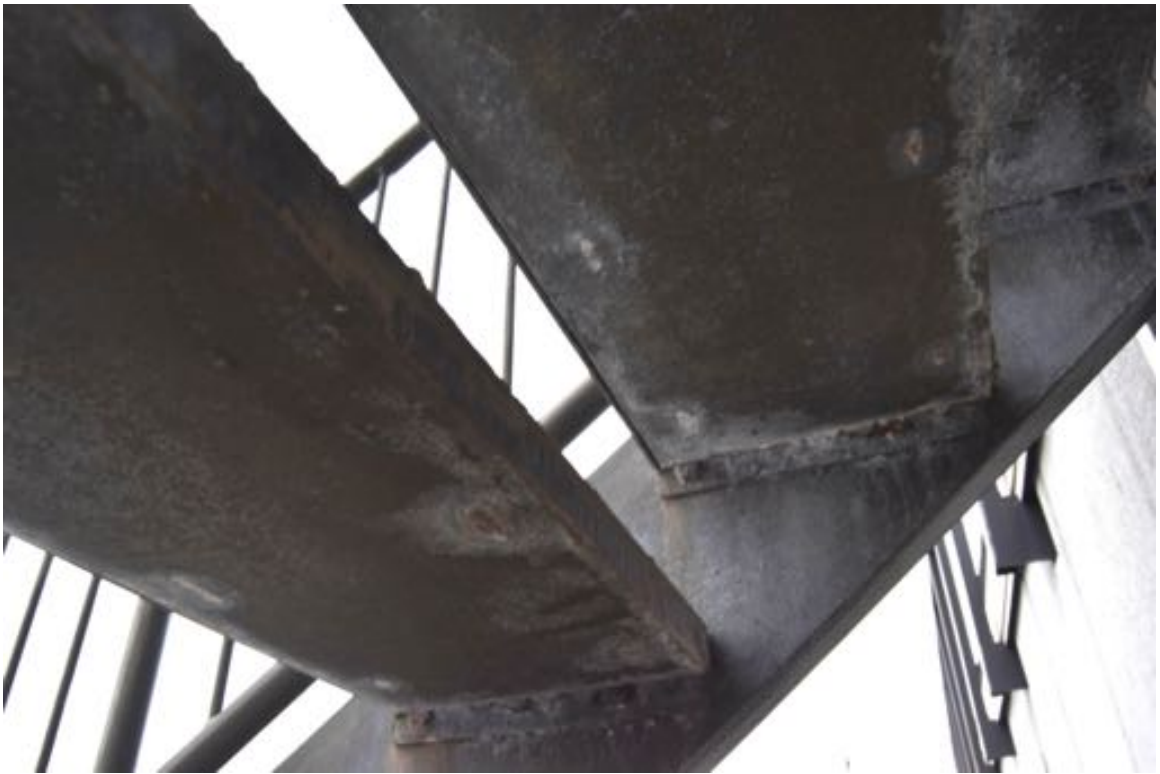
*Photo 7: North staircase is rusting at the bottom.*

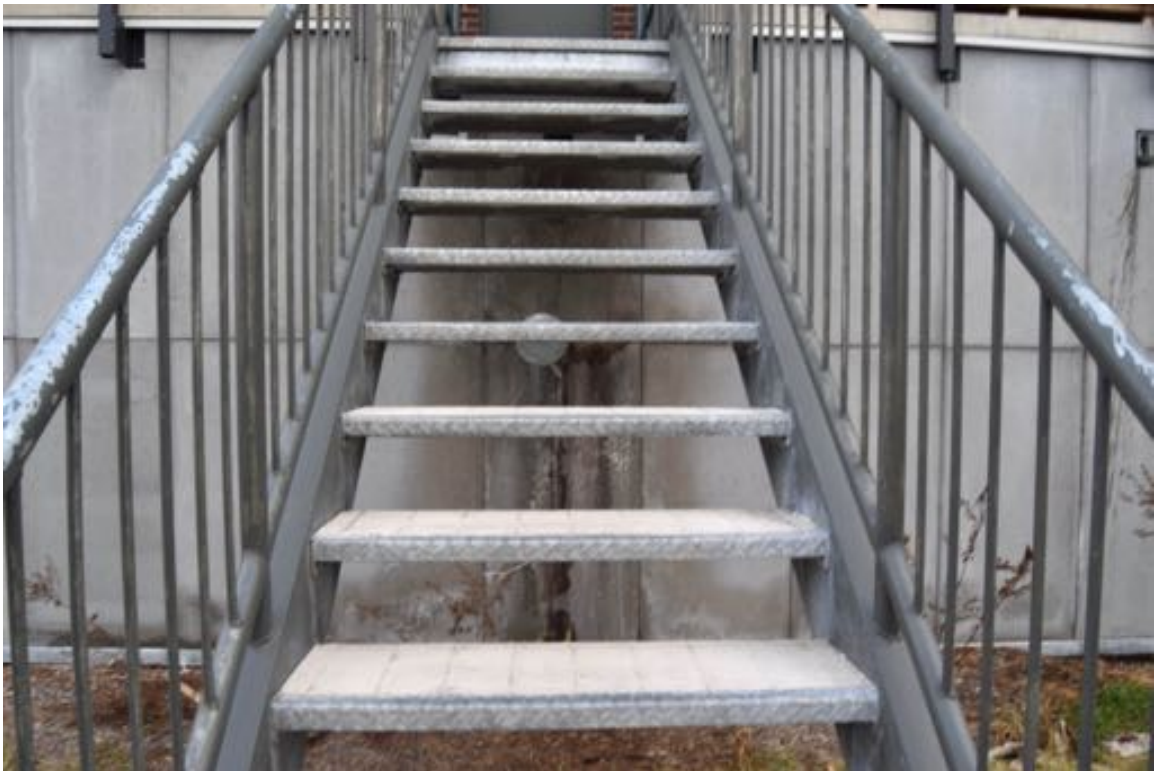
*Photo 8: Paint is peeling on the north staircase railings, and risers.*

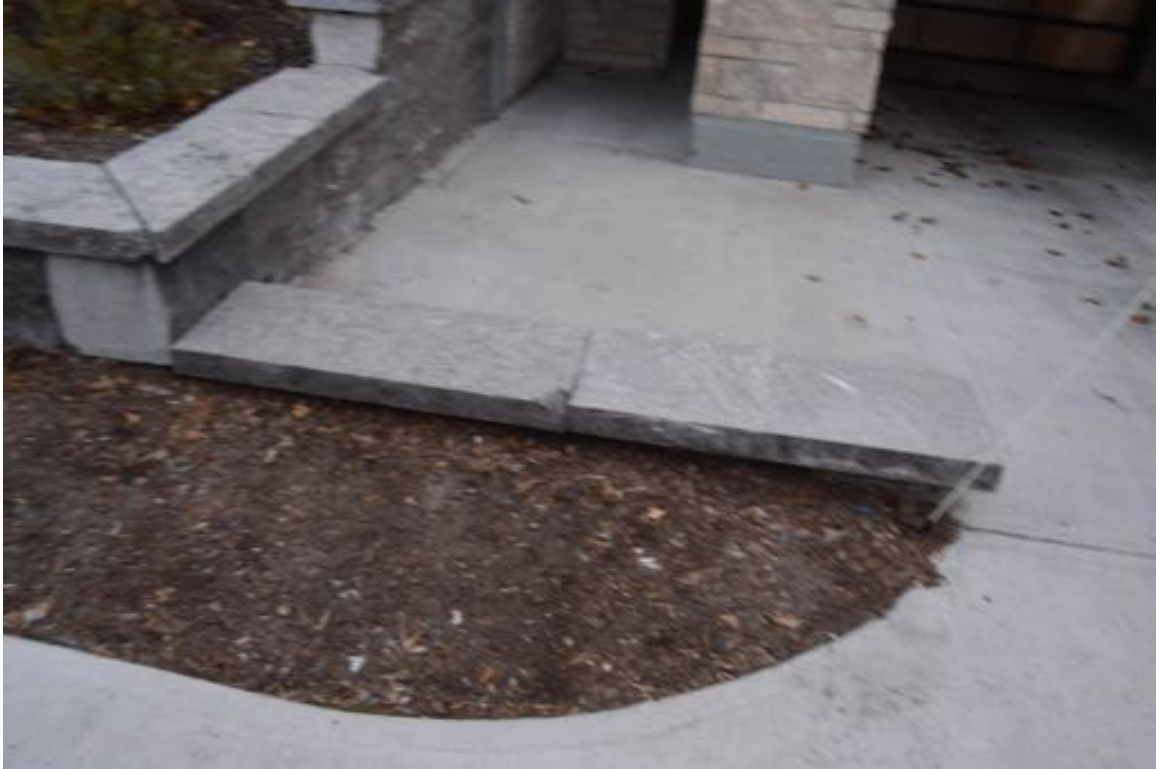
*Photo 11: Sod areas adjacent to entrance ramp have sod missing.*

The builder will review the above deficiencies and repair the soft landscaping items under the requirements of the first year warranty.

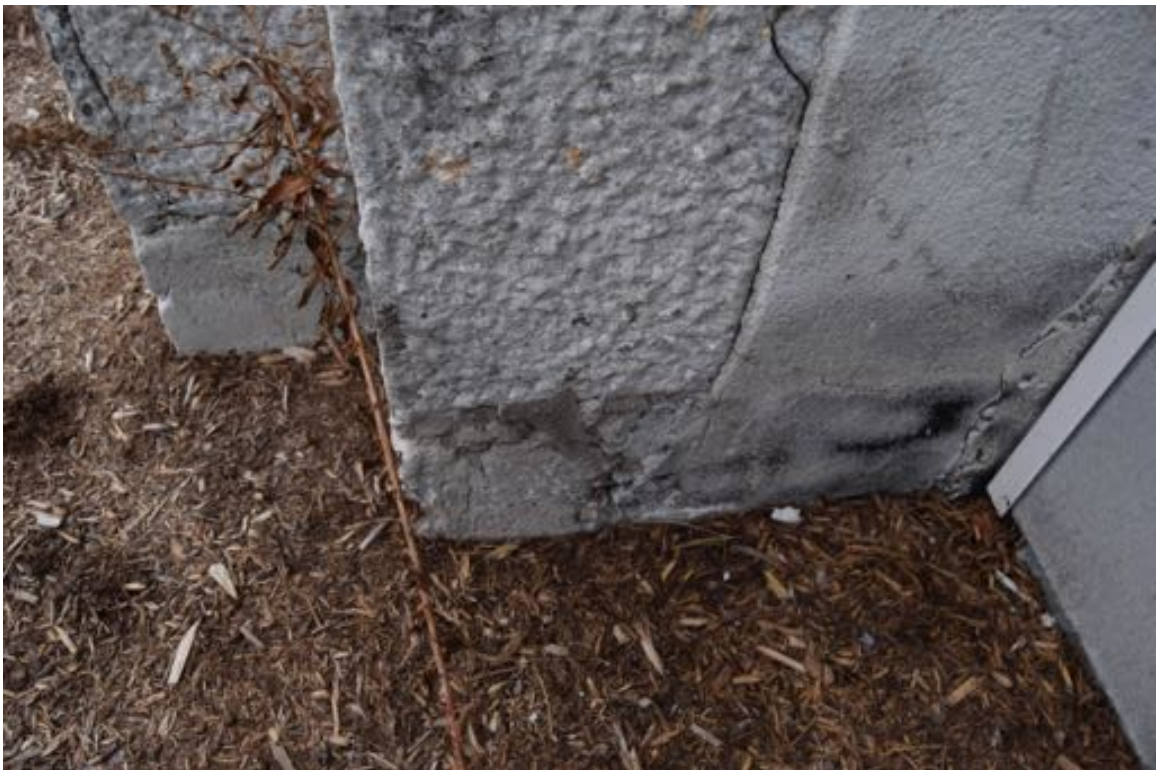
- (9) Staining on the foundation walls and on the brick on the north side of the building, as well as cracked foundation walls (103).
- (10) North elevation, near gridline E, portions of foundations under the existing stone veneer are deteriorating. Refer to Photo 12.

*Photo 12: North elevation, near gridline E, portions of foundations under the existing stone veneer are deteriorating .*

The builder will review the above noted deficiencies and make any required repairs under the requirements of the first year warranty.

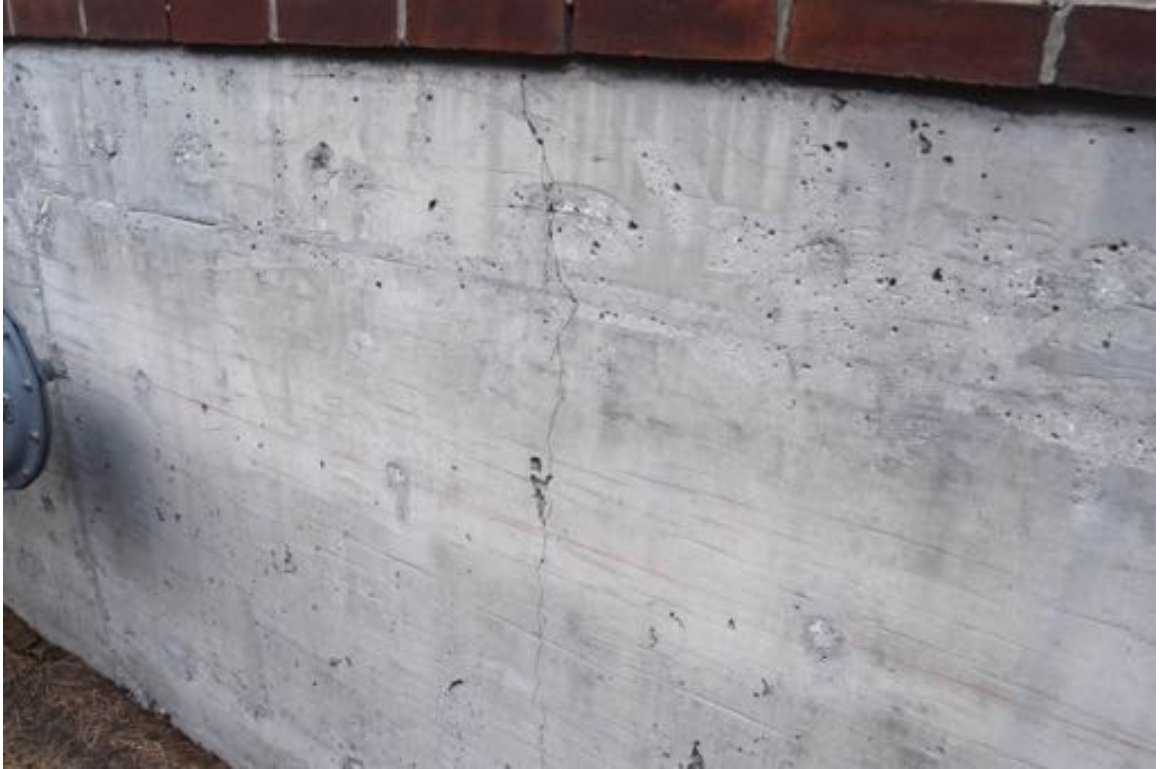
*Photo 13: Southeast side of the building, a crack was noted on the exposed foundation wall.*

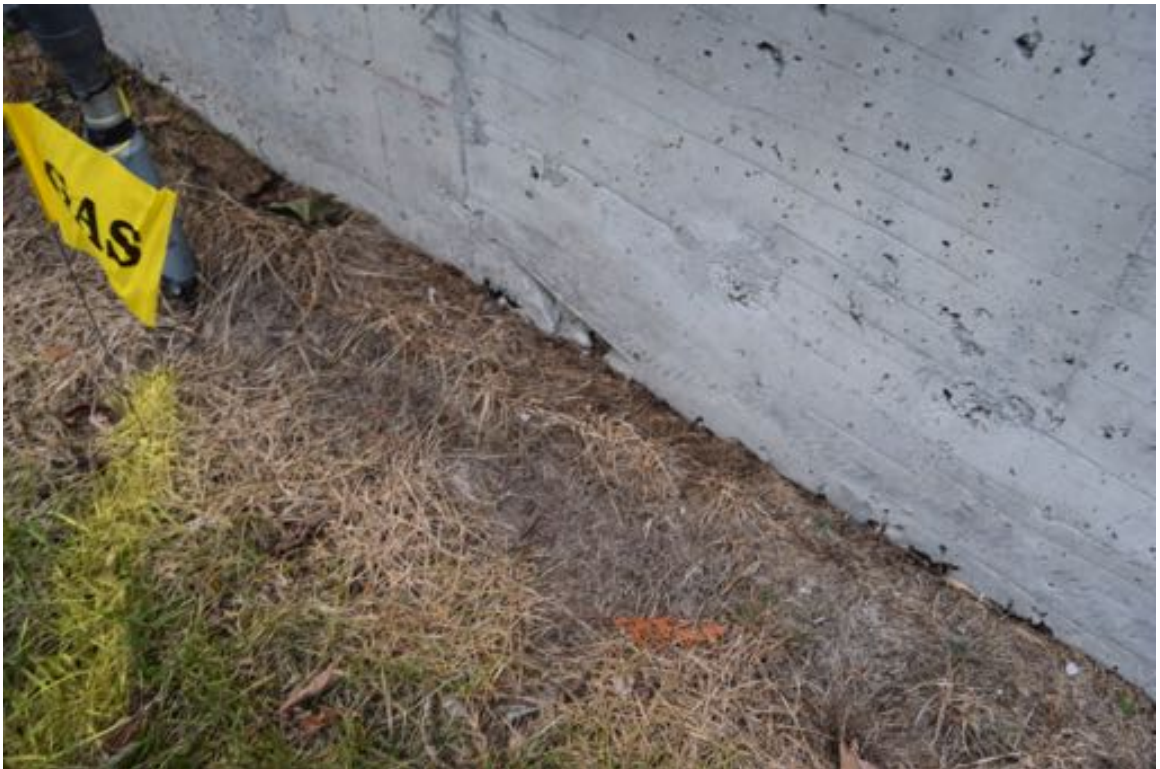
*Photo 14: Southeast side, foundation honeycombing near grade.*

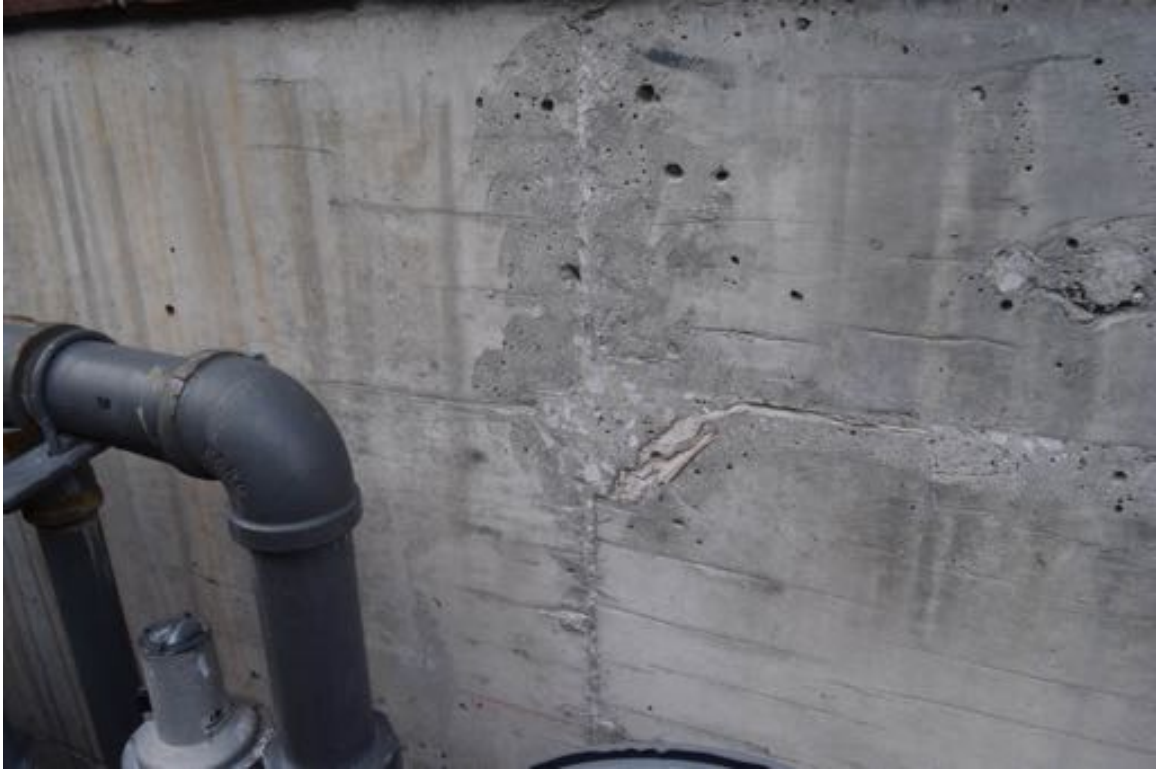
*Photo 15: Southeast side, in general the foundation finishes are poor with remnants of formwork visible.*

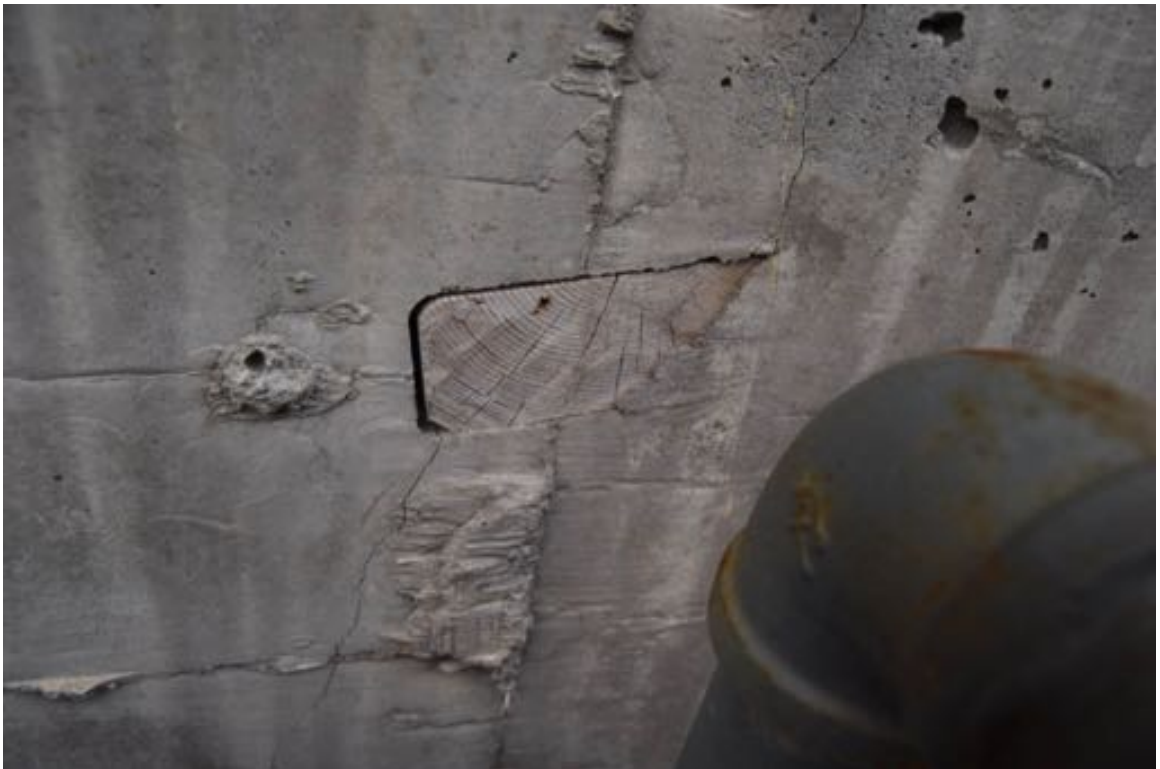
*Photo 16: Southeast side, portions of form work remnants, and a wooden board visible at the foundation.*

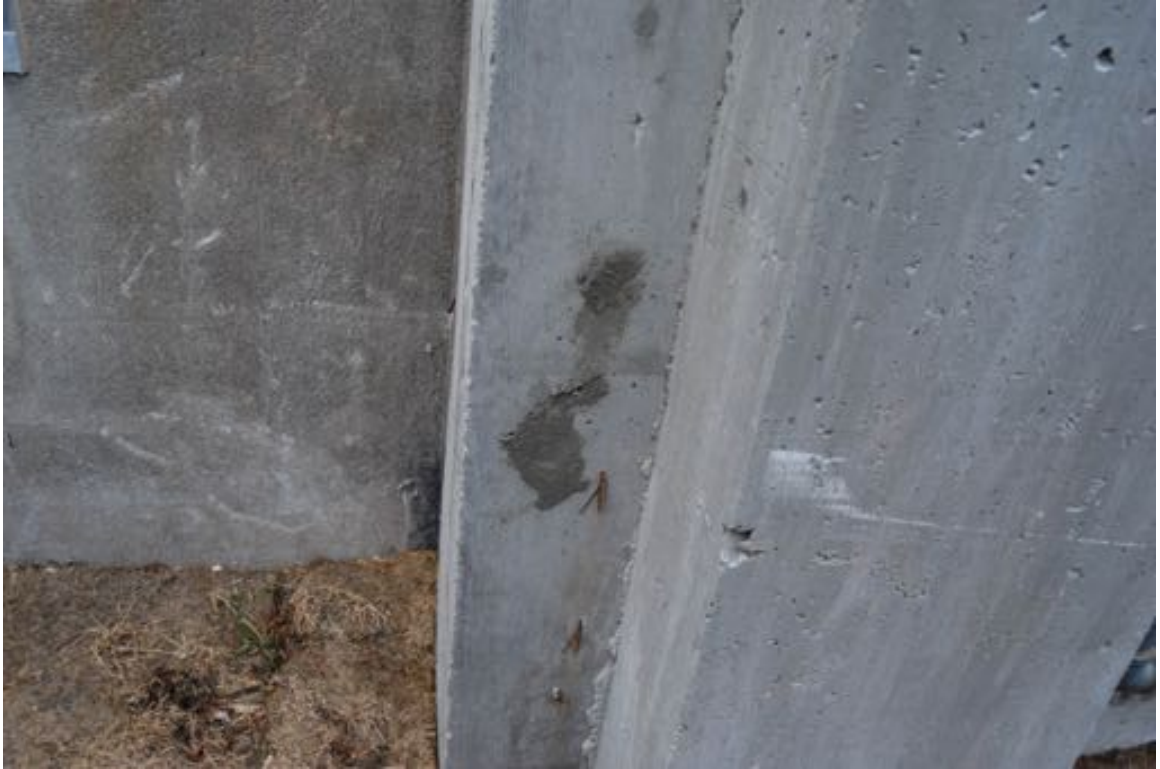
*Photo 17: Southeast elevation, rusting nails protruding from the foundation.*

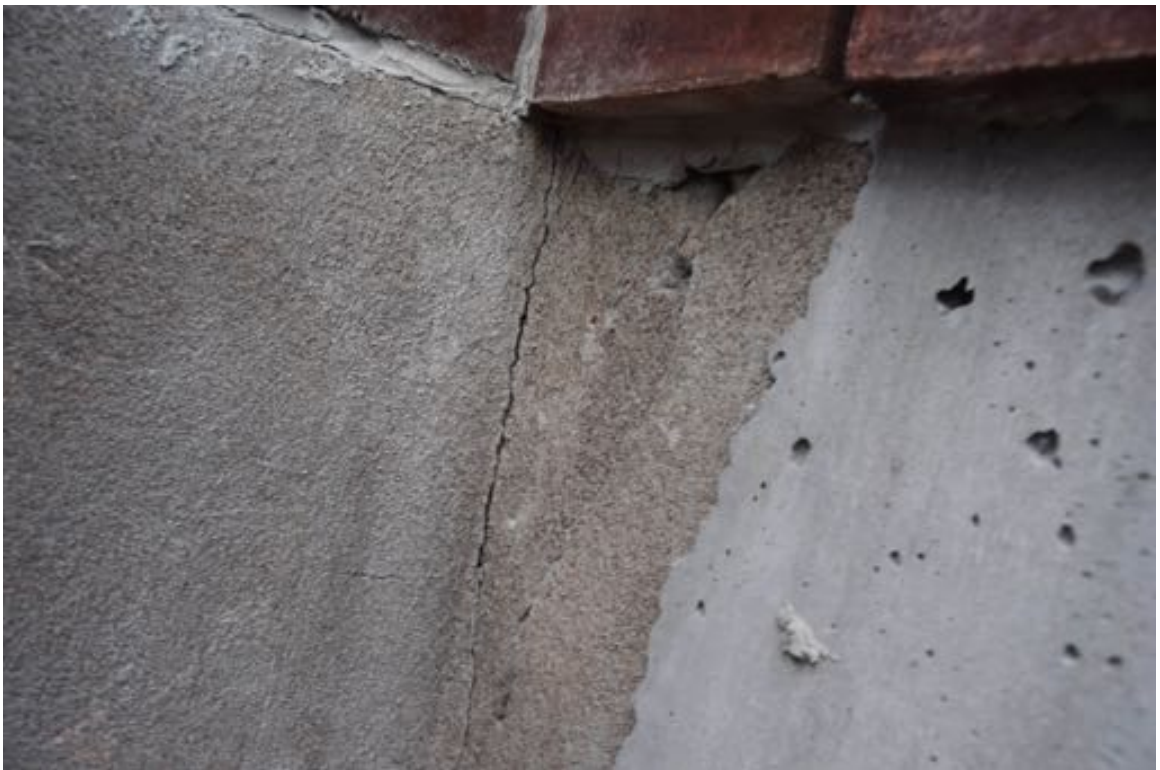
*Photo 18: Southeast corner, multiple cracks noted at the existing foundation wall. This appears to be not new construction, not the 'exposed architectural finished concrete' specified in the architectural drawings.*

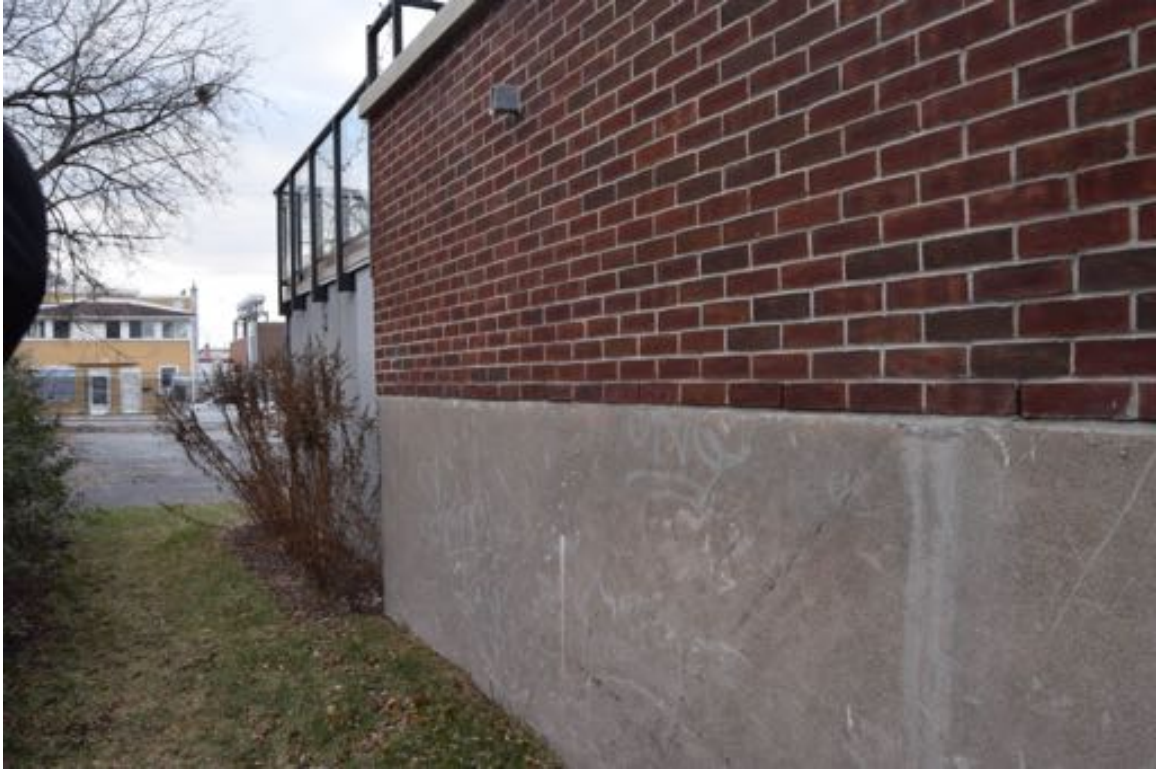
*Photo 19: Multiple graffiti, scratch marks, and stains are also noted at this exposed foundation wall.*

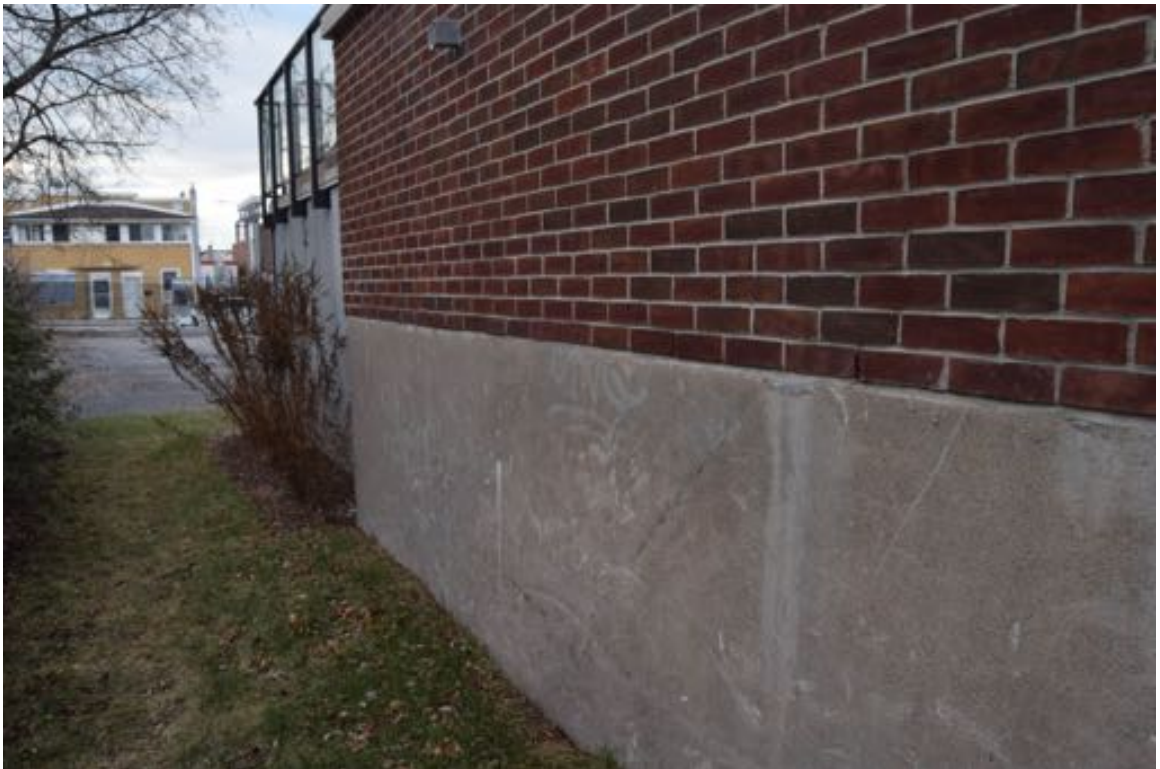
*Photo 20: The southeast corner above grade foundation wall appears to be from the old existing building, and not new construction.*

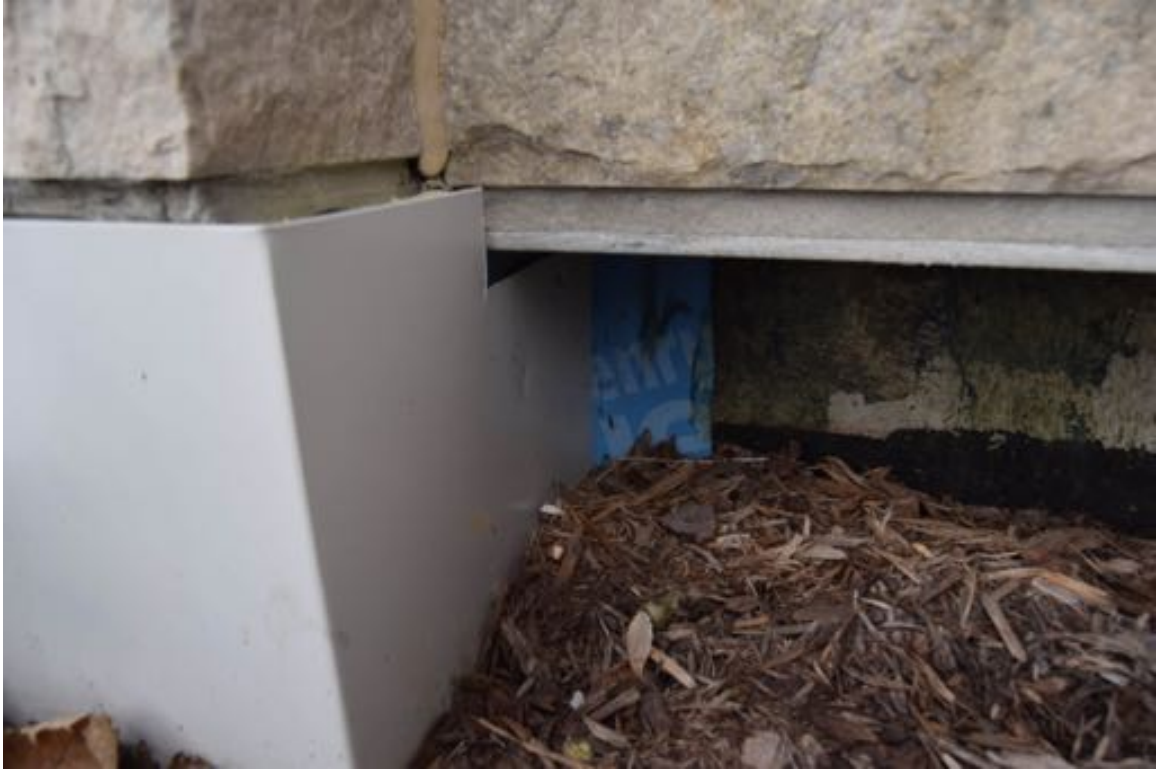
*Photo 21: Northeast corner, portions of air/vapour membrane and primer visible near grade, under the stone veneer.*

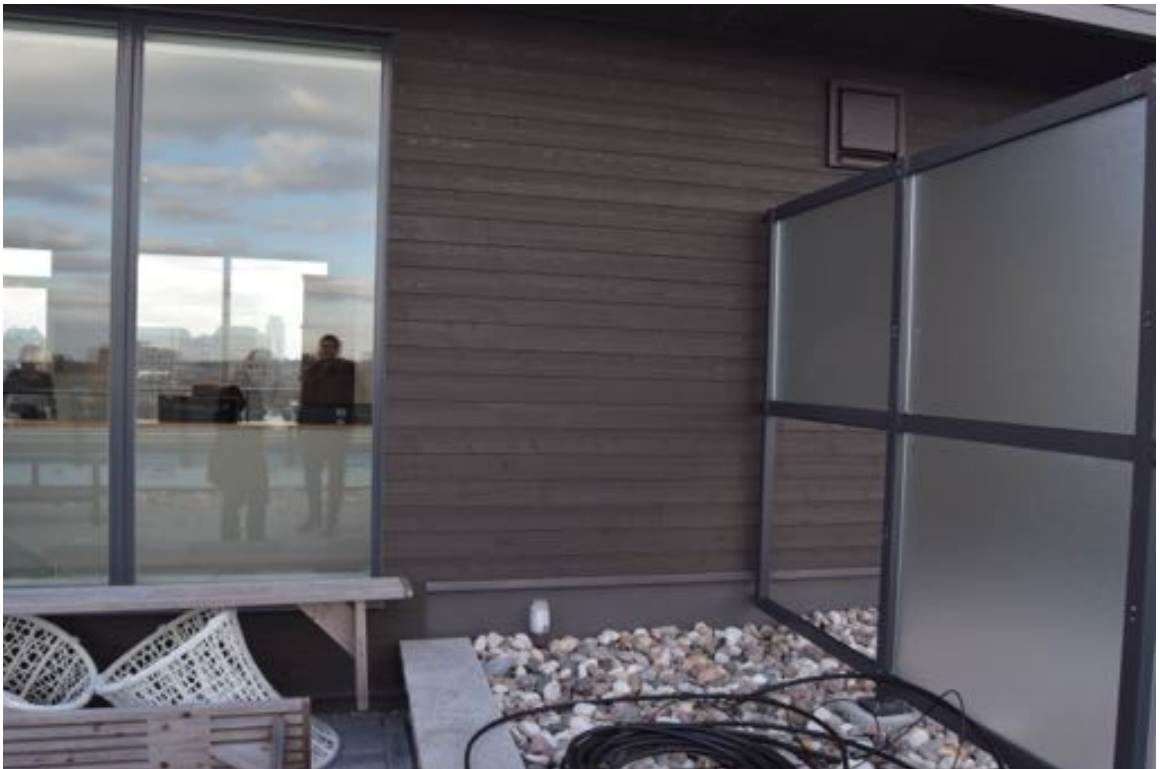
- (8) Unit owner reports a concern with the privacy fence (peeling paint, loose) (302).
- (9) Unit owner reports that the privacy screen is broken and needs replacement (302).
- (10) Glass panel piece missing in terrace privacy screen at Unit 302. Refer to Photo 22.

*Photo 22: Glass panel piece missing in terrace privacy screen at Unit 302.*

The builder will review the above noted deficiencies and make any required repairs under the requirements of the first year warranty.

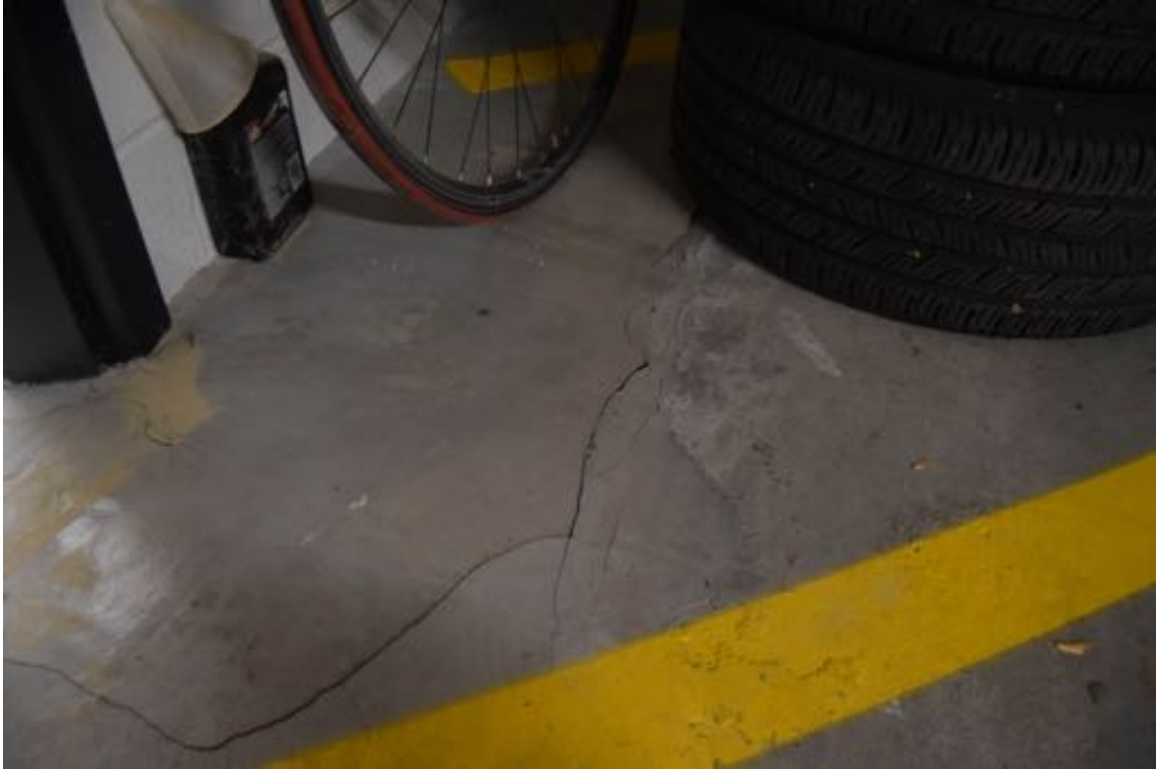
*Photo 23: There are various size cracks in the cement slab at multiple locations.*

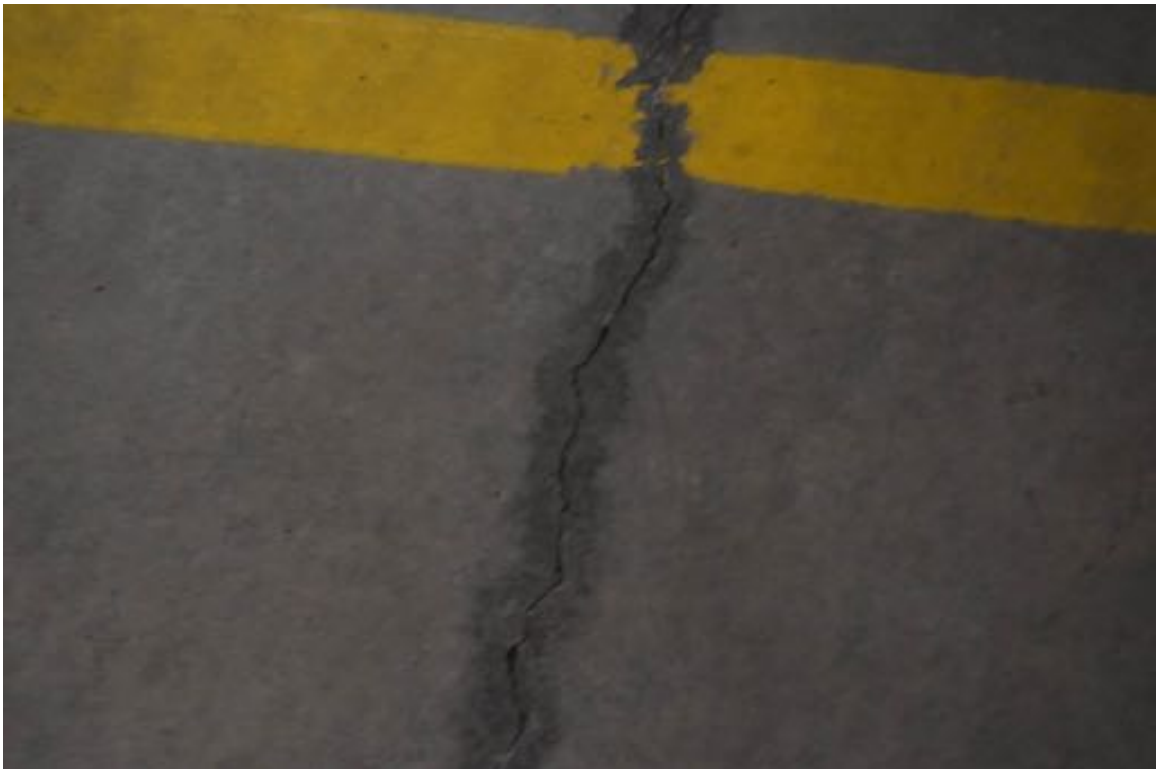
*Photo 24: There are various size cracks in the cement slab at multiple locations.*

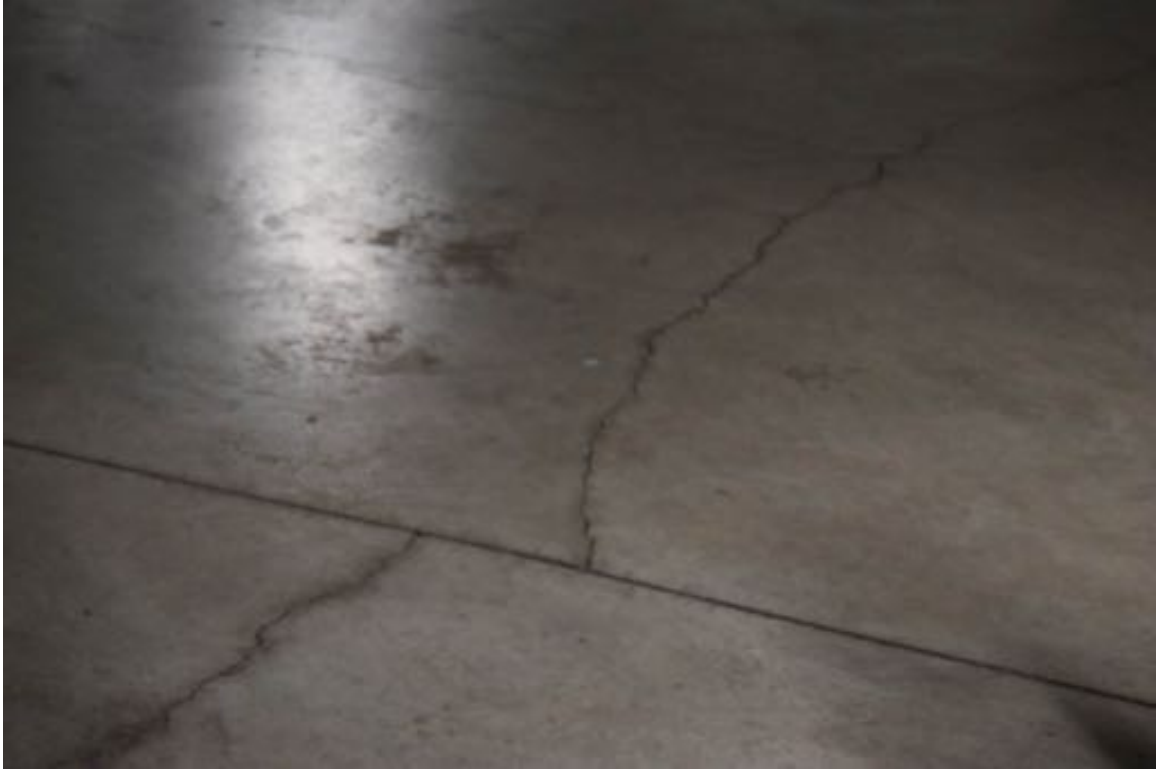
*Photo 25: There are various size cracks in the cement slab at multiple locations.*

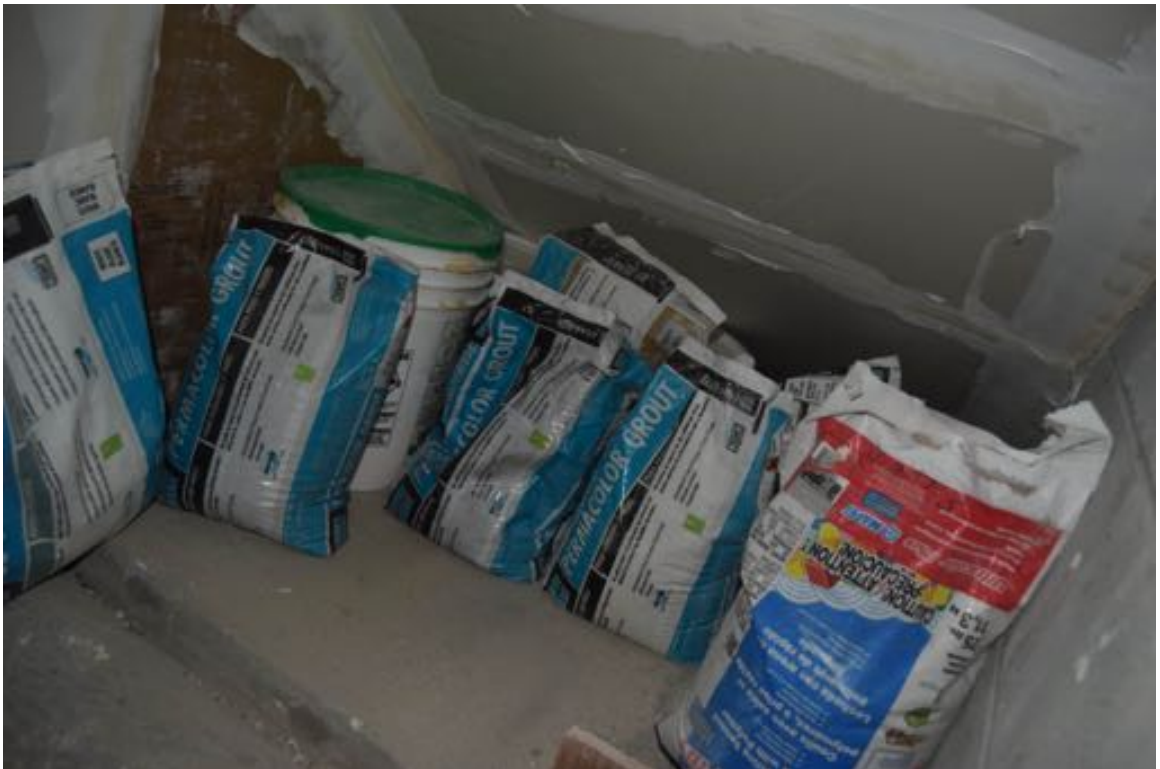
*Photo 26: Left over construction materials kept in storage in one of the fan rooms.*

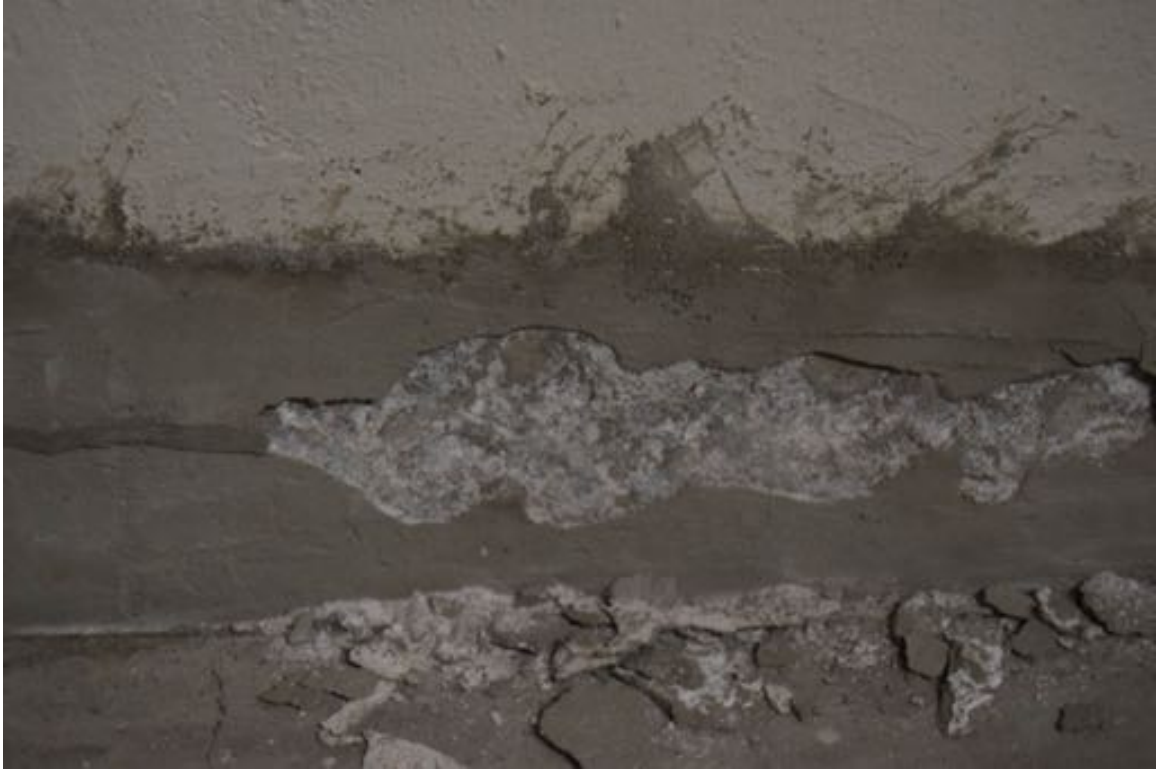
*Photo 27: The parging coat on the foundation walls is deteriorating.*
