## **BOARD of DIRECTORS - OCSCC1009**

#### **APPENDIX D: DEFICIENCIES TRACKING SUMMARY**

The purpose of the performance audit is to identify performance deficiencies of the common elements of the Condominium that may give rise to a warranty claim under the builder's warranty.

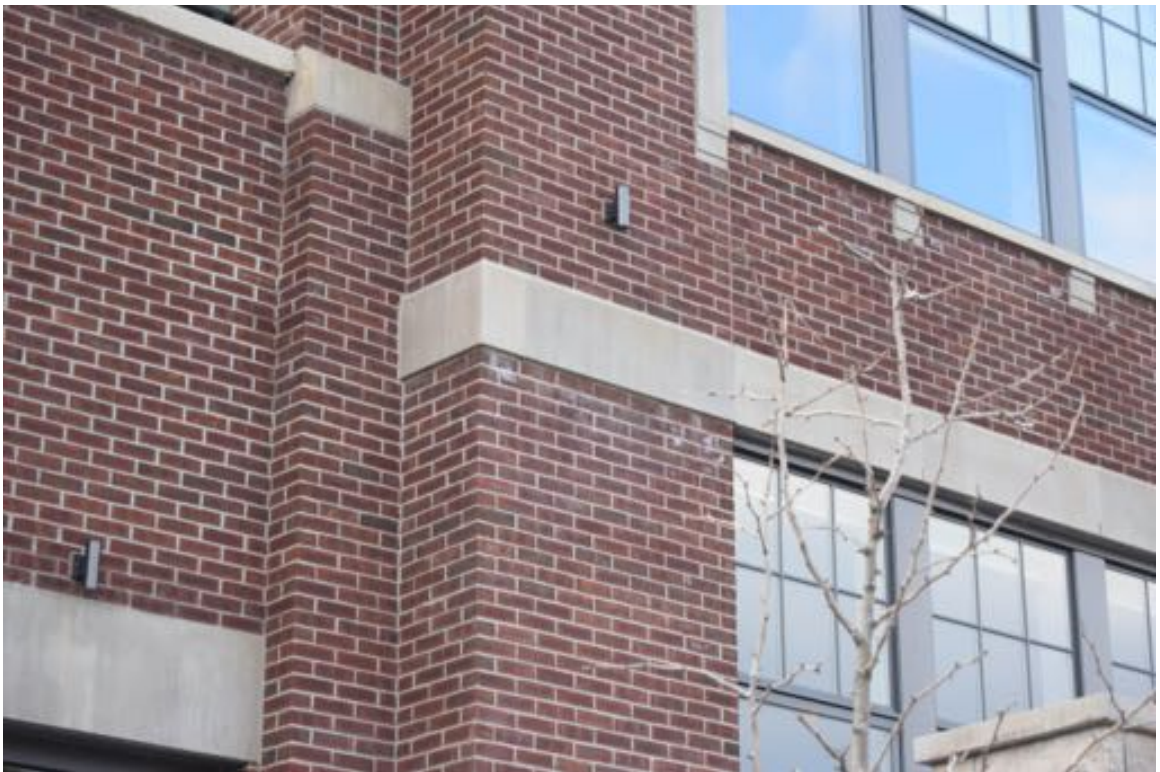
*Photo 28: Southeast corner of the building, discoloration/staining visible on brick veneer under precast panels*

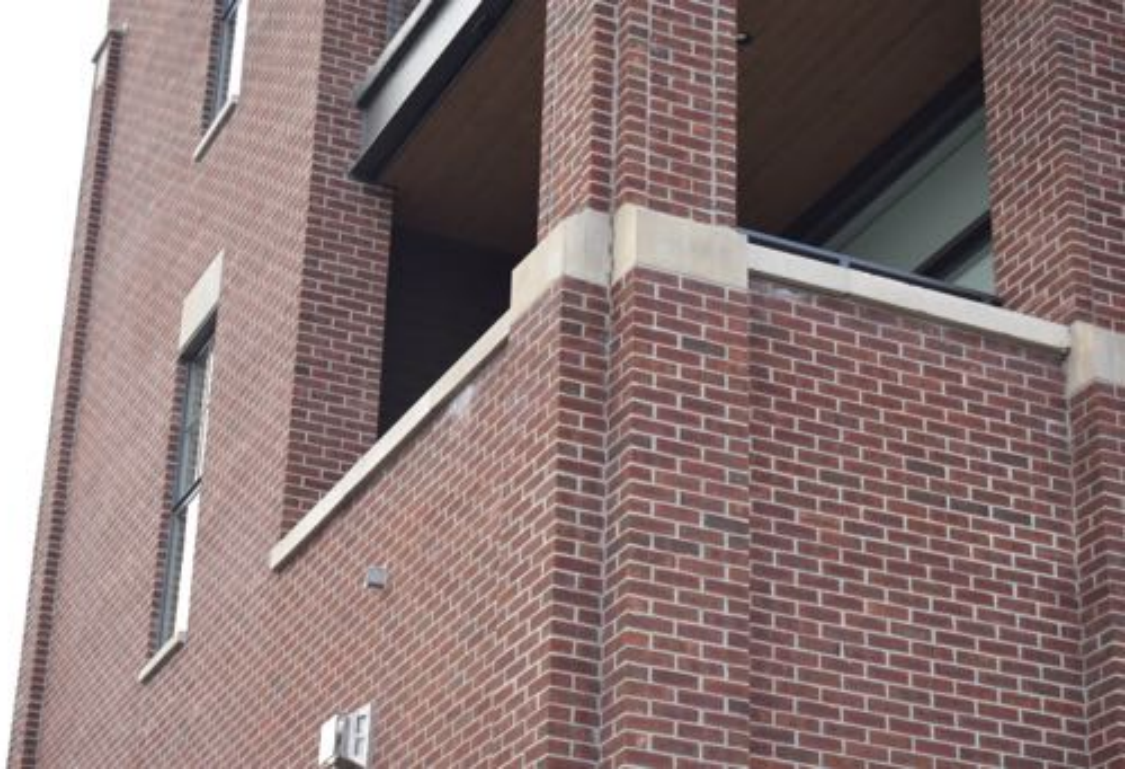
*Photo 29: Southeast corner of the building, discoloration/staining visible on brick veneer under balcony precast caps.*

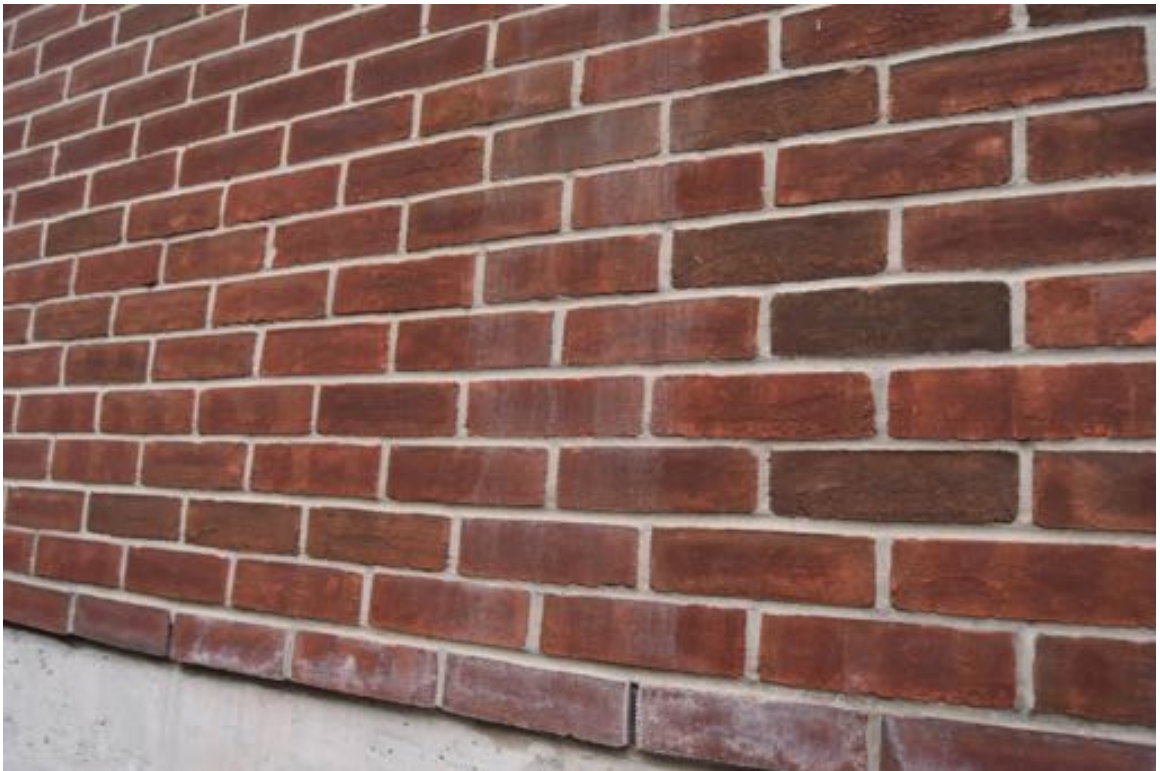
*Photo 30: Southeast corner of the building, discoloration/staining visible on brick veneer under balcony scupper.*

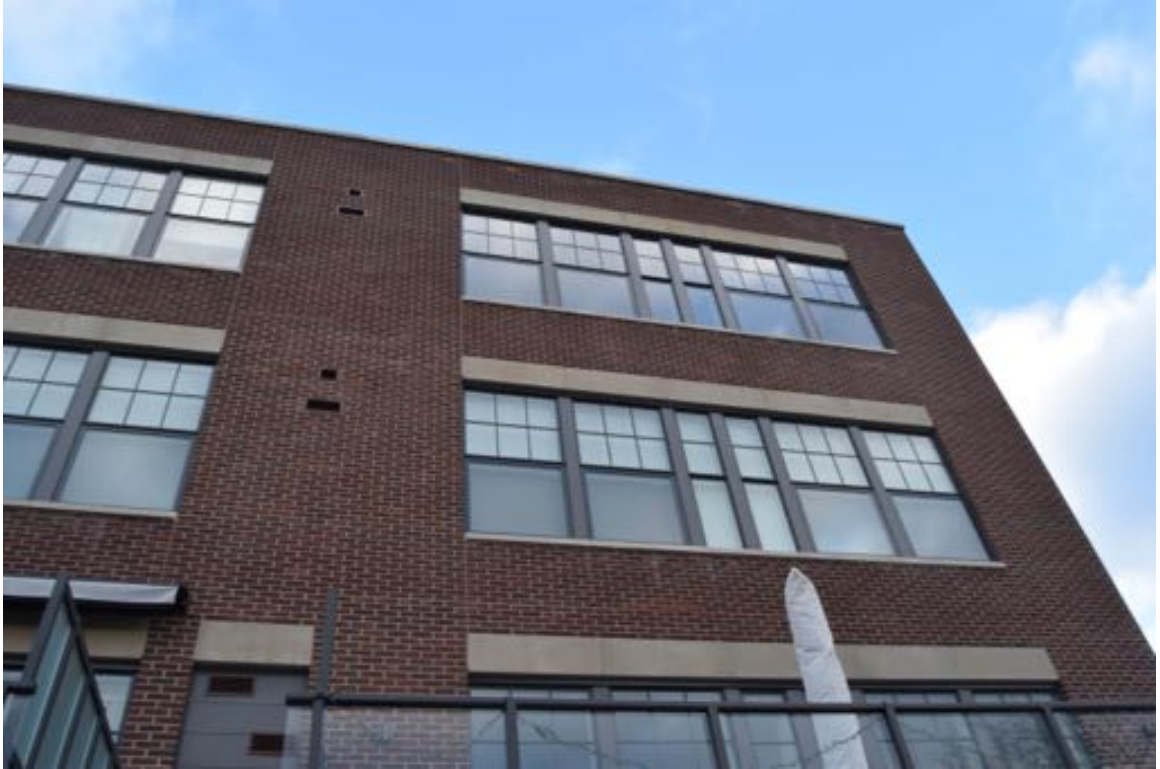
*Photo 31: West elevation, discoloration/staining visible on brick veneer under numerous window concrete precast sills.*

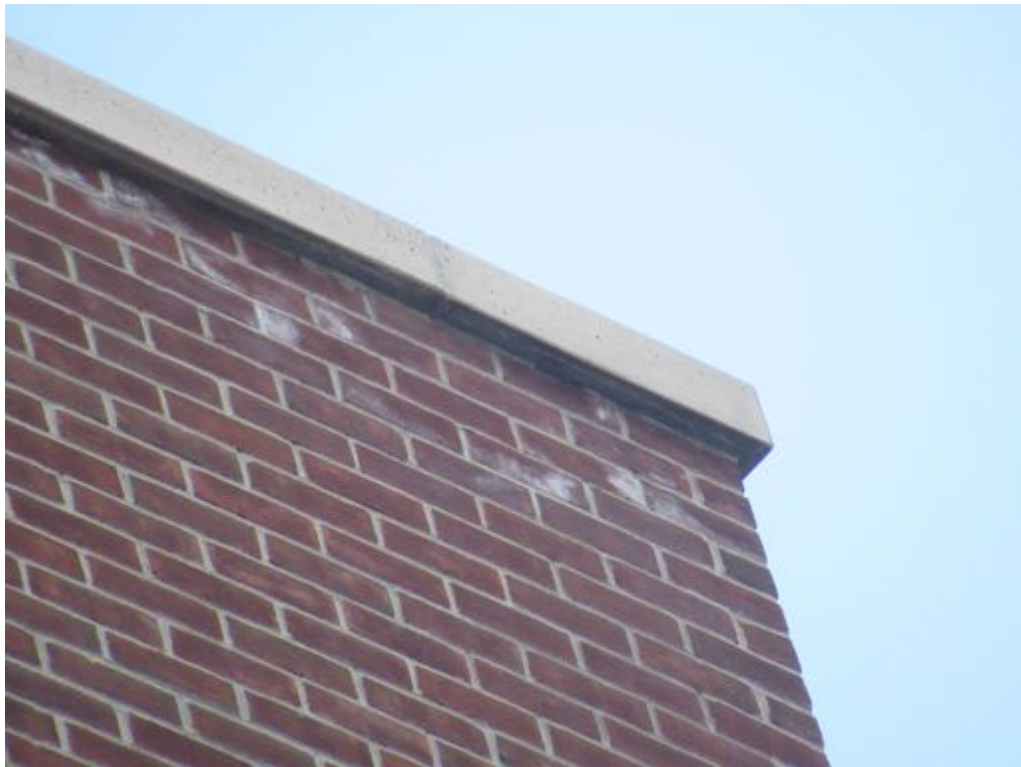
*Photo 32: West elevation, discoloration/staining visible on brick veneer under rooftop terrace concrete precast tops.*

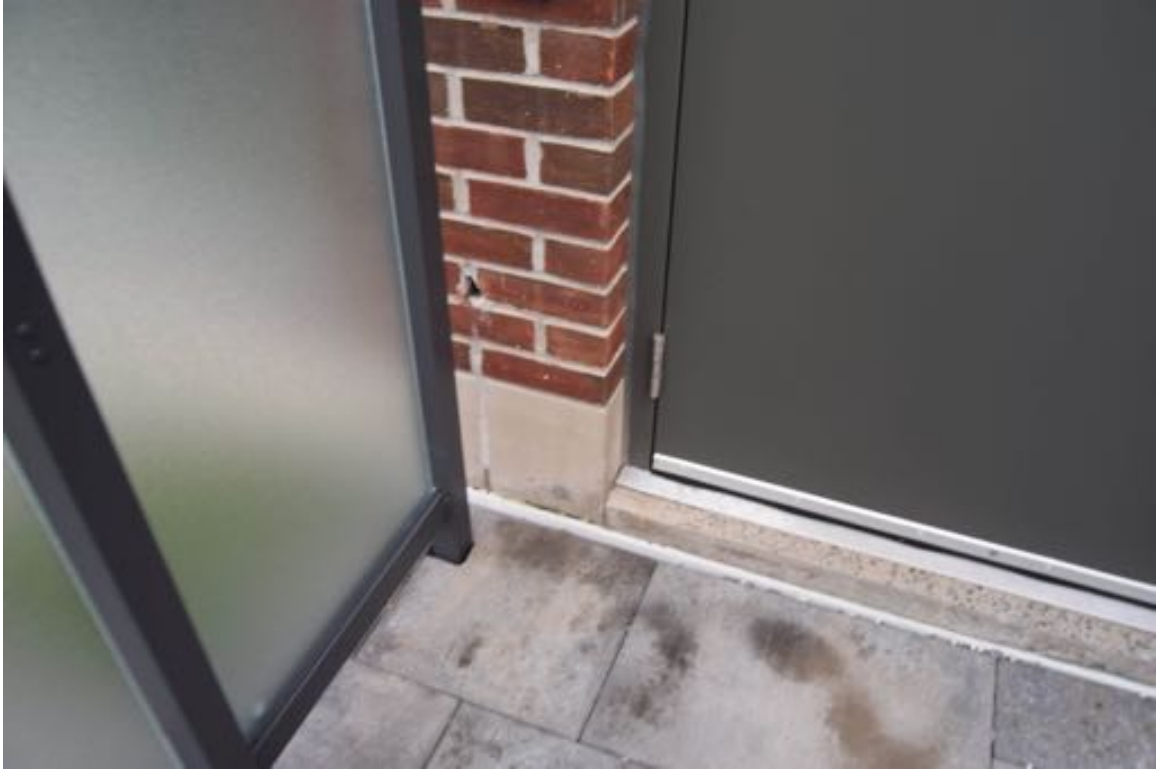
*Photo 33: West elevation, hole in the brick veneer, near the entrance to stairwell B door.*

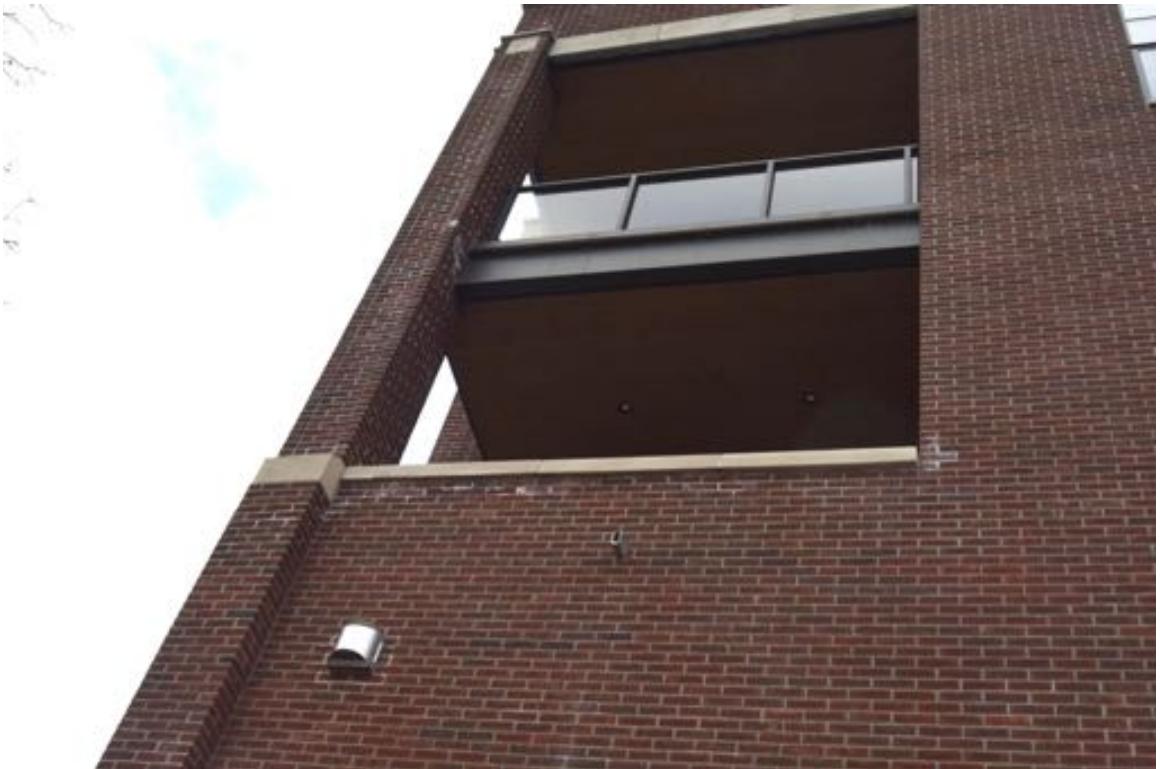
*Photo 34: North elevation, discoloration/staining visible on brick veneer under precast elements.*

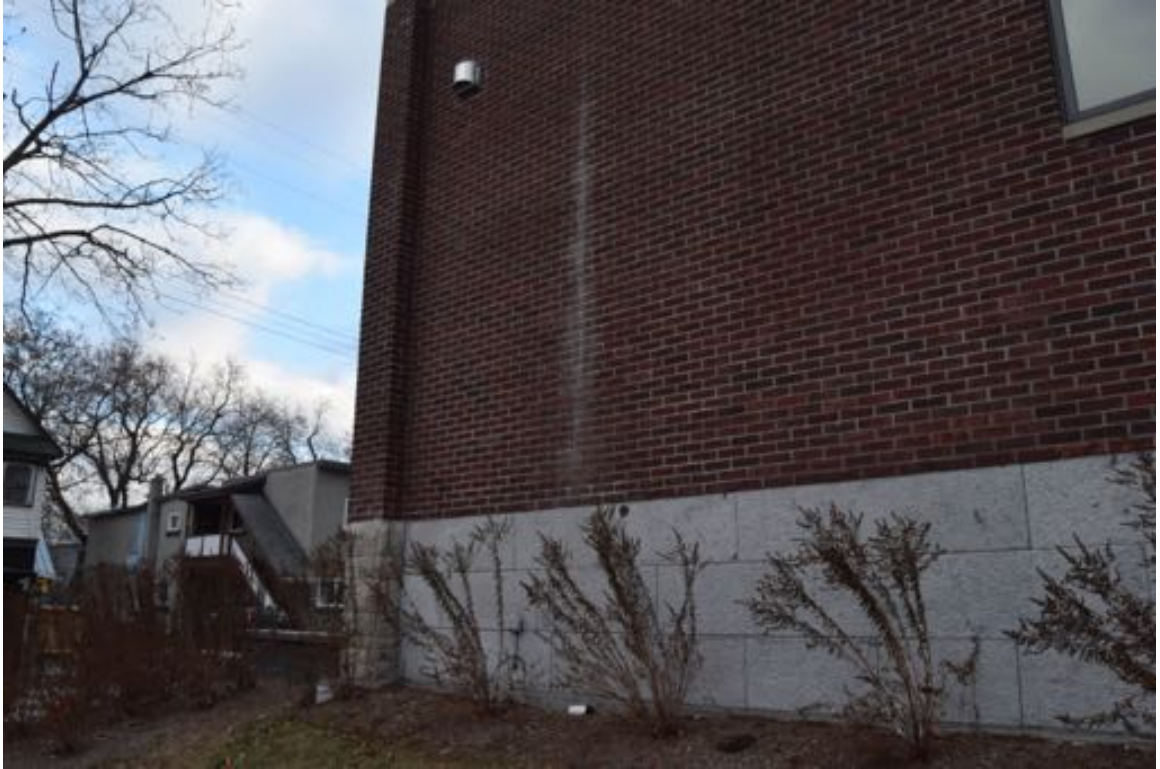
*Photo 35: North elevation, significant staining visible from the balcony scuppers on the brick veneer.*

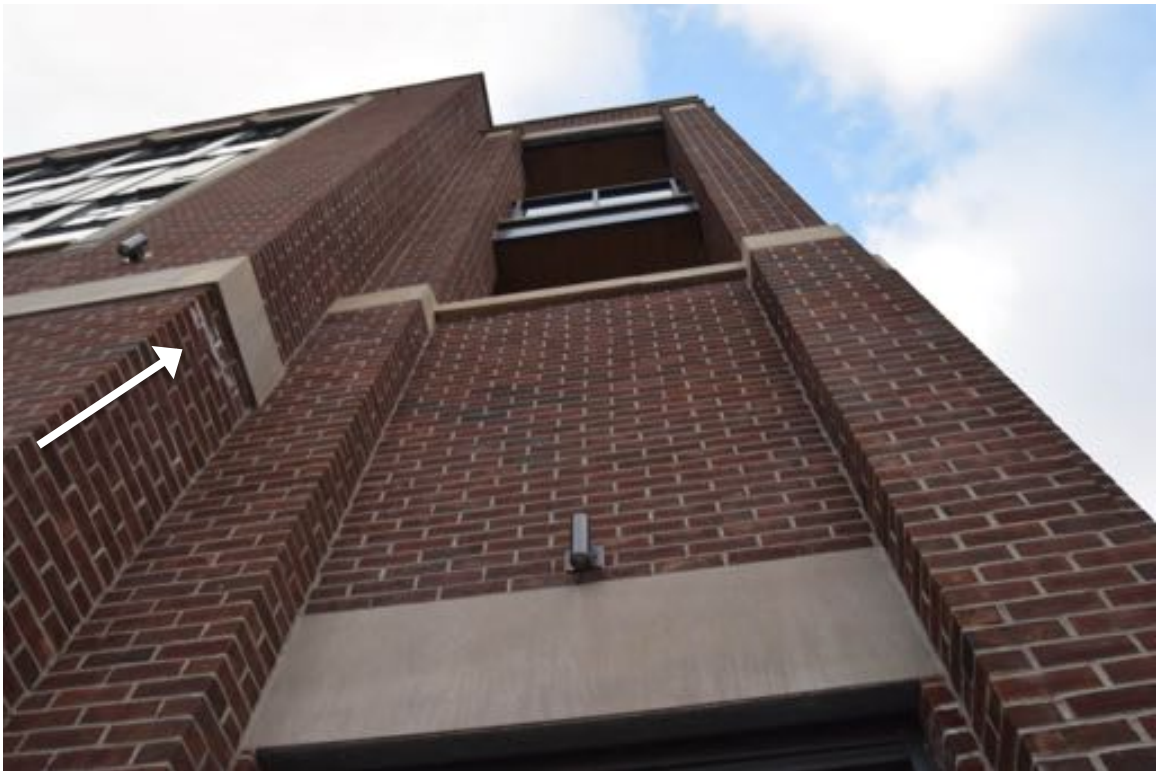
*Photo 36: East elevation, northeast corner of the building, discoloration/staining visible under a precast cladding panel.*

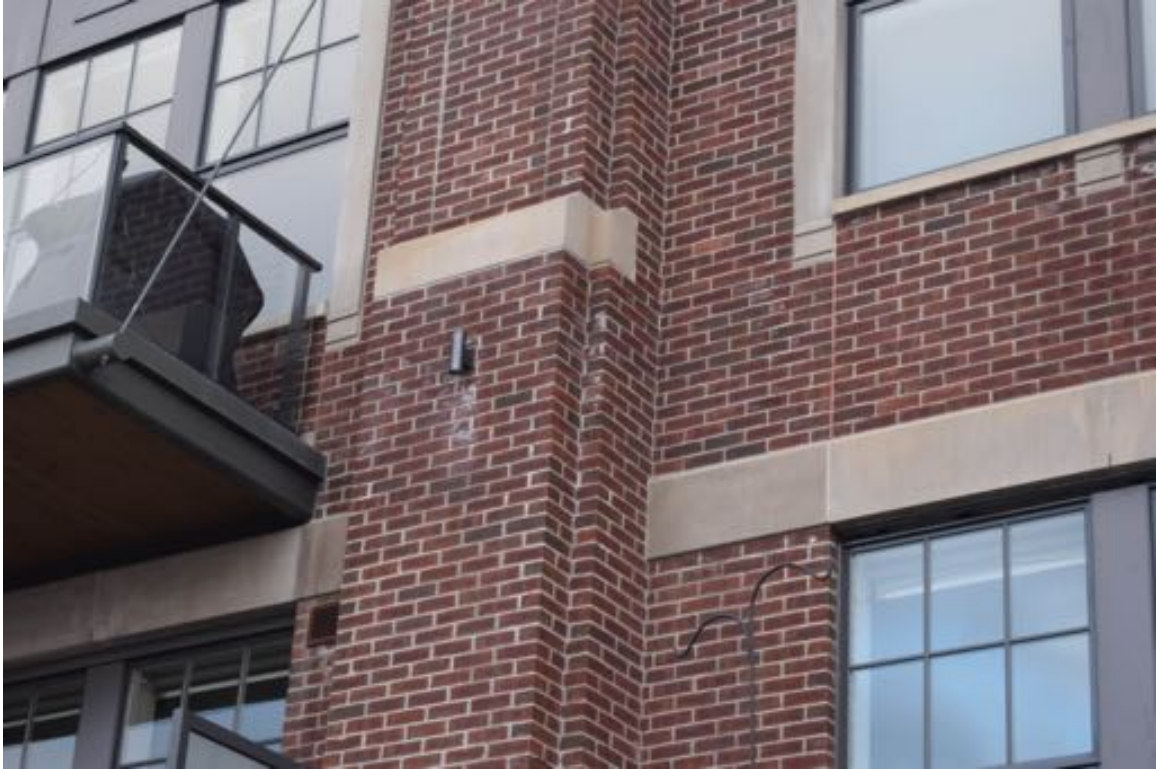
*Photo 37: East elevation, there are numerous locations where there is discoloration/staining on the brick veneer, including under precast concrete elements, precast parapet caps, under exterior lighting, etc*

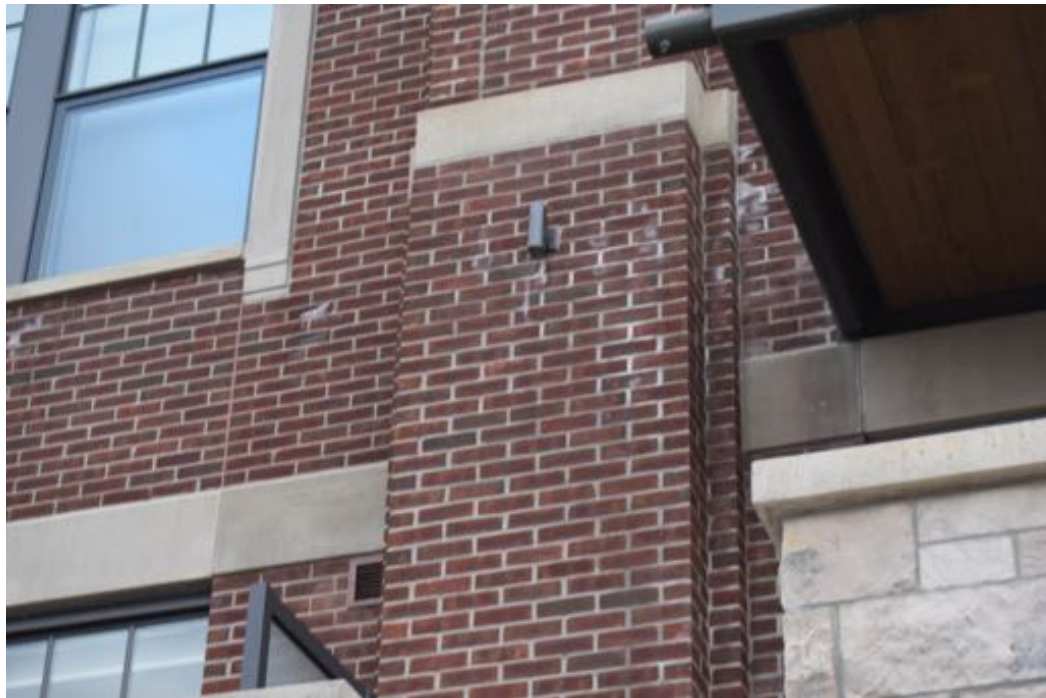
*Photo 38: East elevation, there are numerous locations where there is discoloration/staining on the brick veneer, including under precast concrete elements, precast parapet caps, under exterior lighting, etc*

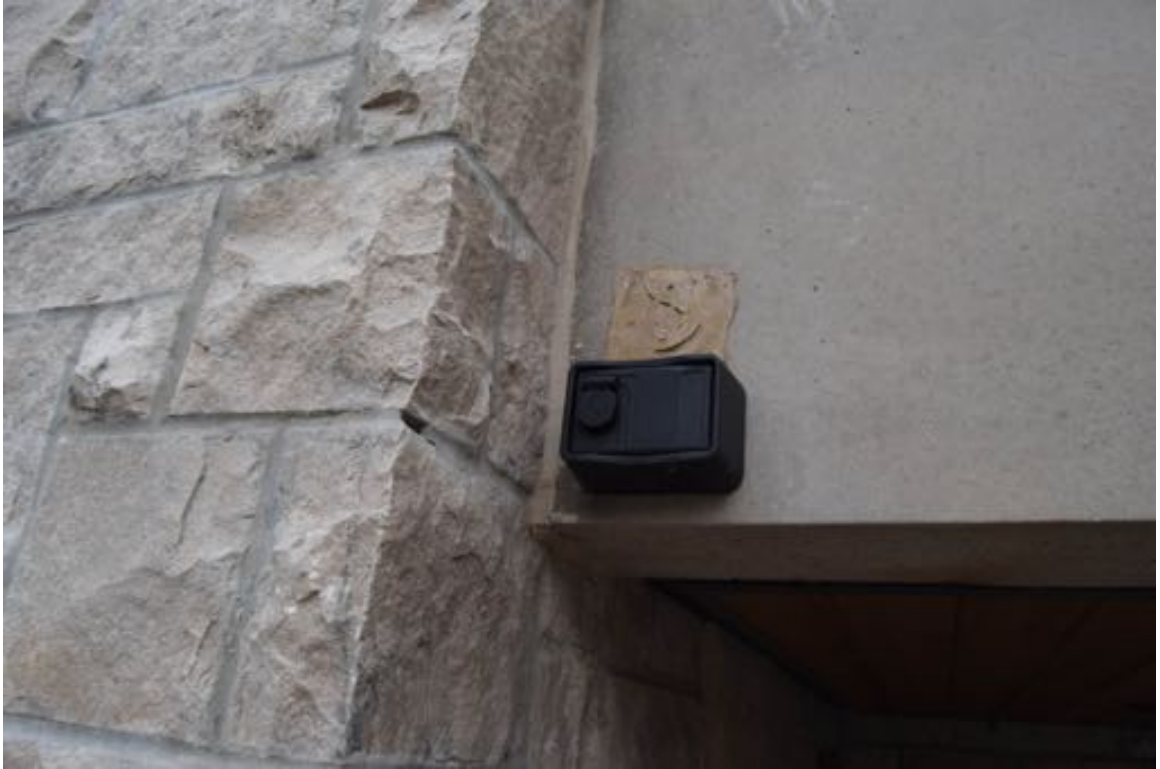
*Photo 39: There are remnants of previous lockbox.*

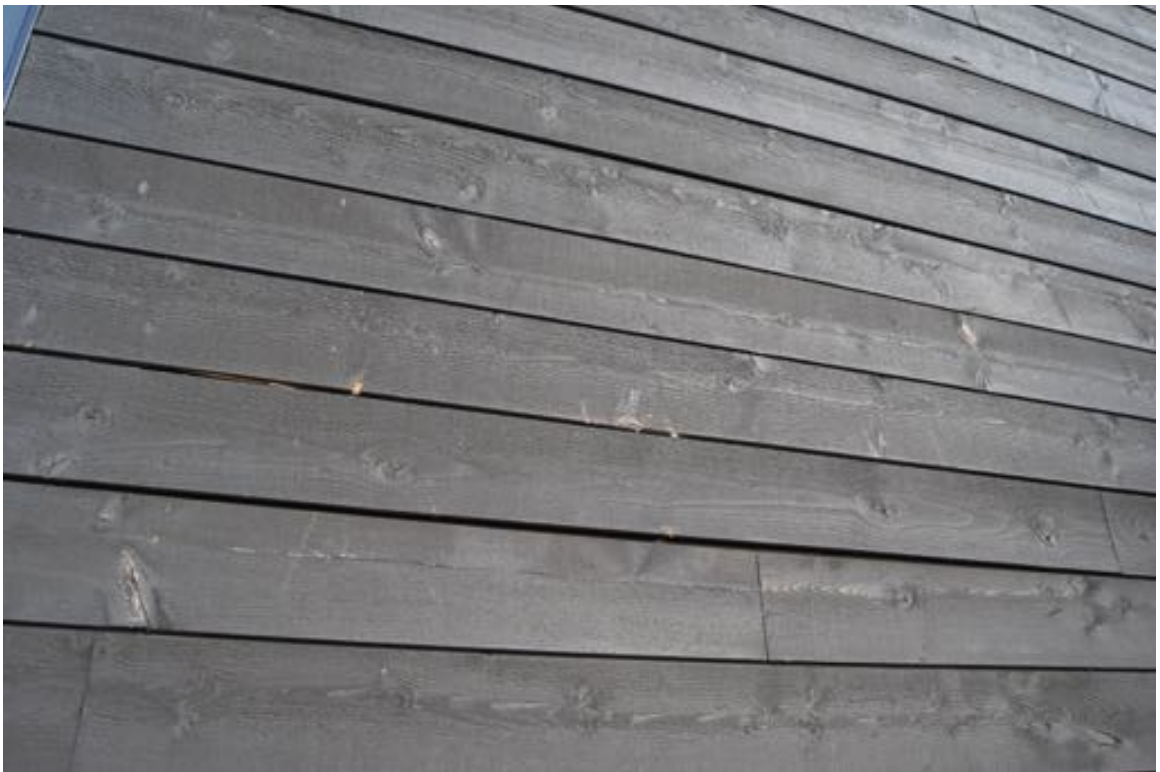
*Photo 40: Various dings/scratch marks observed on the wood cladding, at northwest common fourth floor terrace.*

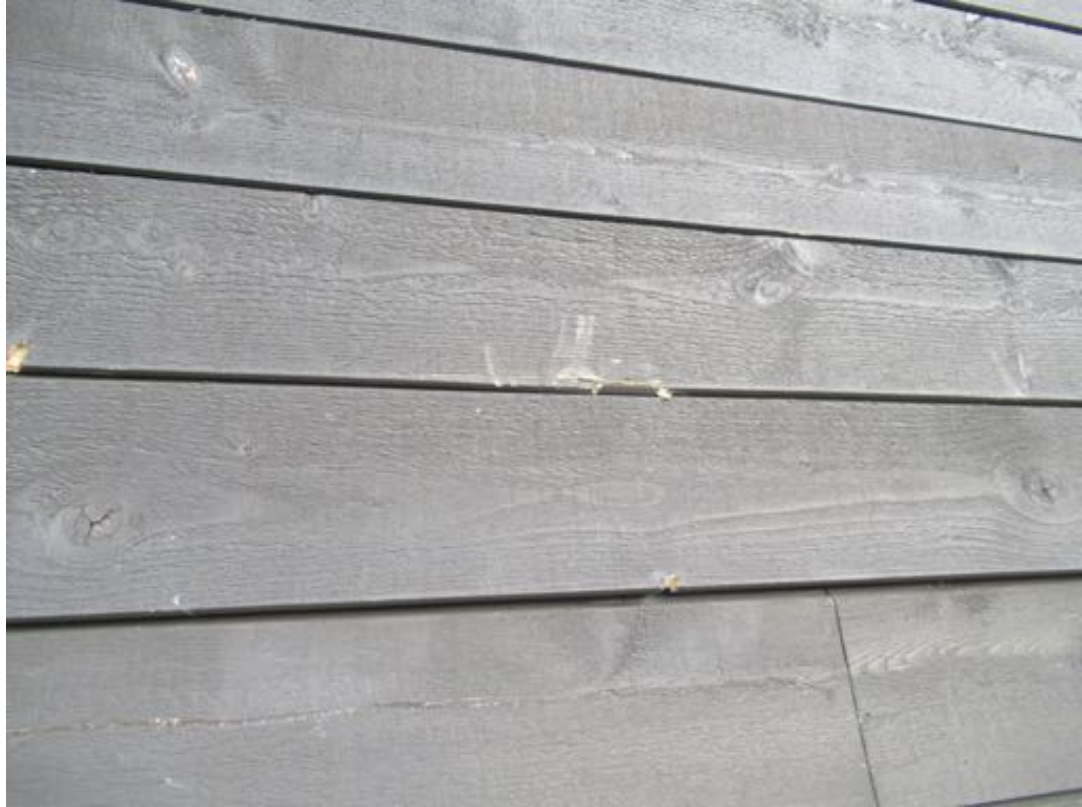
*Photo 41: Various dings/scratch marks observed on the wood cladding, at northwest common fourth floor terrace.*

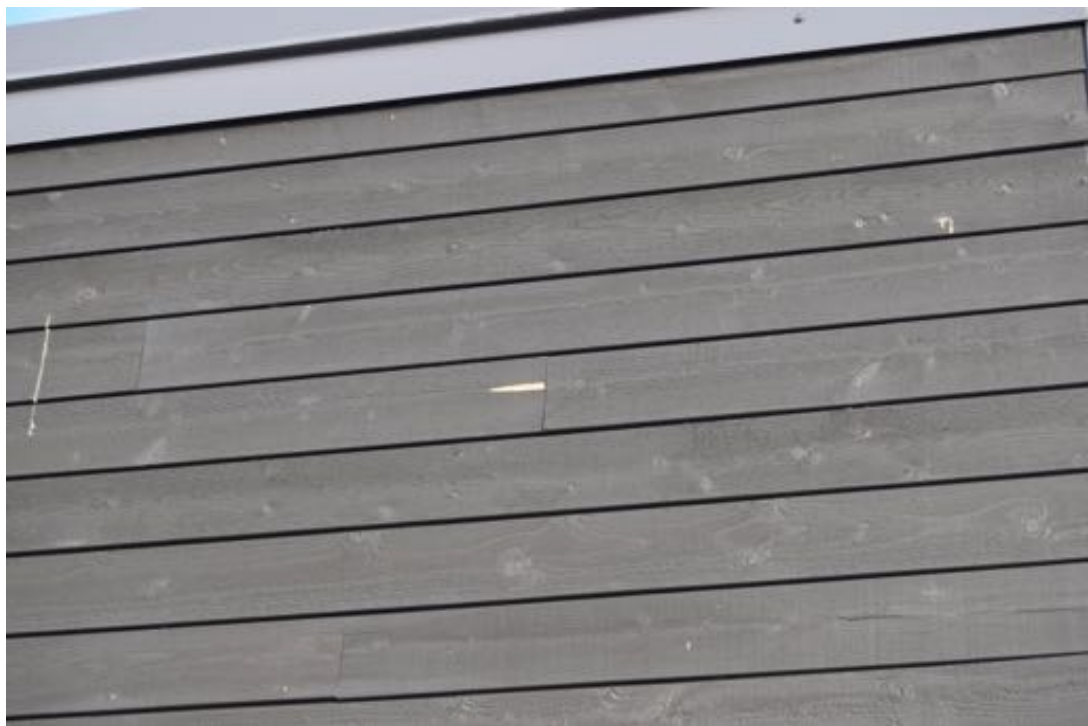
*Photo 42: Wood siding is chipped on the wood cladding, at southeast common fourth floor terrace.*

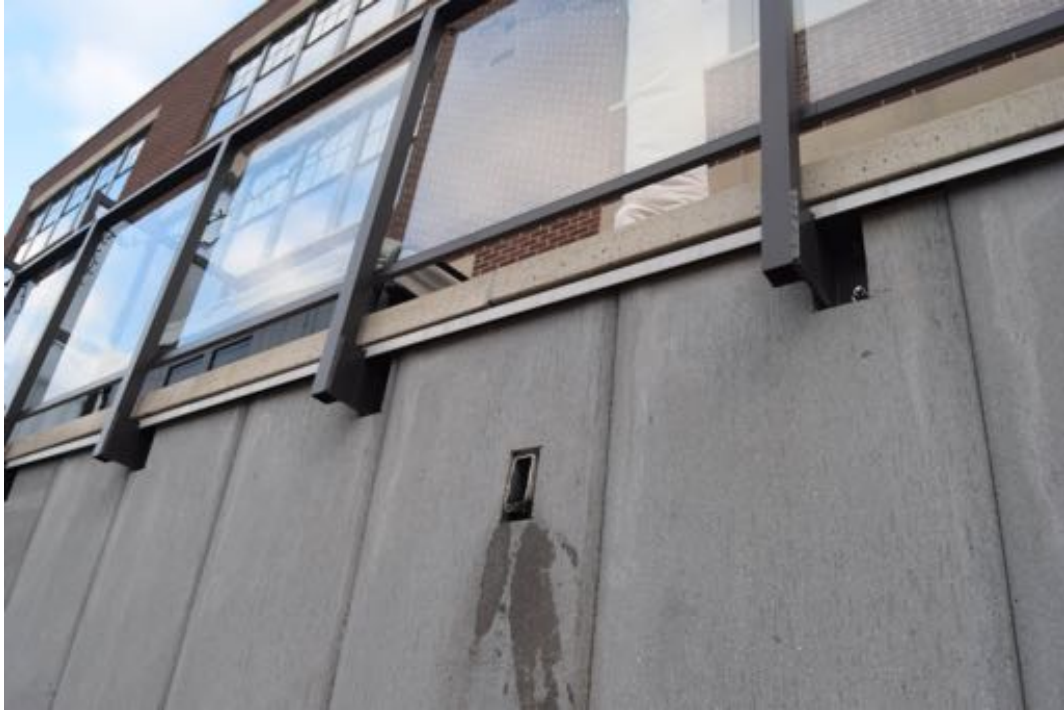
*Photo 45: At the west elevation, multiple scuppers for terrace drains do not extend far enough beyond the cement insulation panels, causing heavy staining, ice build-up, and deterioration of the panels.*

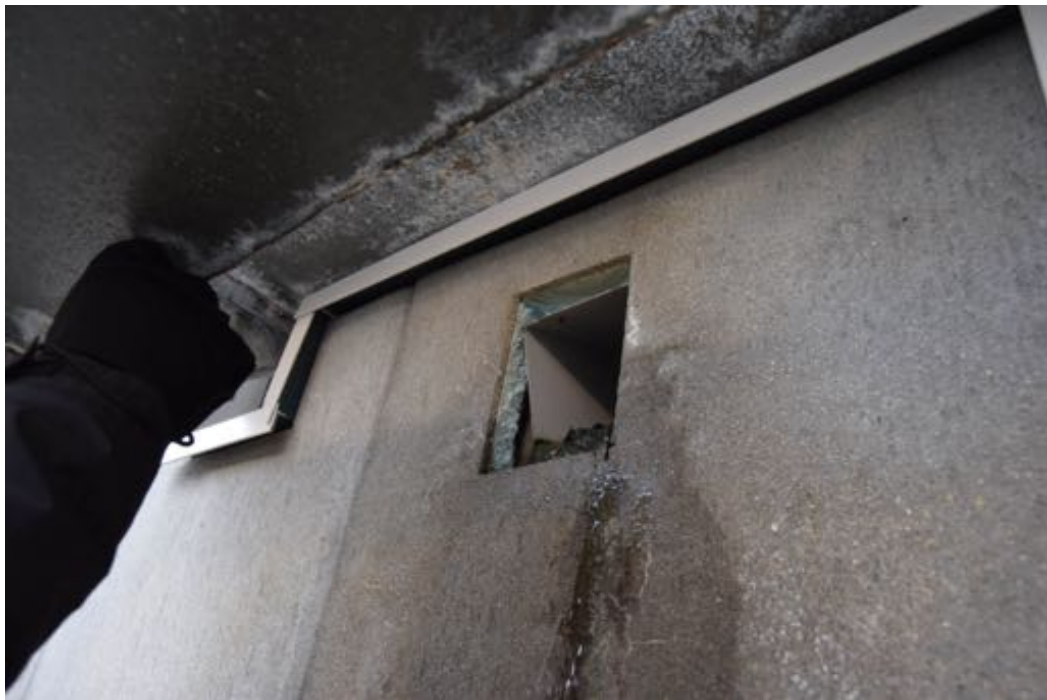
*Photo 46: At the west elevation, multiple scuppers for terrace drains do not extend far enough beyond the cement insulation panels, causing heavy staining, ice build-up, and deterioration of the panels.*

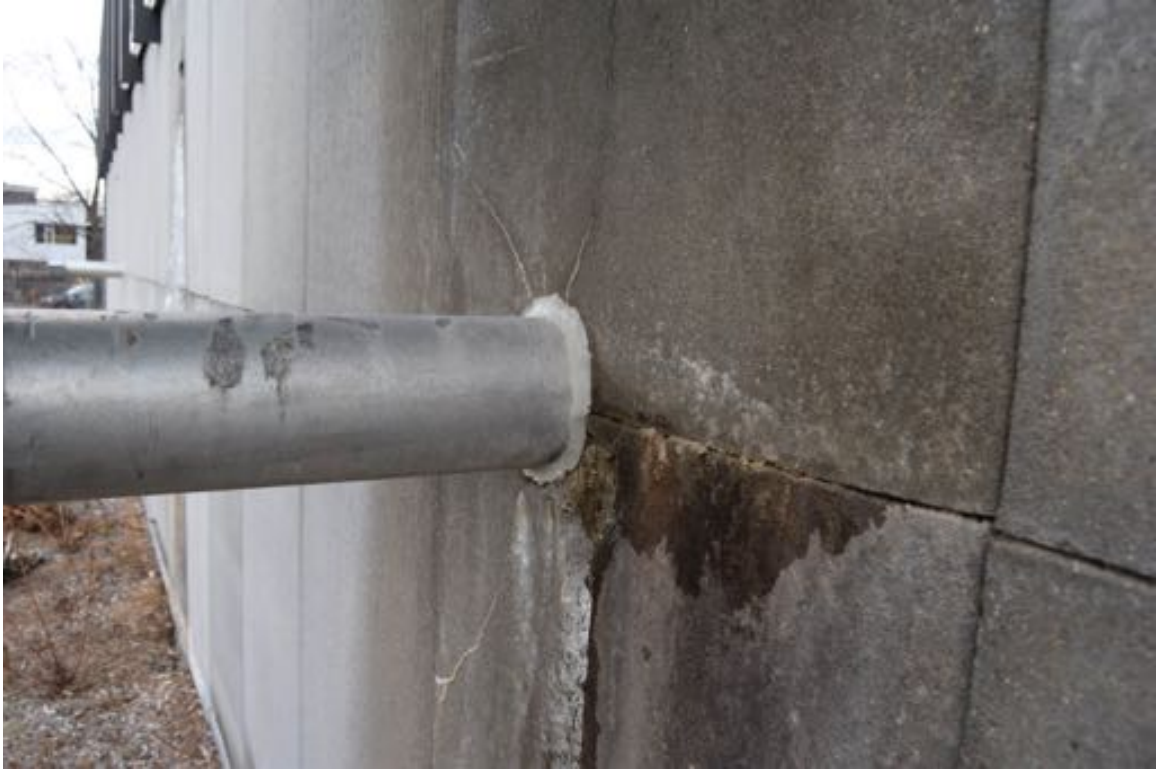
*Photo 47: At the west elevation, scupper appears draining behind a panel, causing deterioration between panels near an exhaust vent.*

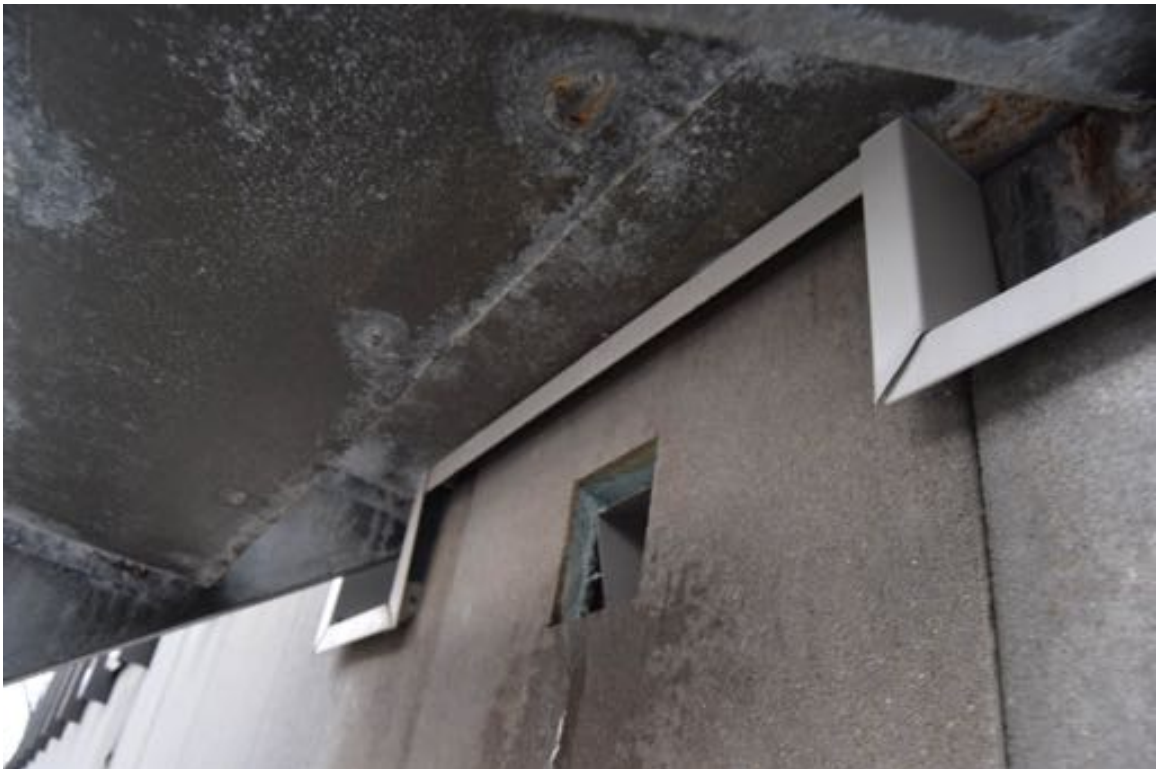
*Photo 48: At the west elevation, scupper appears draining behind a panel, causing deterioration between panels near an exhaust vent.*

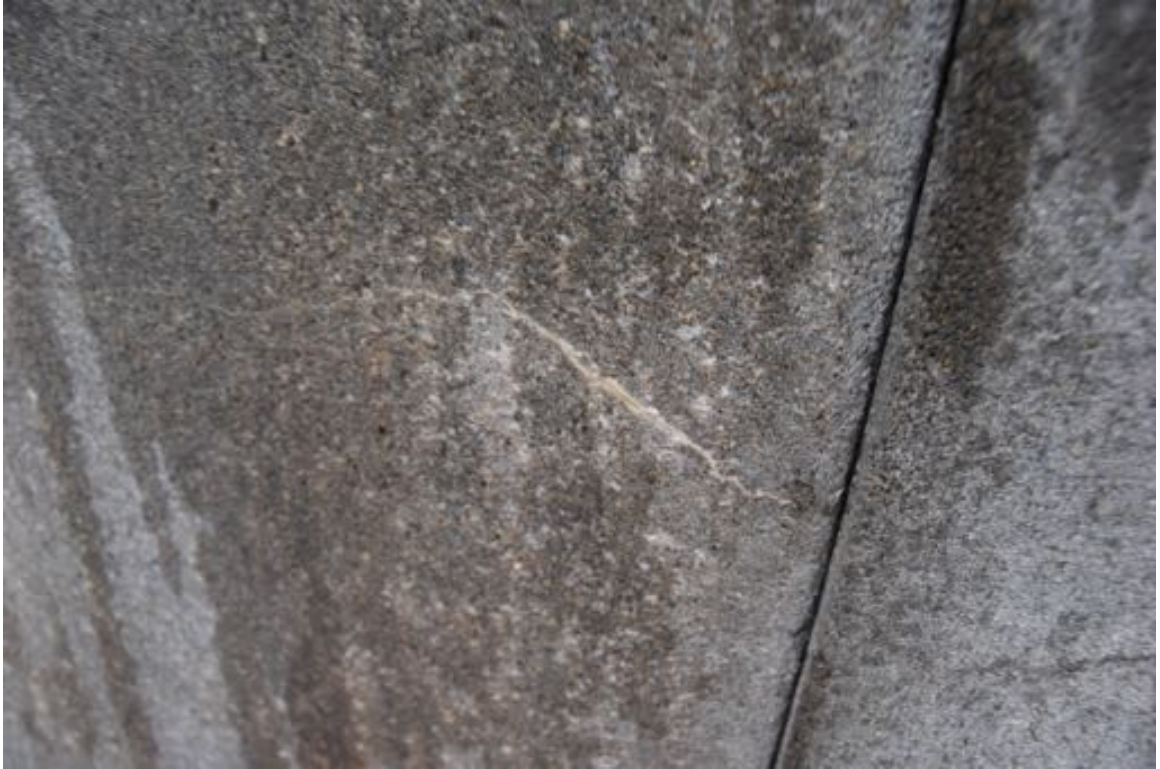
*Photo 49: Multiple cracks are visible in the panels, particularly under the scuppers.*

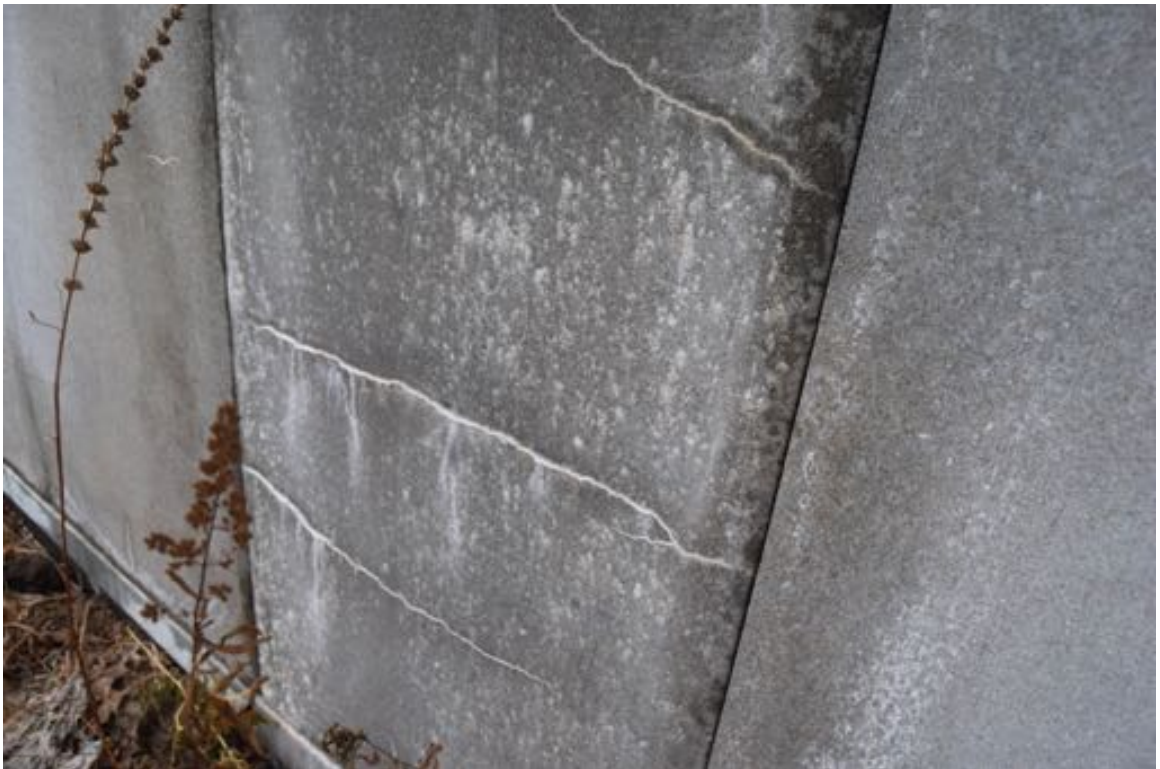
*Photo 50: Multiple cracks are visible in the panels, particularly under the scuppers.*

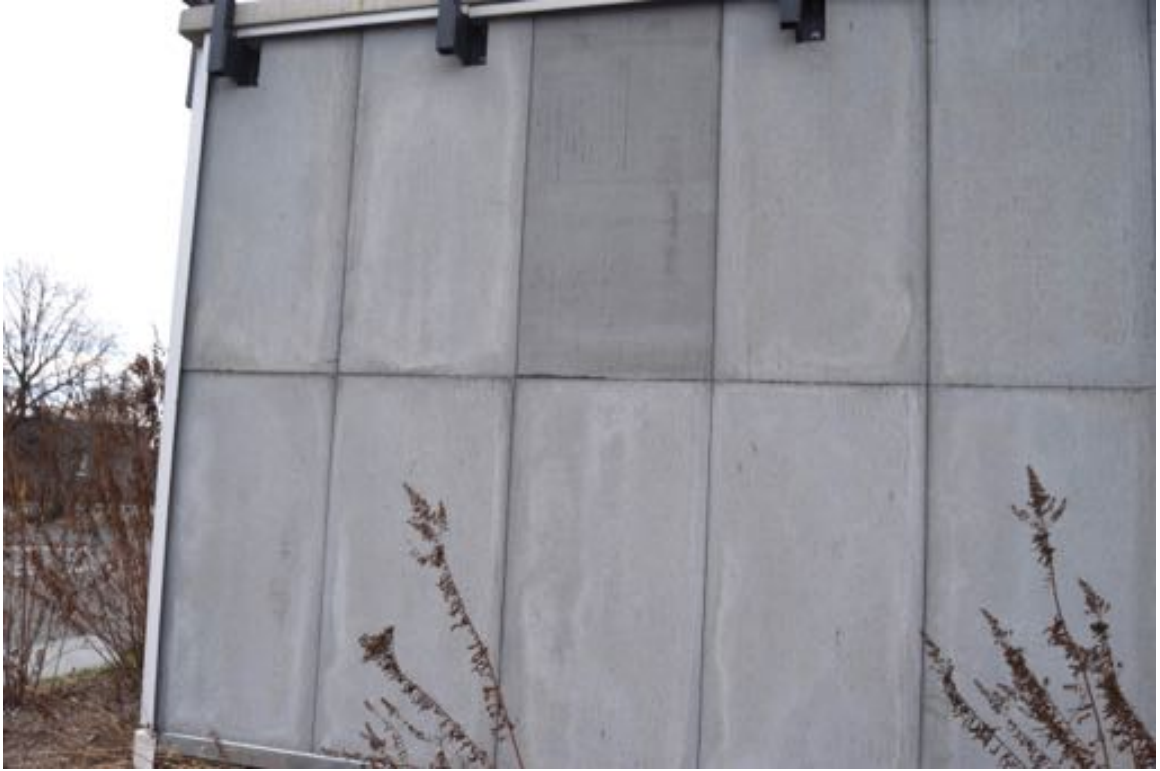
*Photo 51: Northwest corner of the terraces, the panels appear to be generally discolored.*

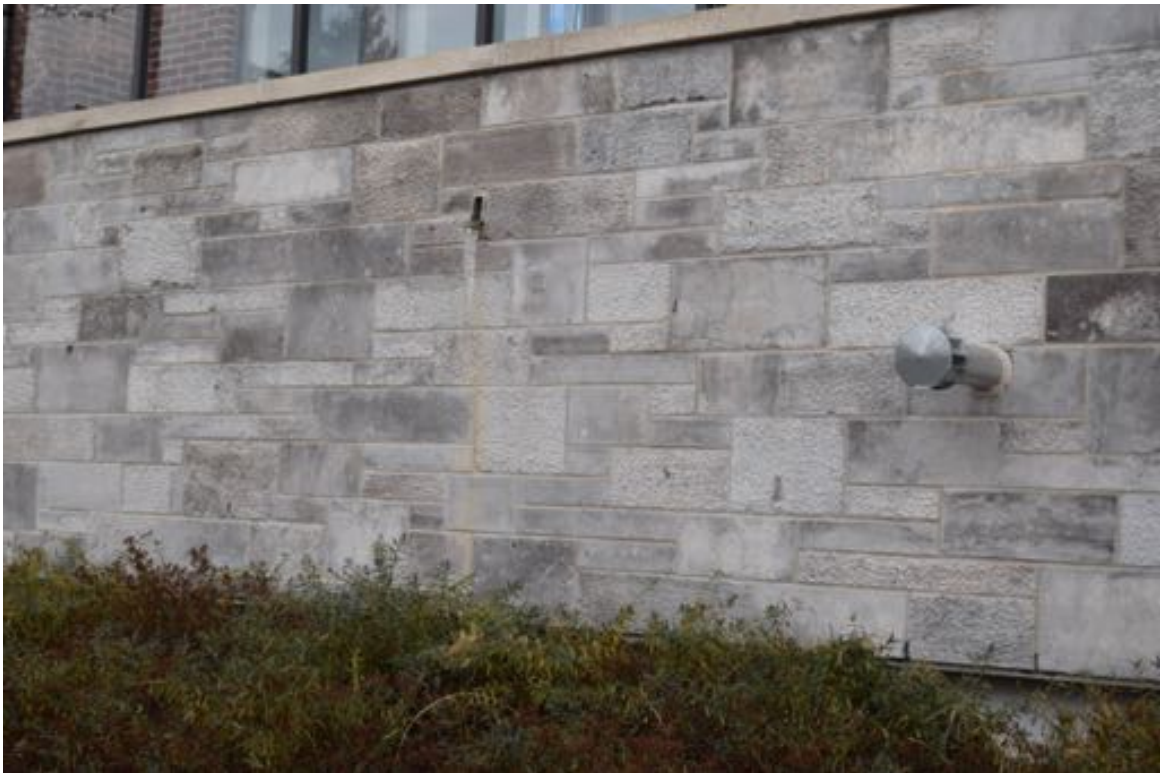
*Photo 52: East elevation, the masonry veneer cladding of north terrace has staining/discolorations under the scupper.*

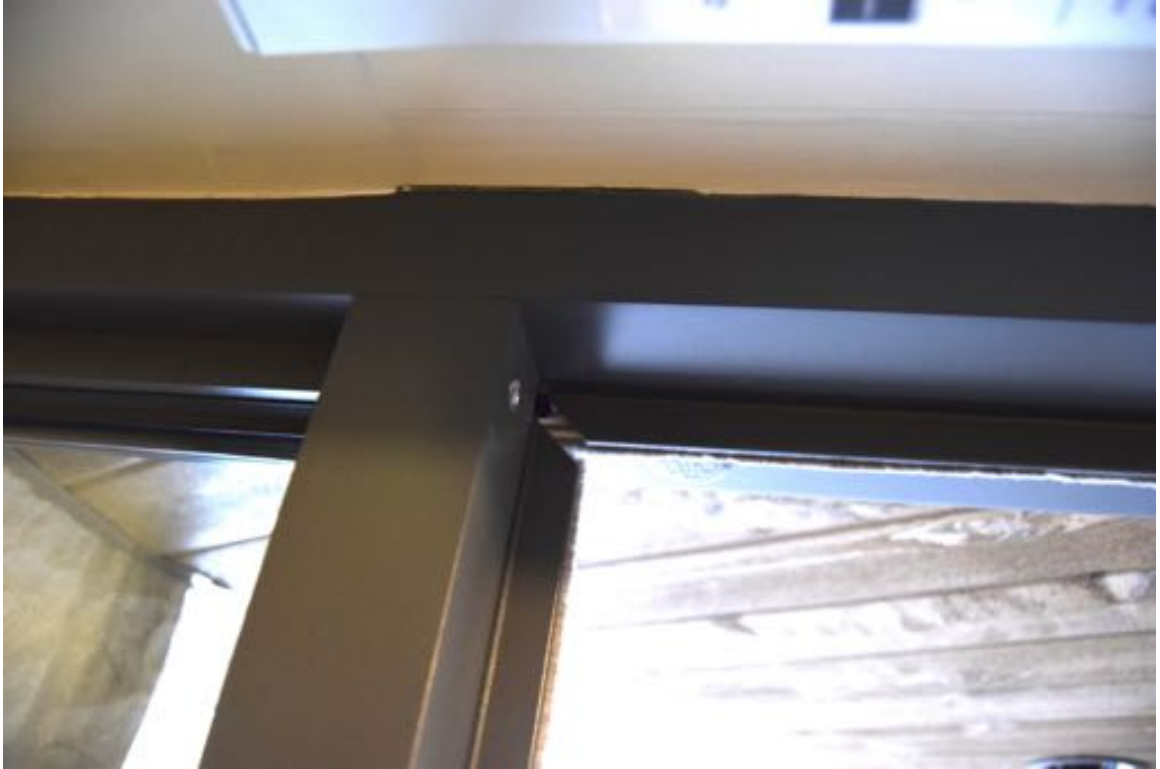
*Photo 53: North lobby, there is a gap in the door frame visible.*

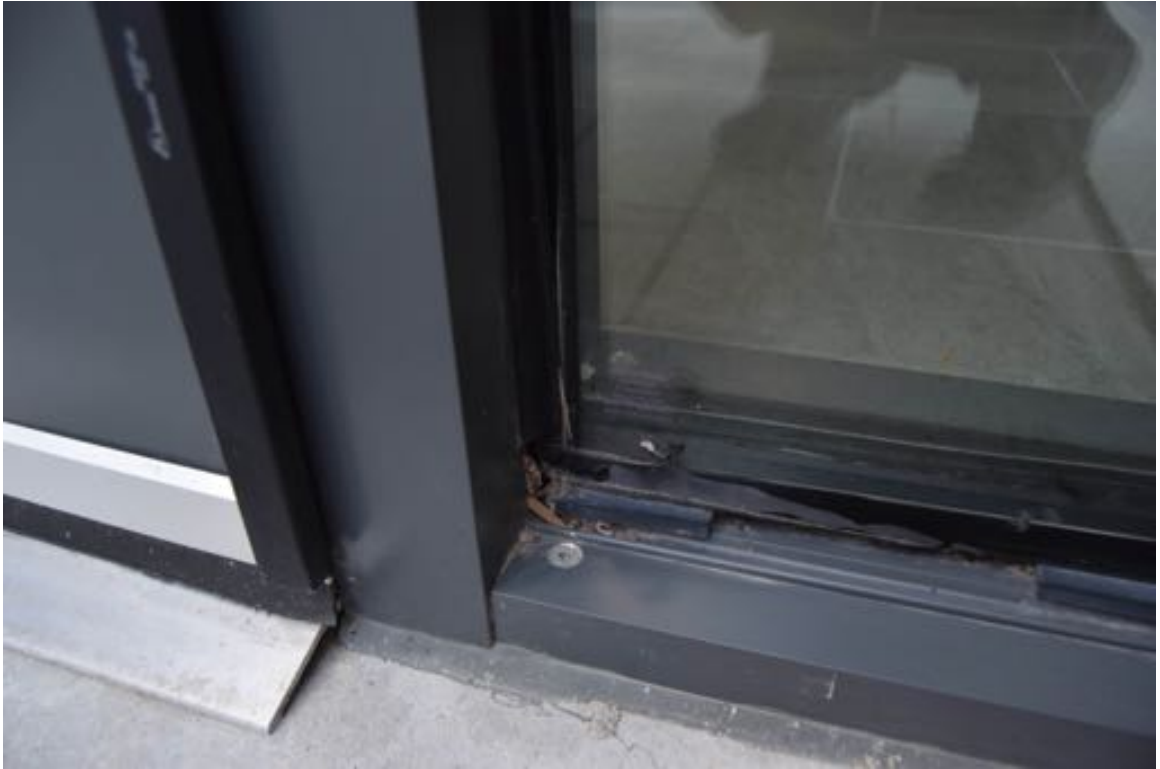
*Photo 55: Northeast exterior door to stairwell D, a cap piece is missing.*
