## **BOARD of DIRECTORS - OCSCC1009**

#### **APPENDIX D: DEFICIENCIES TRACKING SUMMARY**

The purpose of the performance audit is to identify performance deficiencies of the common elements of the Condominium that may give rise to a warranty claim under the builder's warranty.

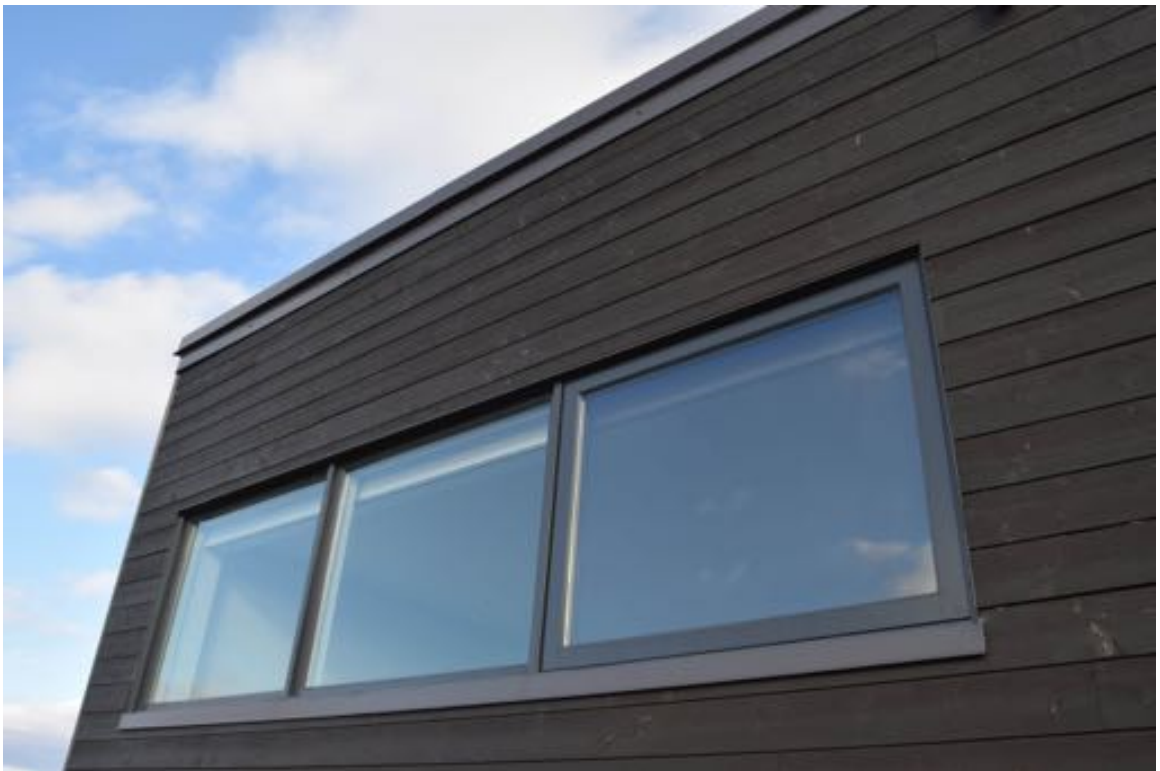
*Photo 56: During the site visit walkthrough, a leak was reported at an elevated transom window, in the fourth floor den of unit 303.*

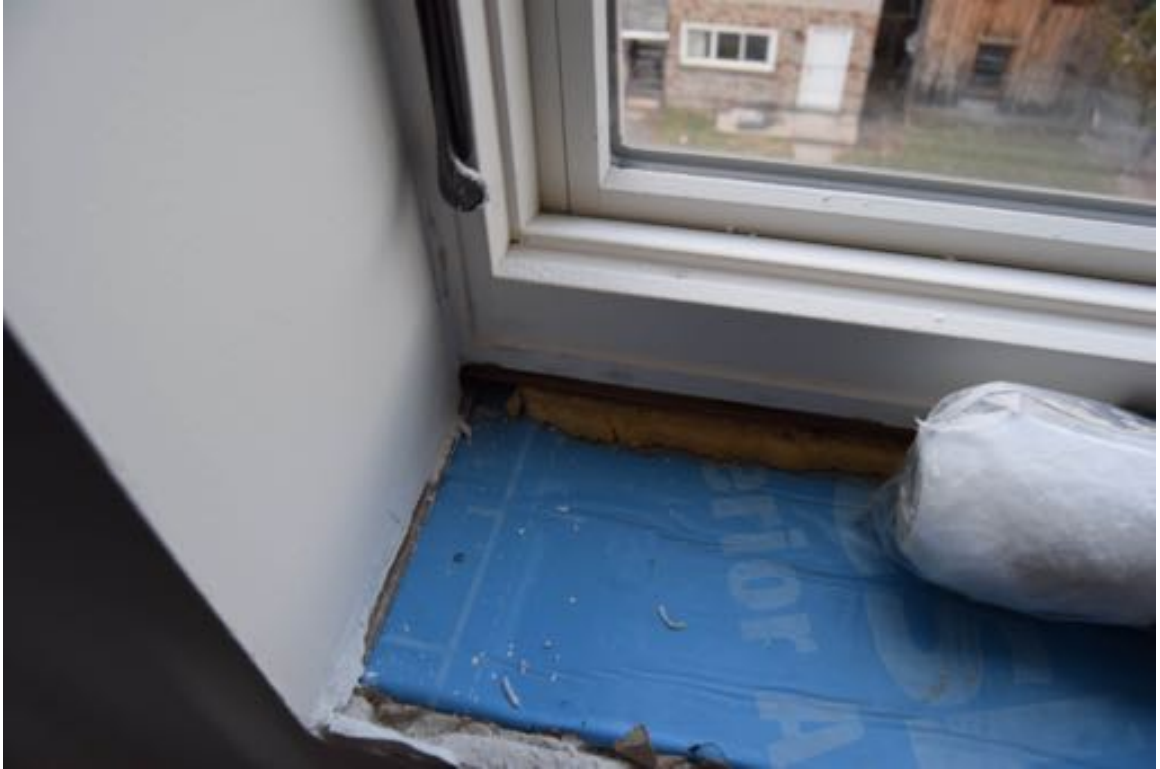
*Photo 57: The windowsill was removed for repairs at a window reviewed at Unit 302, it is not clear if this was due to a leak.*

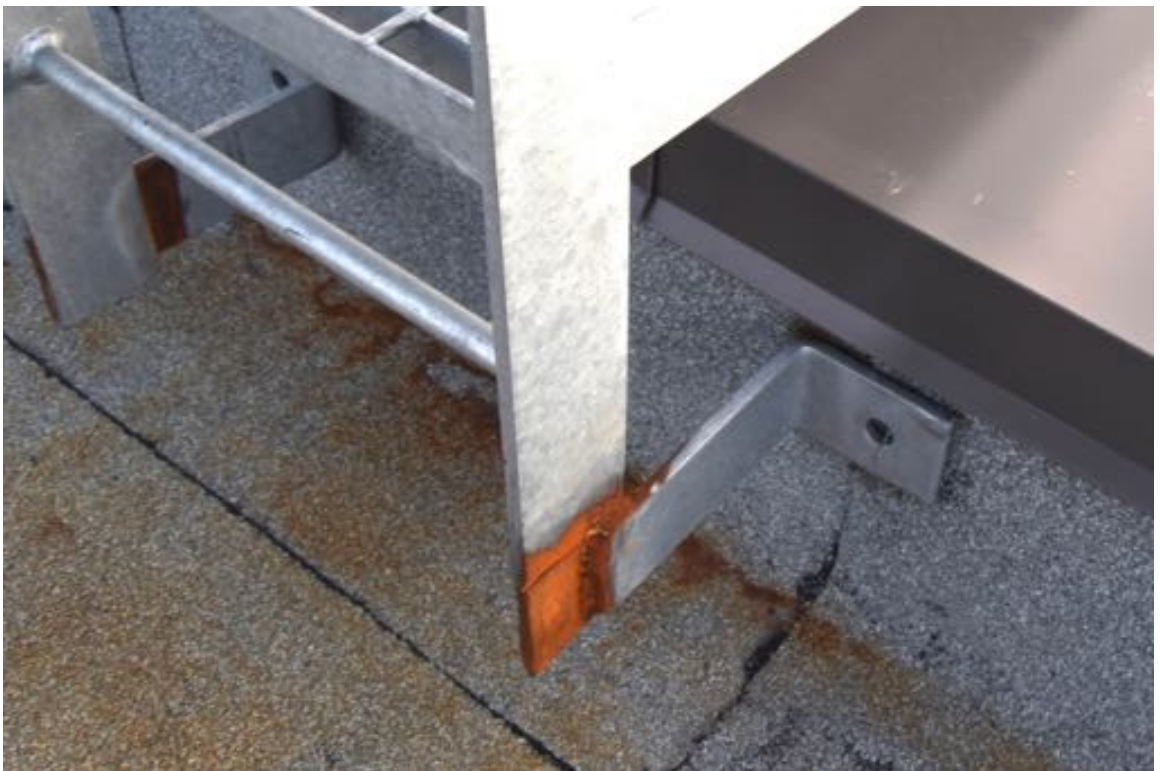
*Photo 58: The metal access stairs to the main roof are not secured at the top .*

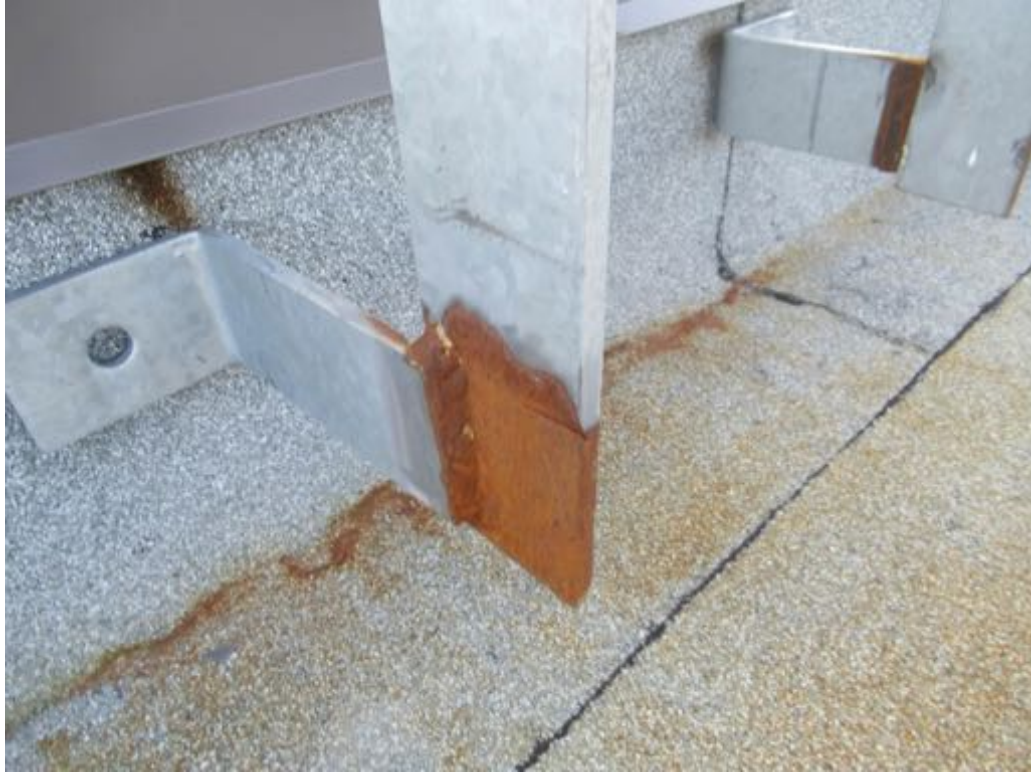
*Photo 59: The metal access stairs appear to be rusting.*

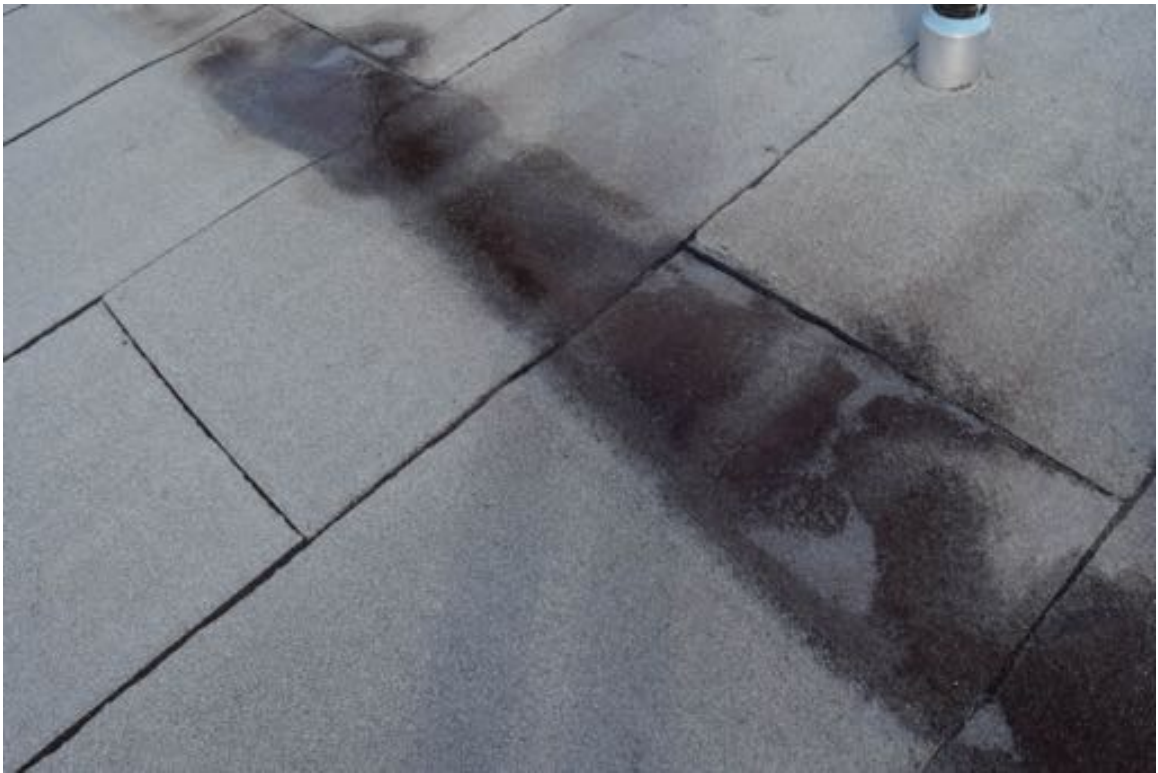
*Photo 60: There is some evidence of standing water on the roof.*

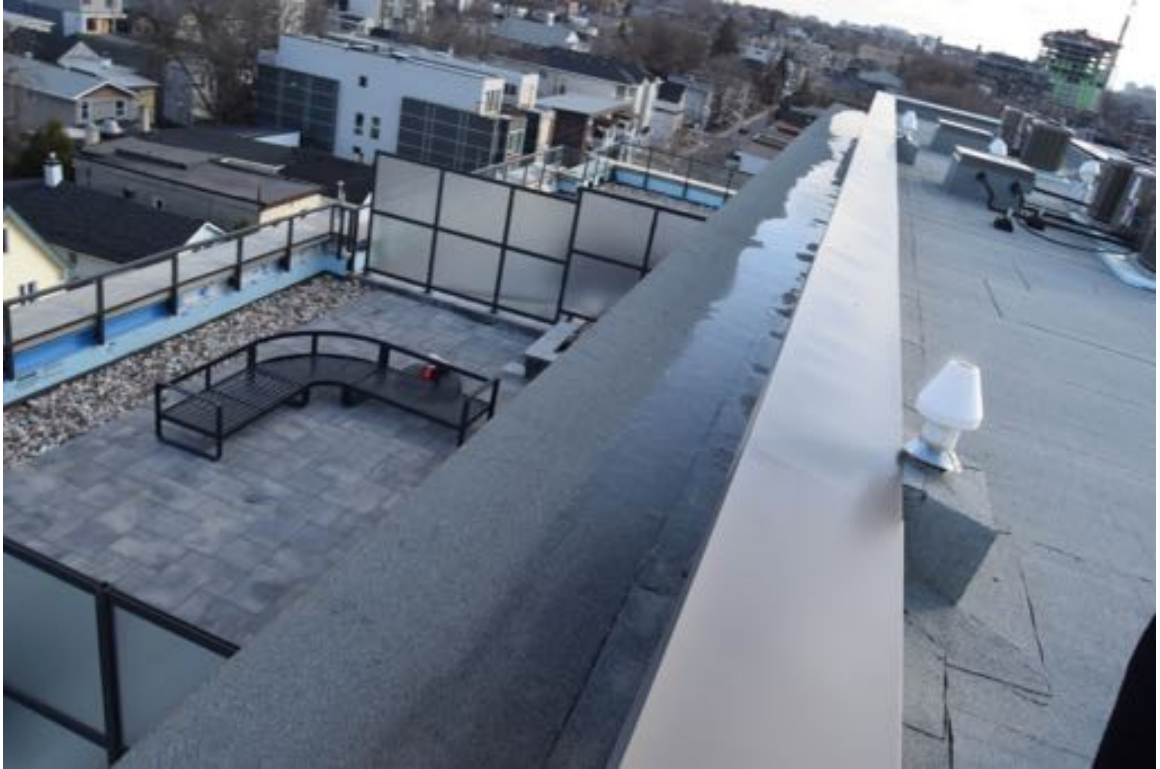
*Photo 61: For the majority of this eyebrow roof, there was standing frozen water observed.*

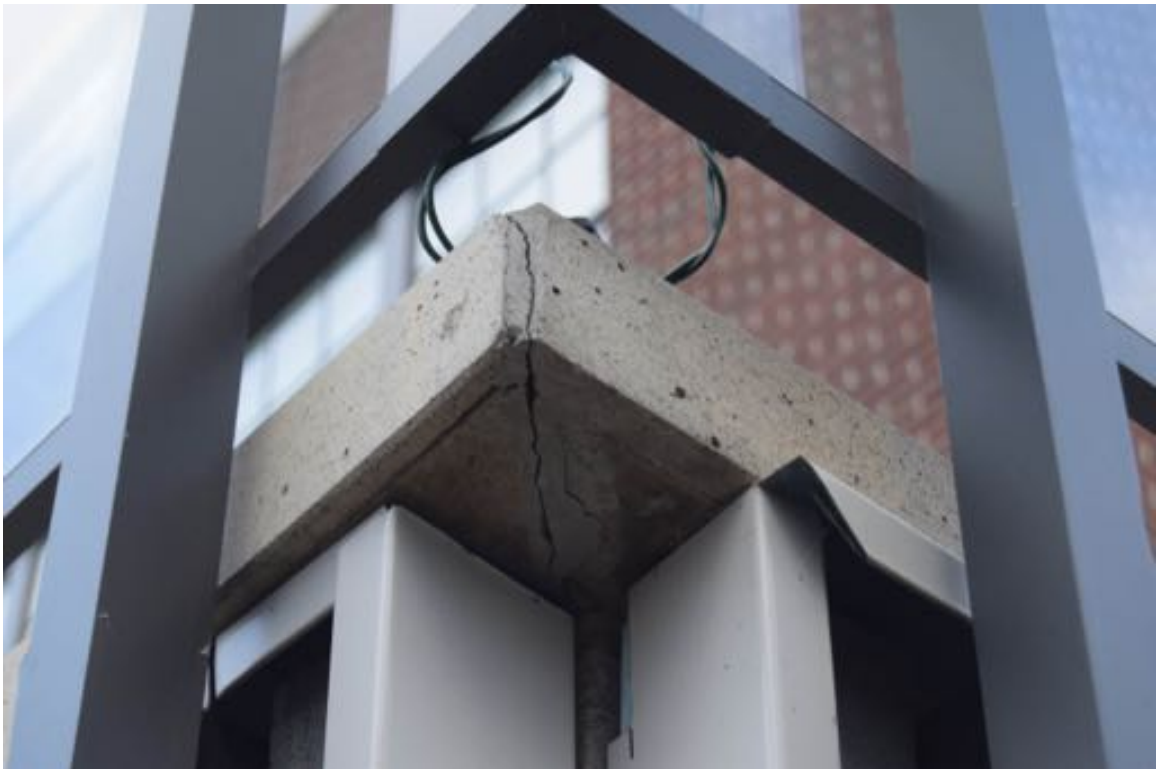
*Photo 62: There is a cracked parapet precast cap, south corner of the southwest terrace.*

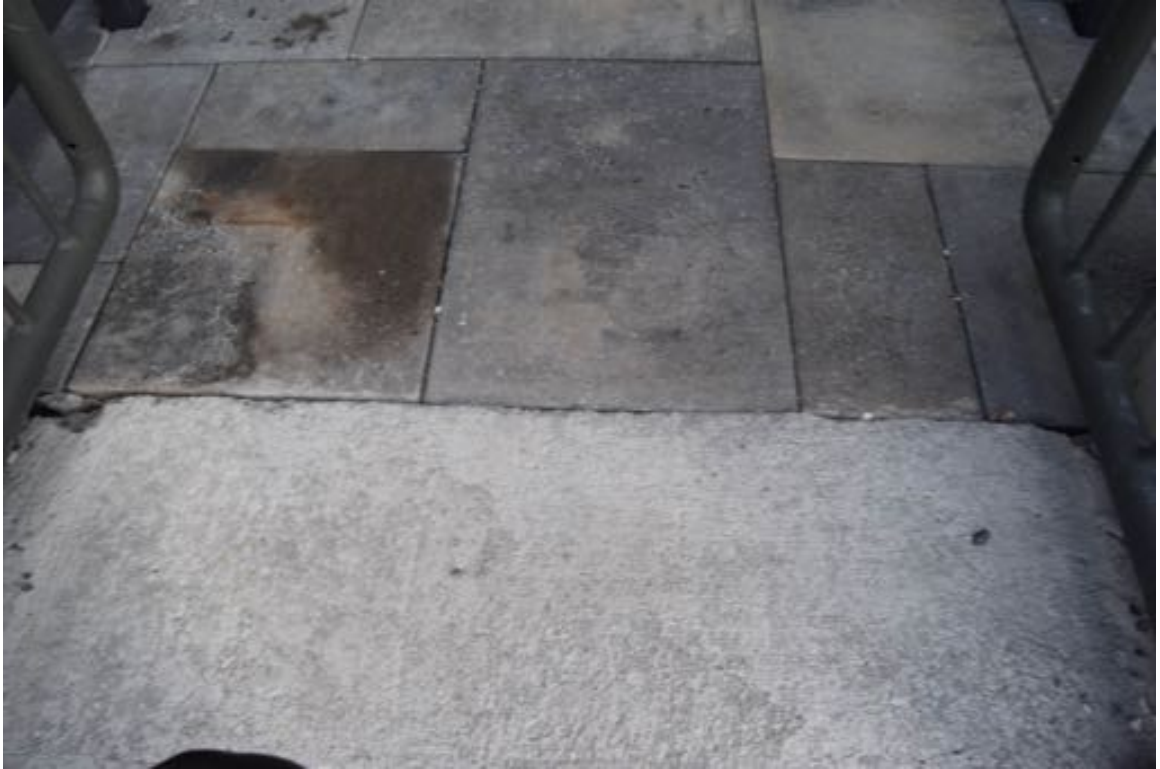
*Photo 63: Multiple first floor terrace pavers are discolored at the walkway leading up to stairwell B entrance.*

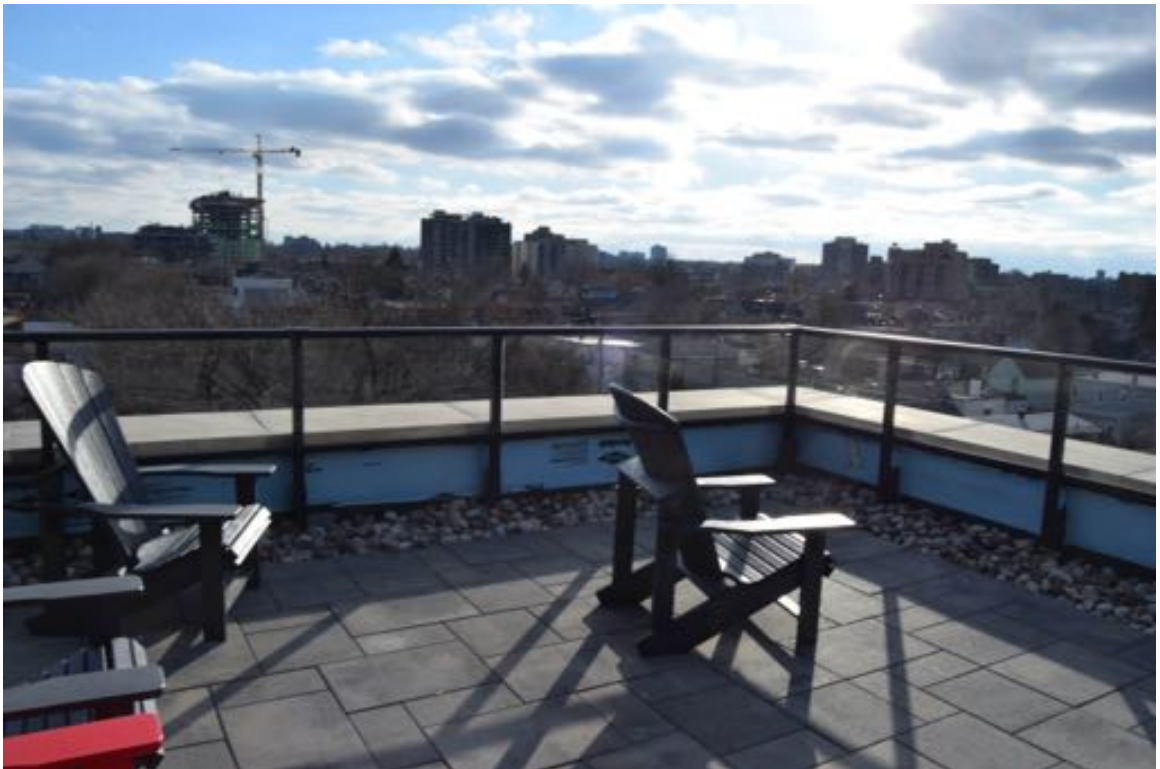
*Photo 64: In multiple areas at the fourth floor terrace parapets, the metal flashing is missing, with the rigid insulation is exposed.*

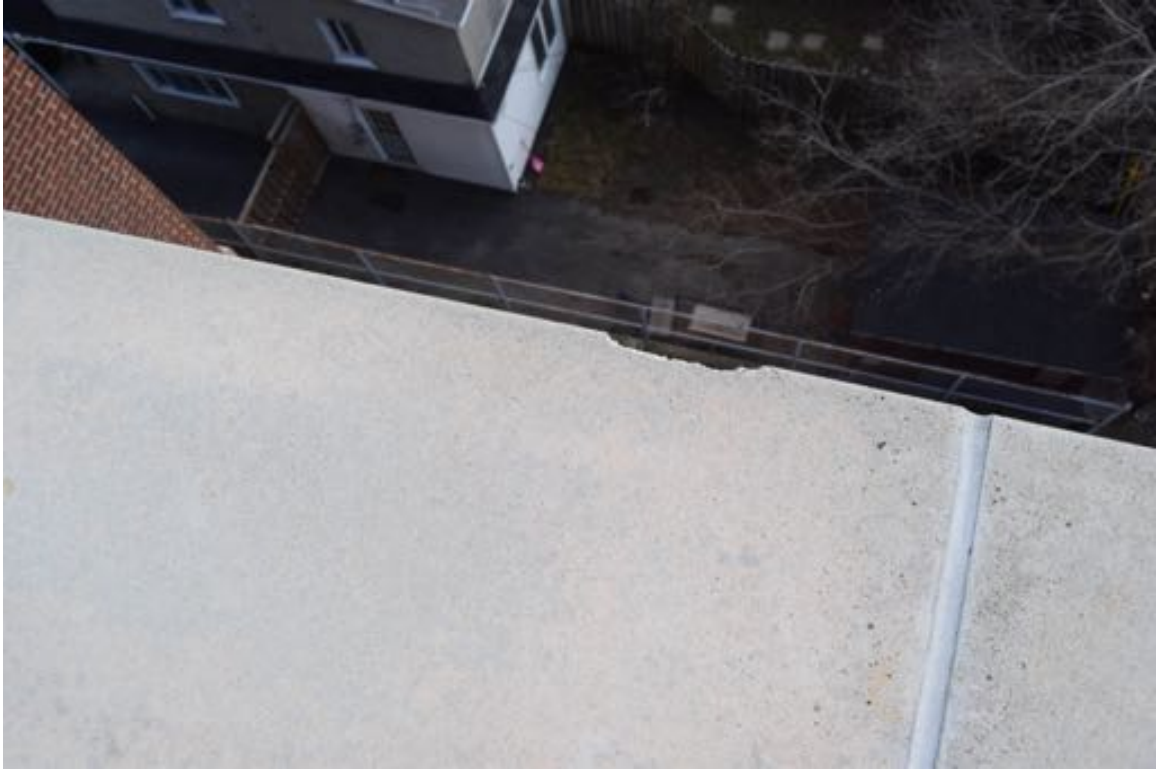
*Photo 65: The fourth floor terrace parapet precast concrete caps are chipped.*

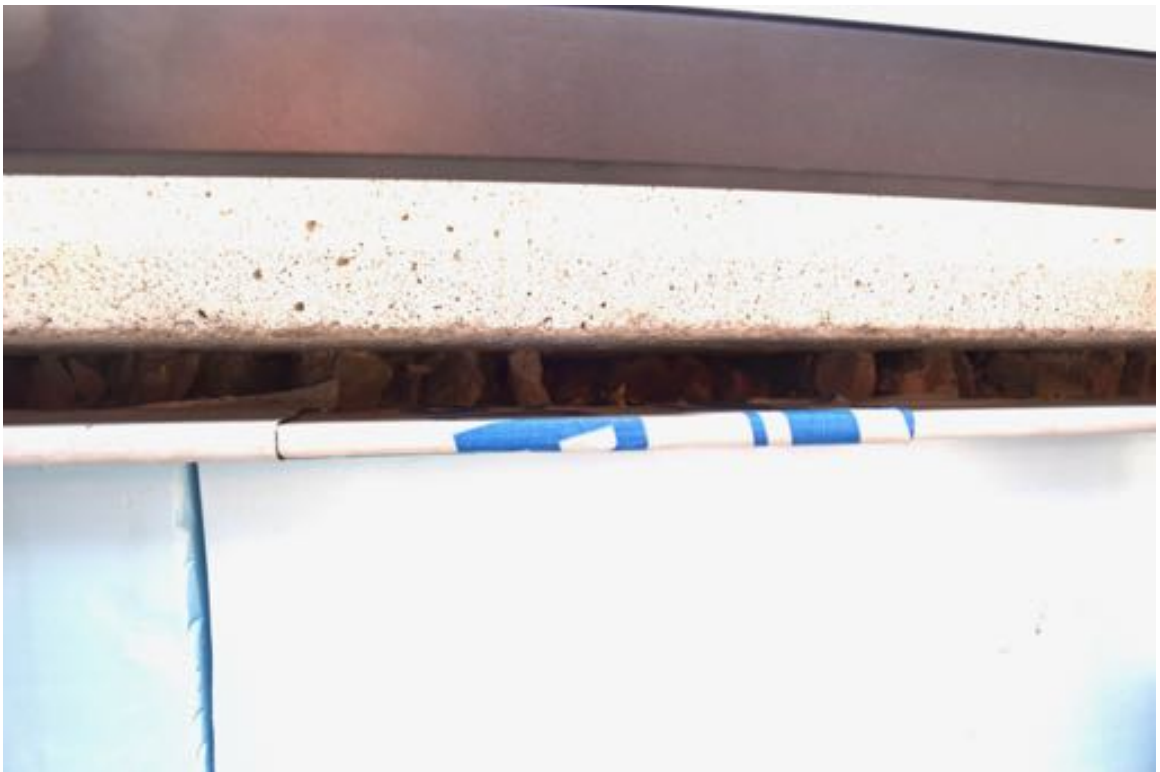
*Photo 66: The mortar under the precast concrete caps on fourth floor terraces appears to be missing/deficient in multiple areas.*

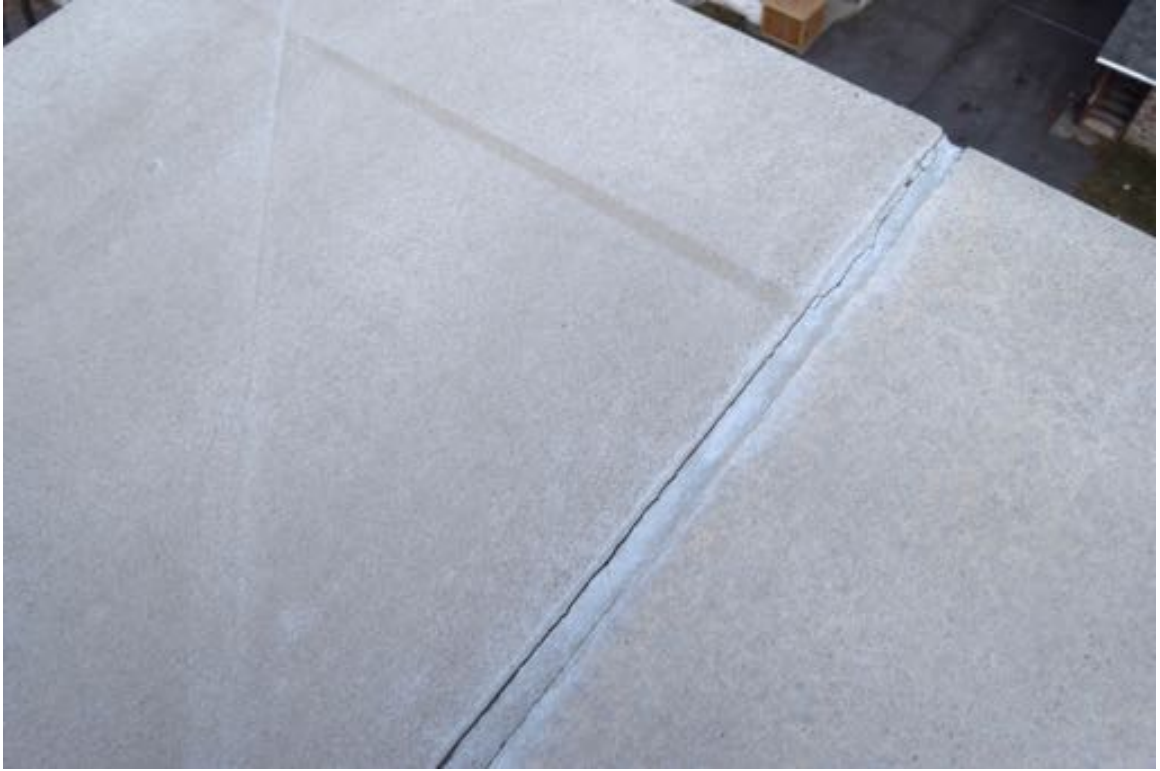
*Photo 67: The mortar between the fourth floor terraces precast concrete caps is cracked, in multiple locations reviewed.*

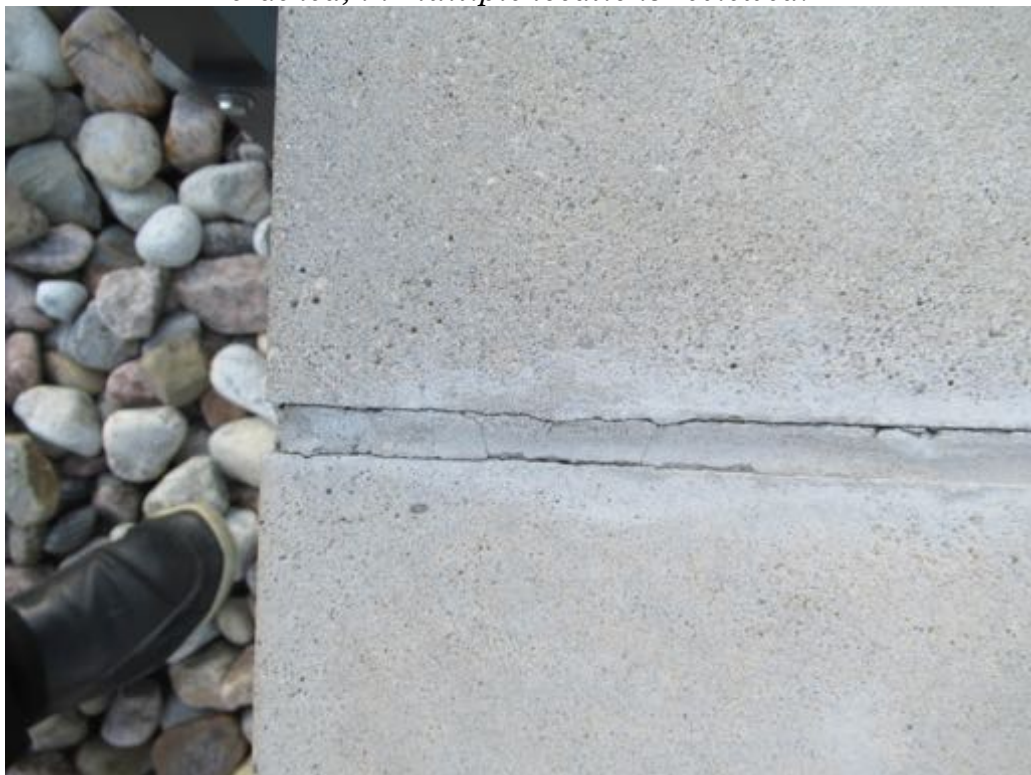
*Photo 68: The mortar between the fourth floor terraces precast concrete caps is cracked, in multiple locations reviewed.*

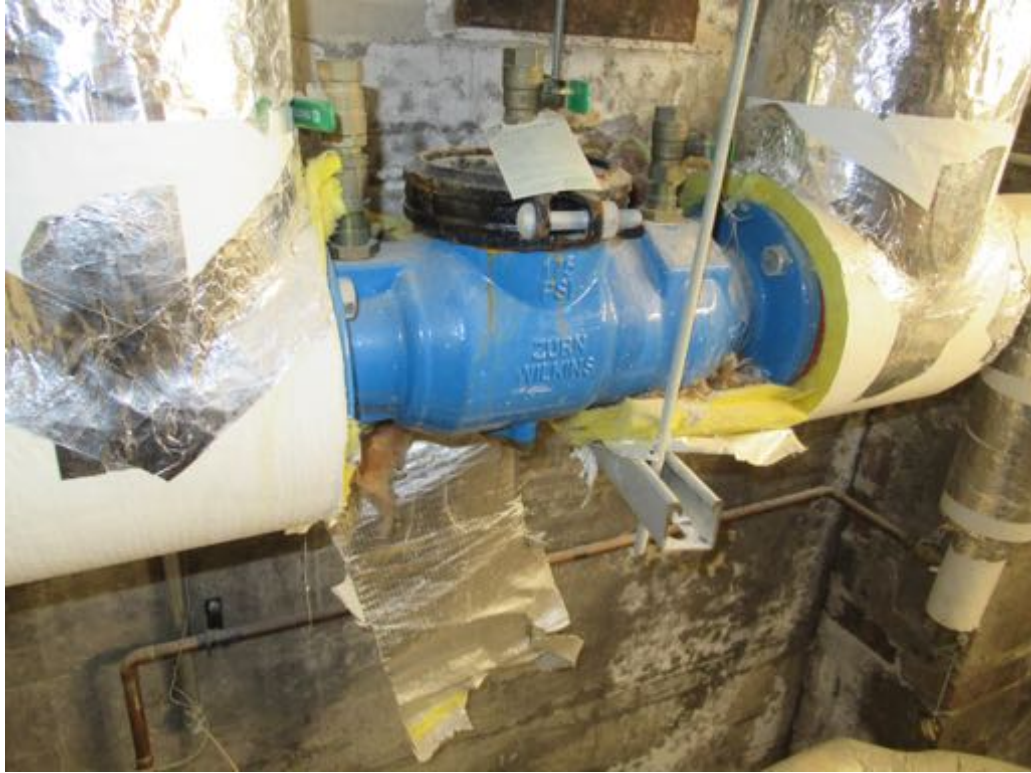
*Photo 69: Insulation appears to have been removed from piping in the water entry room, to be reviewed/repared.*

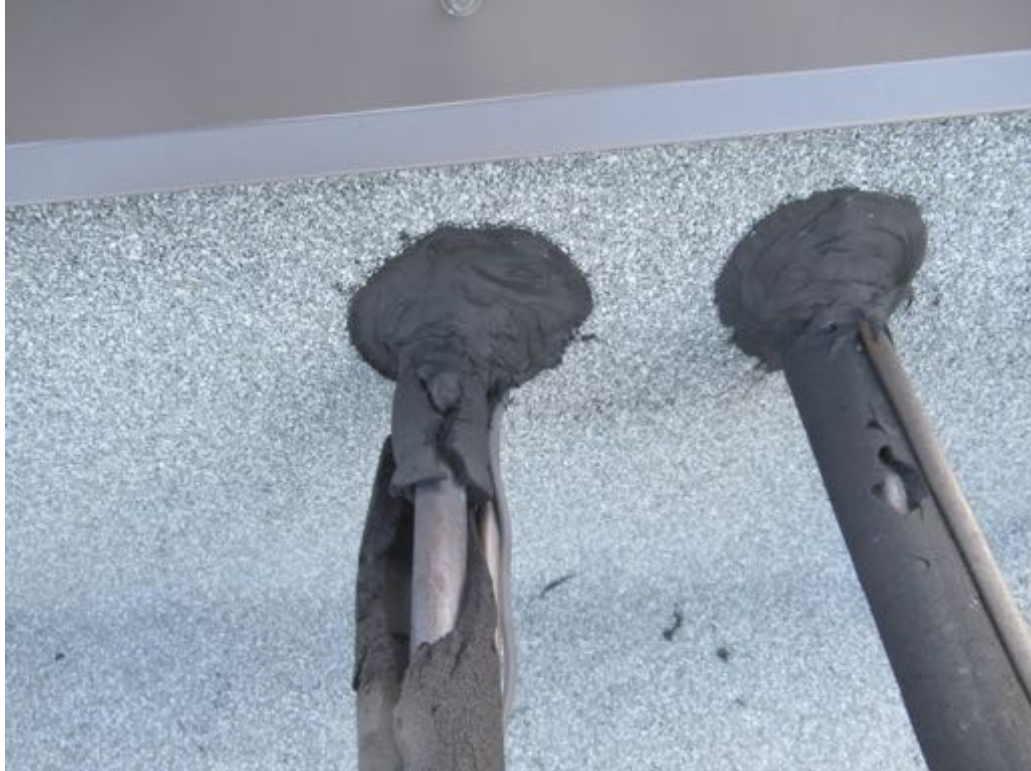
*Photo 71: Piping insulation is deteriorating at certain locations.*

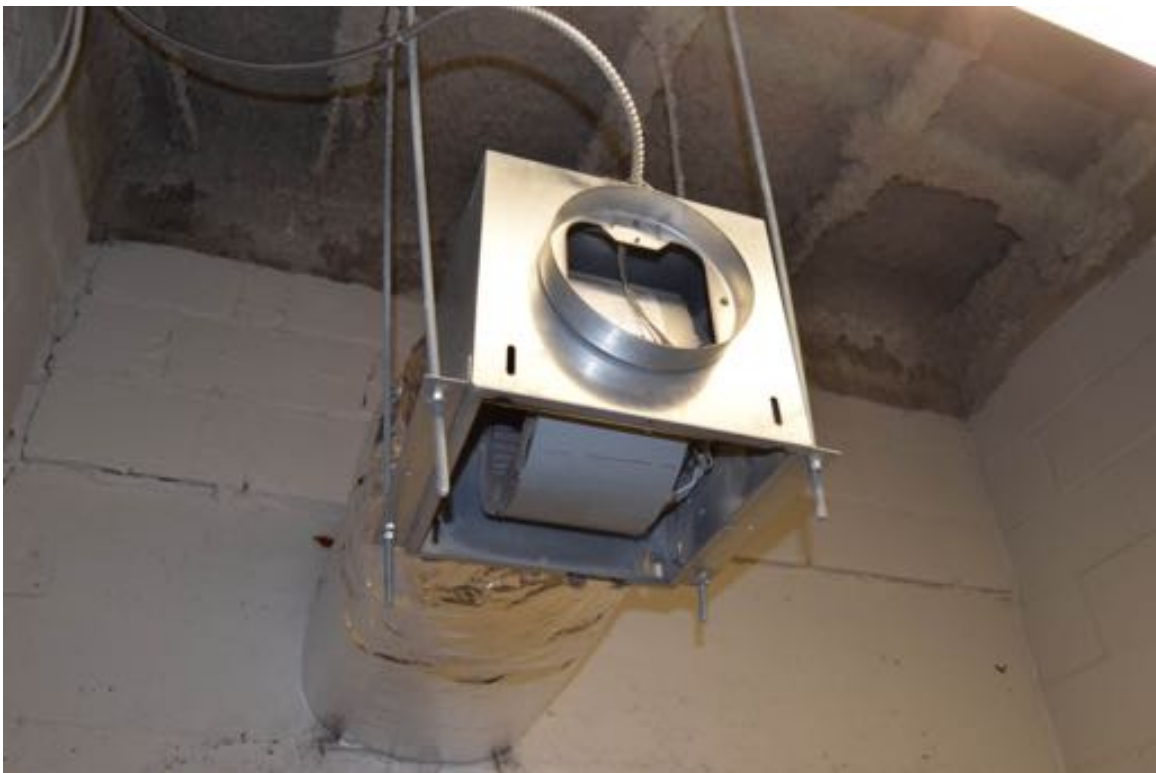
*Photo 72: The garbage room ceiling-hung exhaust fan appears to have panels or ducting missing.*

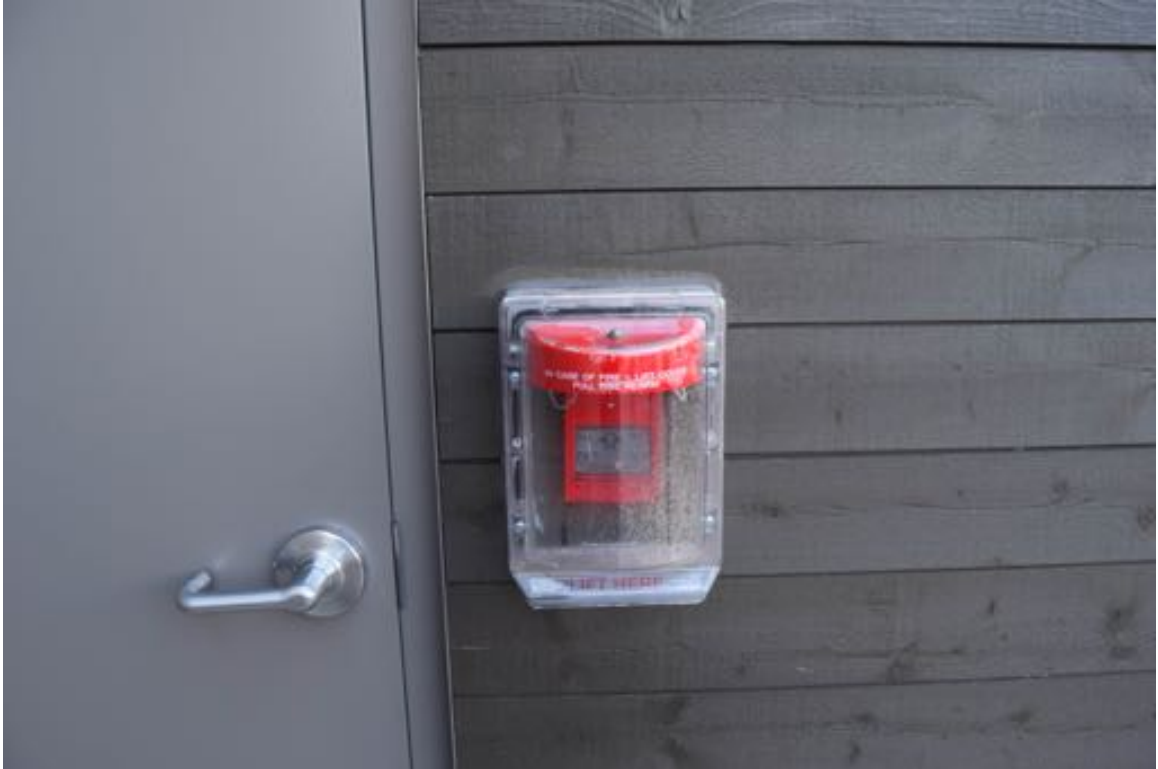
*Photo 73: Condensation in the protective enclosure for a pull station at a fourth floor common terrace.*

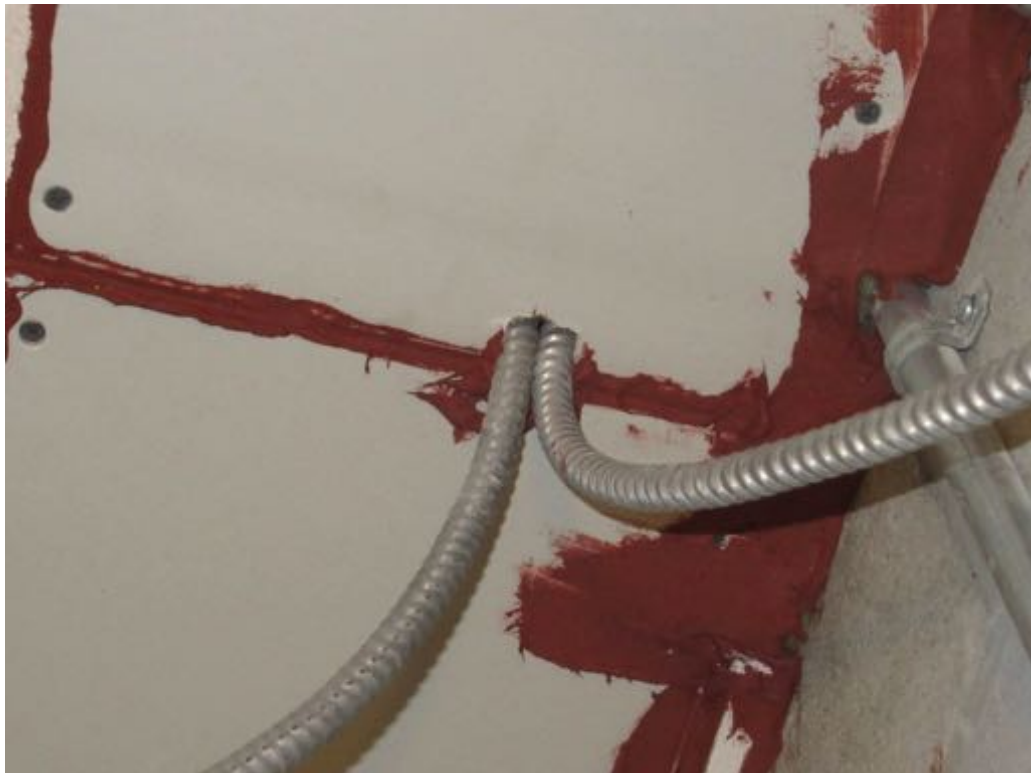
*Photo 74: In the elevator control room, firestopping is missing around a ceiling penetration .*

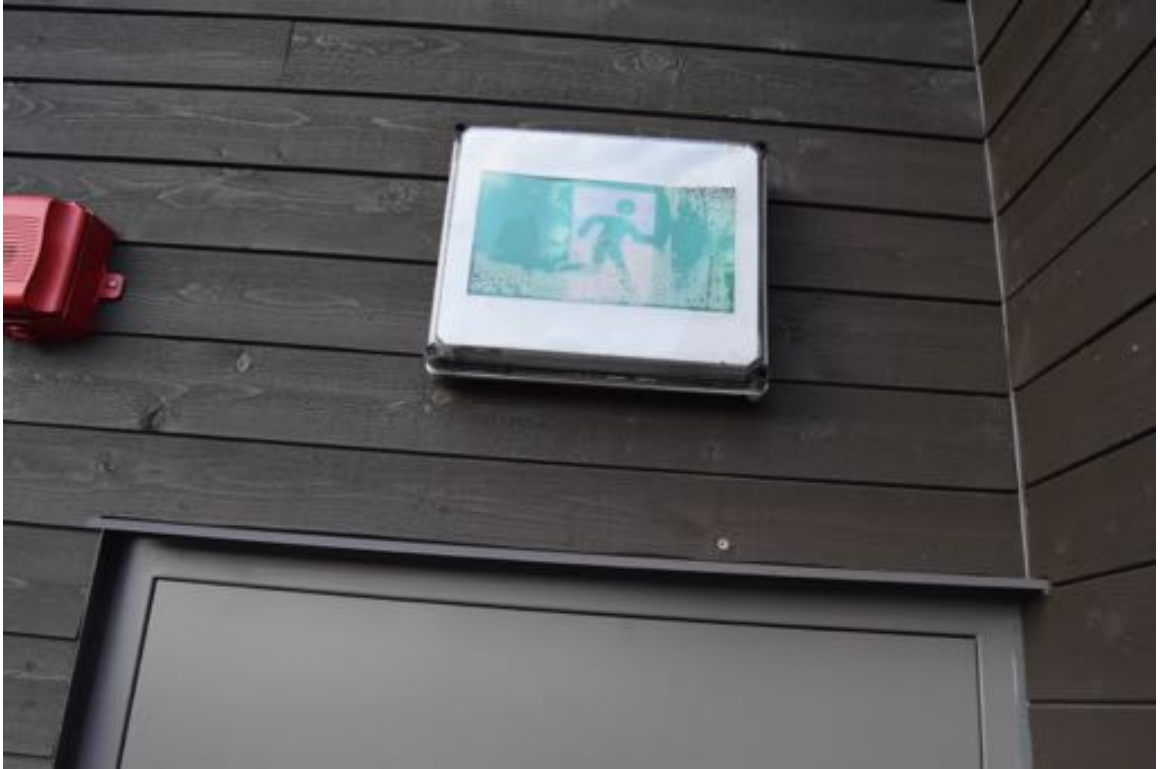
*Photo 75: Condensation in protective enclosure of the exit sign at fourth floor common terrace.*

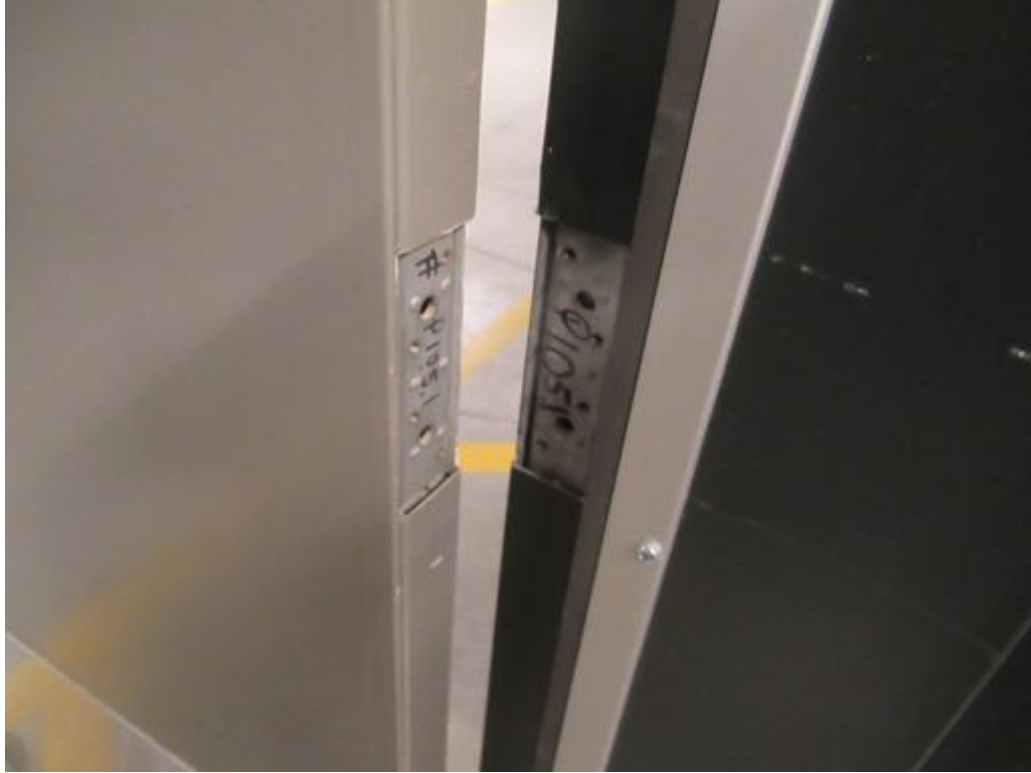
*Photo 87: Garbage room door is missing some hinges.*

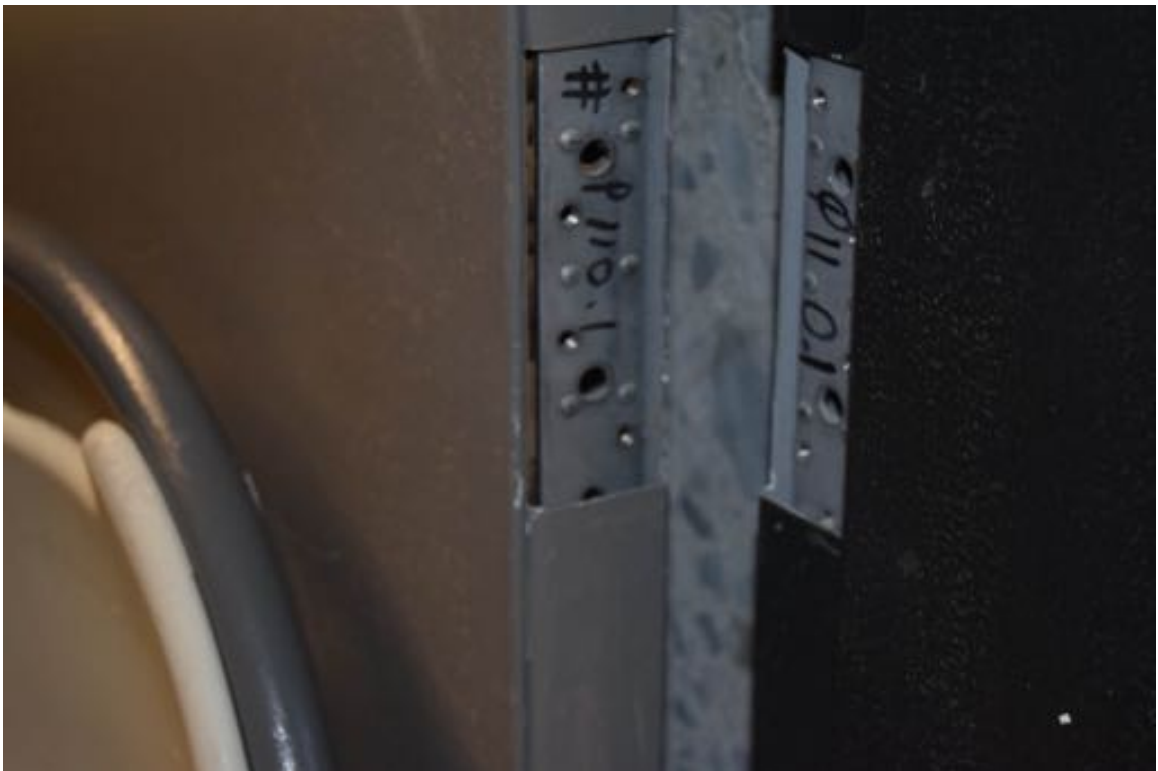
*Photo 88: Unit storage room doors have hinges missing.*
