# **CARLETON CONDOMINIUM CORPORATION 12**

Asbestos Management Plan

**ASBESTOS MANAGEMENT PLAN  
TOWER "A" - 158 MCARTHUR AVENUE, OTTAWA, ONTARIO**

December 2012

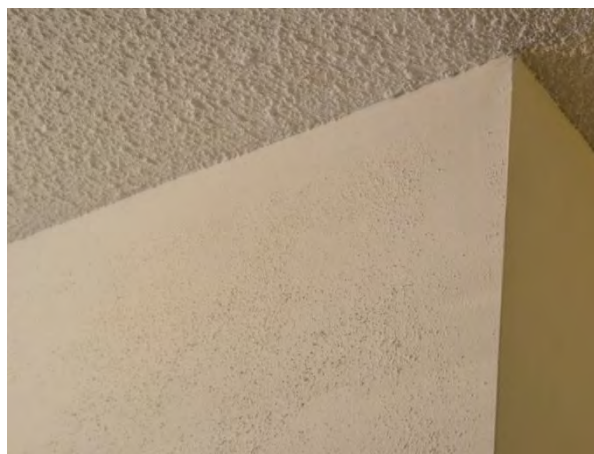
- SA-1 – Drywall Joint Compound – Unit 909 – 2% Chrysotile
- SA-3 – Ceiling Stipple – Unit 809 – 2% Chrysotile
- SA-5 – Drywall Joint Compound – Unit 709 – 2% Chrysotile
- SA-6 – Ceiling Stipple – Unit 709 – 2% Chrysotile
- SA-7 – Drywall Joint Compound – Unit 609 – 2% Chrysotile
- SA-8 – Ceiling Stipple – Unit 609 – 2% Chrysotile
- SA-9 – Wall Texture – Unit 609, East Wall – 2% Chrysotile
- SA-12 – Ceiling Stipple – Unit 409 – 2% Chrysotile
- SA-13 – Drywall Joint Compound – Unit 409 – 2% Chrysotile

**Figure 1** – Asbestos containing ceiling stipple (top of photo) and wall texture (Unit 609)

- **CEILING STIPPLE and WALL TEXTURE** – Due to the friable nature of the ceiling stipple and wall texture, Type 3 asbestos abatement measures and procedures are recommended for the removal of 1m<sup>2</sup> or more of ceiling stipple/wall texture. However, if less than 1m<sup>2</sup> is likely to be disturbed, Type 2 asbestos abatement measures and procedures may be implemented with the use of non-powered hand tools.

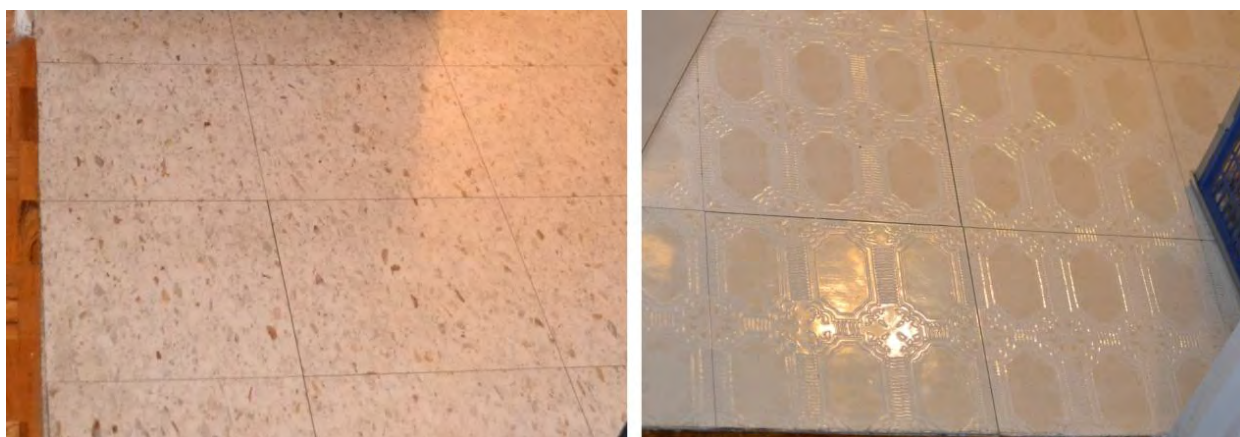
According to the analytical results, the following flooring building materials are **NON DETECT** for asbestos: the sheet vinyl flooring in units 109 and 1507; and the 12” x 12” vinyl floor tiles in Unit 101 and 708 (Fig. 2).

**Figure 2** – Vinyl Floor Tiles, **non-detect** for asbestos. Left: grey with brown speckles, from Unit 708. Right: white pattern, from Unit 101.

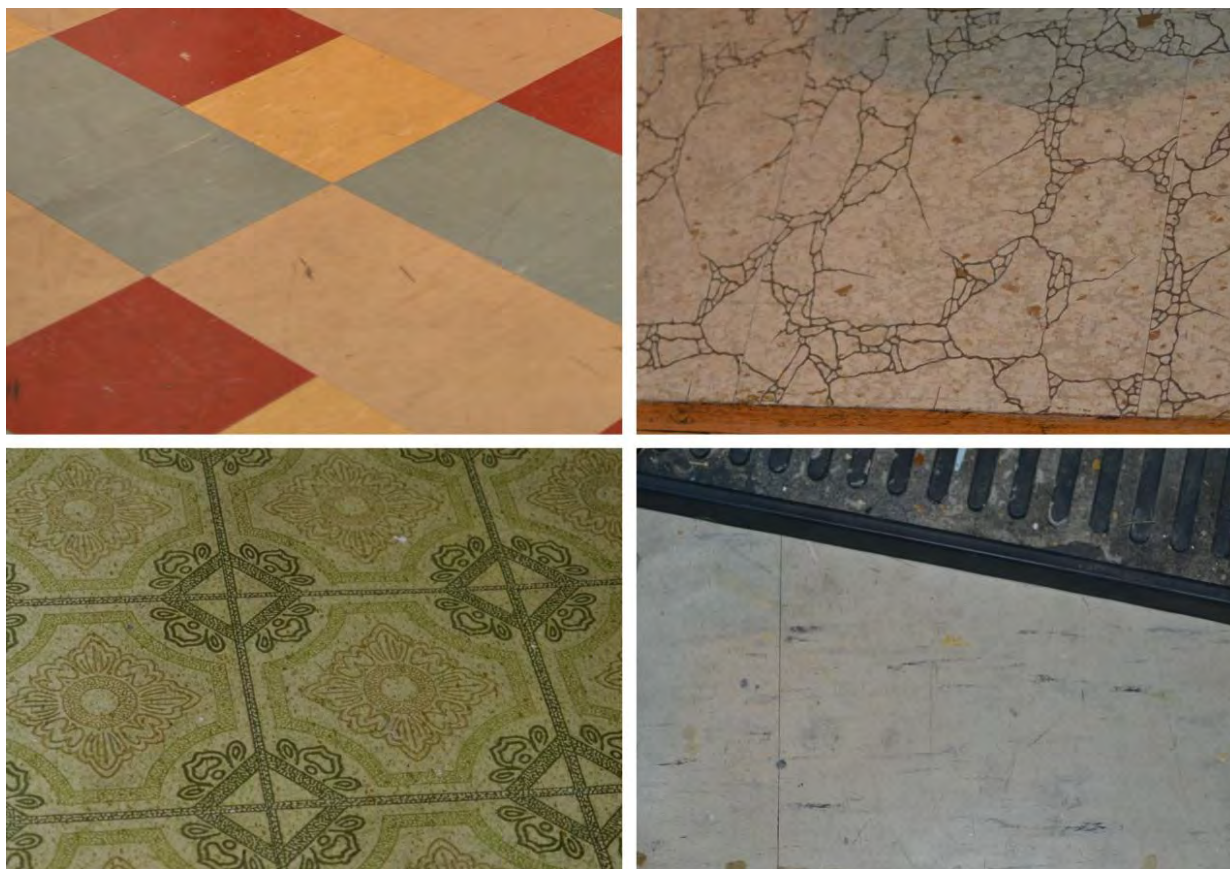
Various vinyl floor tiles found throughout the building are **ASBESTOS CONTAINING** (Fig. 3): the basement bicycle room floor tiles (red, green, beige, and yellow); the green “patterned” floor tiles in Unit 608; the rock pattern floor tiles in Unit 104, and the white speckled tiles found in Unit 1507. These floor tiles may be found in other units and can be also assumed to be asbestos containing based on homogeneity. The following samples confirm the presence of asbestos in these materials:

- SA-20 – Floor Tile (green) – Basement Bicycle Room – 5% Chrysotile
- SA-23 – Floor Tile (red) – Basement Bicycle Room – 5% Chrysotile
- SA-26 – Floor Tile (beige) – Basement Bicycle Room – 5% Chrysotile
- SA-29 – Floor Tile (yellow) – Basement Bicycle Room – 5% Chrysotile
- SA-41 – Floor Tile (green pattern) – Unit 608 Kitchen – 5% Chrysotile
- SA-44 – Floor Tile (rock pattern) – Unit 104 Hallway – 5% Chrysotile
- SA-53 – Floor Tile (white speckled) – Unit 1507 Hallway Closet – 5% Chrysotile

**Figure 3 – ASBESTOS CONTAINING Vinyl Floor Tiles.** Top left: red, green, beige, and yellow tiles from the basement bicycle room. Top right: rock pattern tiles from Unit 104. Bottom left: green pattern tiles from Unit 608. Bottom right: white speckled floor tiles from Unit 1507.

**NOTE: Other floor tiles and/or sheet vinyl flooring not depicted in this report may be asbestos containing. Therefore, flooring materials in question should be sampled for asbestos on a project specific basis.**
