RESERVE FUND STUDY
FOR
CARLETON CONDOMINIUM CORPORATION 22

REPORT PREPARED FOR
CARLETON CONDOMINIUM CORPORATION 22
c/o Bridgeport Realty Management
100 Argyle Avenue, Ottawa, Ontario

January 5, 2016

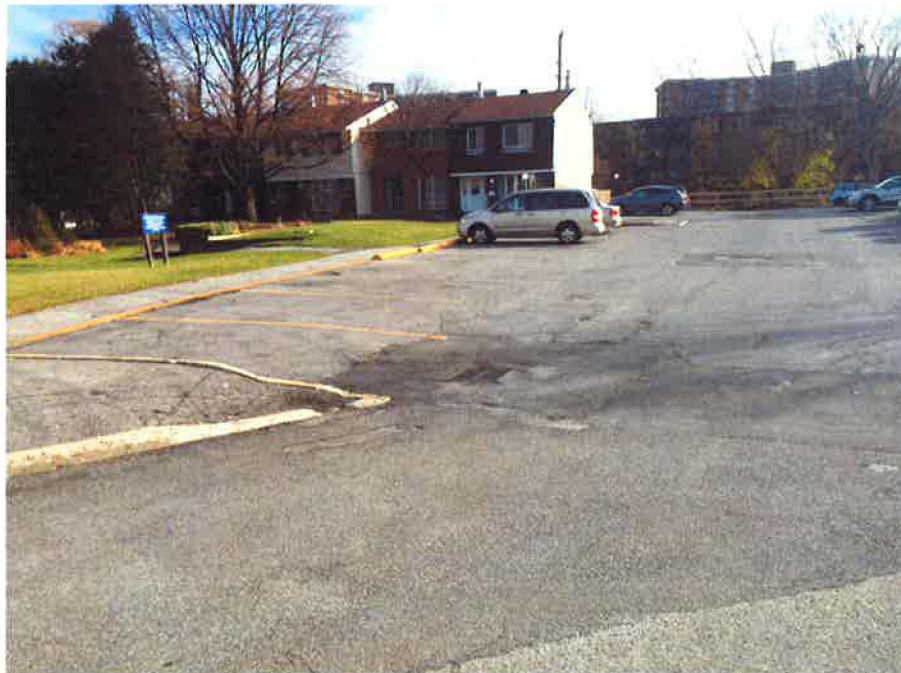
The asphalt pavement on the roadways and parking areas is in poor to fair condition as moderate surface erosion, heaving, and isolated transverse cracks were observed at isolated locations with the worst being in the rear parking lot beside units 1-21. Given the current condition of the asphalt pavement, it is our recommendation that the roadways and parking areas be reconstructed in the near future. Complete reconstruction involves the removal of existing asphalt pavement as well as the existing sub-base. New sub-base materials are then implemented and compacted, prior to the reinstatement of a new asphalt overlay. This is often required instead of resurfacing due to pavement sub-base deterioration, or because another overlay will adversely affect levels and drainage. Complete reconstruction of the rear parking lot is expected to cost \$68,000 and we have budgeted this work in fiscal year 2016/17. The remaining asphalt reconstruction is expected to cost \$282,000 and has been budgeted for fiscal year 2020/21.

2 Showing the condition of the asphalt pavement in the rear parking lot. Note cracking and heaving

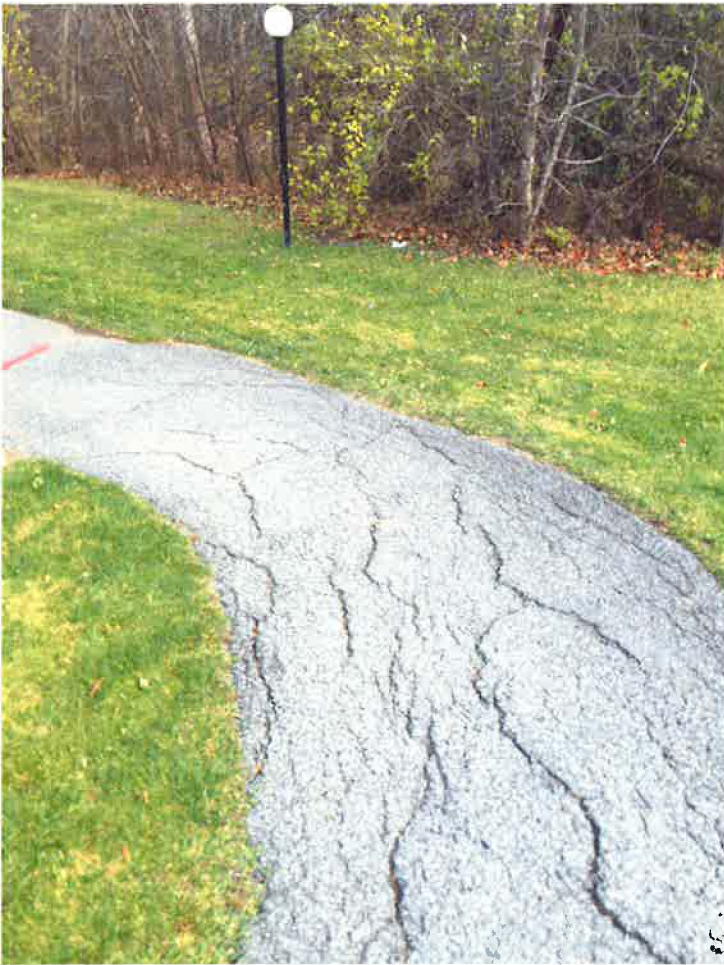
The asphalt walkways are in poor to fair condition and should be replaced in the near future. Pavement cracking, settlement and heaving are present. Complete reconstruction of the walkways is estimated to cost \$170,000 and this work is budgeted for fiscal year 2020/21 and every 20 years thereafter.

- 3 Showing poor condition of the asphalt walkways. Note severe cracking.

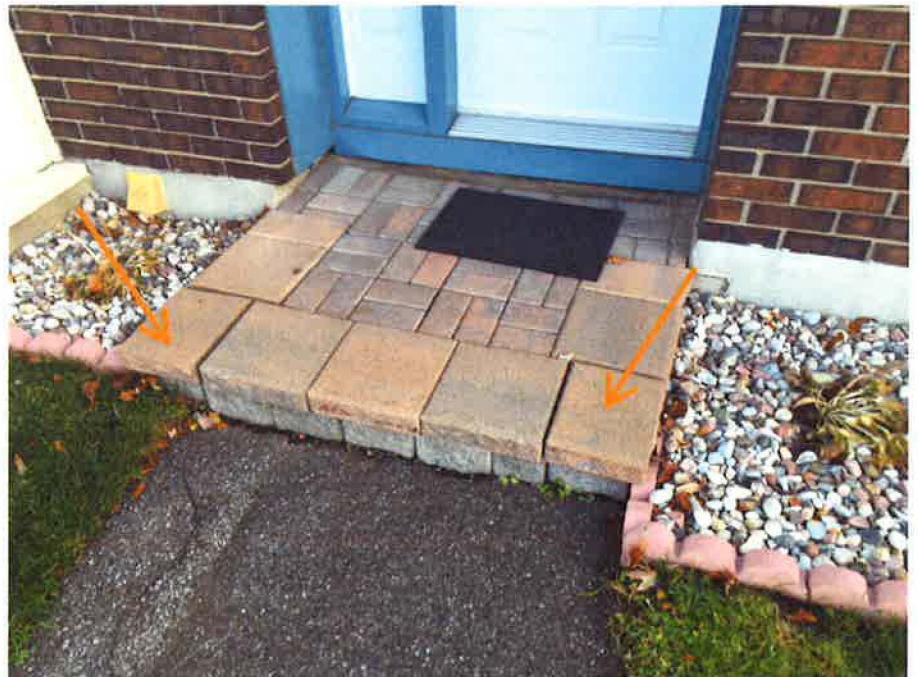
The interlocking unit pavers and dry stack units at the front entrances of each unit vary in condition throughout the complex. Separation of the dry stack units and settlement of the whole front entrance system was typically observed. We recommend all front entrance steps be replaced with precast concrete steps to avoid further deterioration and settlement of the existing system. We expect installation of the precast entry steps at each unit to cost \$260,000 and should be carried out on an as-required basis. As such, we have budgeted this work over a 10-year period beginning in fiscal year 2016/17.

- 4 Showing settled interlocking unit pavers at front entrance to a unit

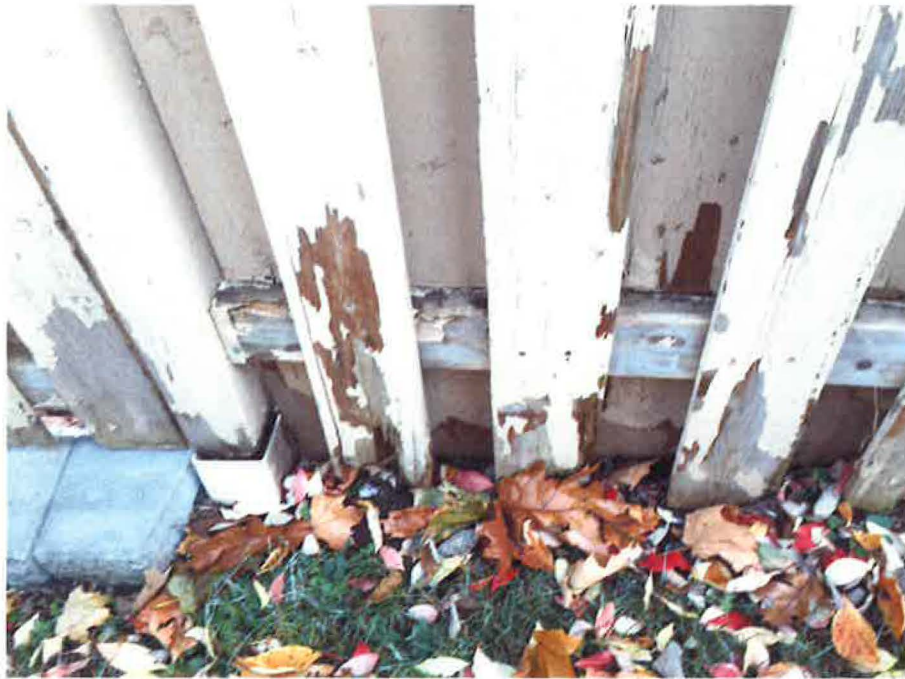
The wood privacy fencing is in poor condition and should be replaced in the near future. Unstable posts and rotted wood was observed at multiple locations. Replacement of the wood fencing is estimated to cost \$200,000 and this work has been budgeted over a 2-year period beginning in fiscal year for fiscal year 2016/17 and every 25 years thereafter.

5 Showing a section of deteriorated wood fencing

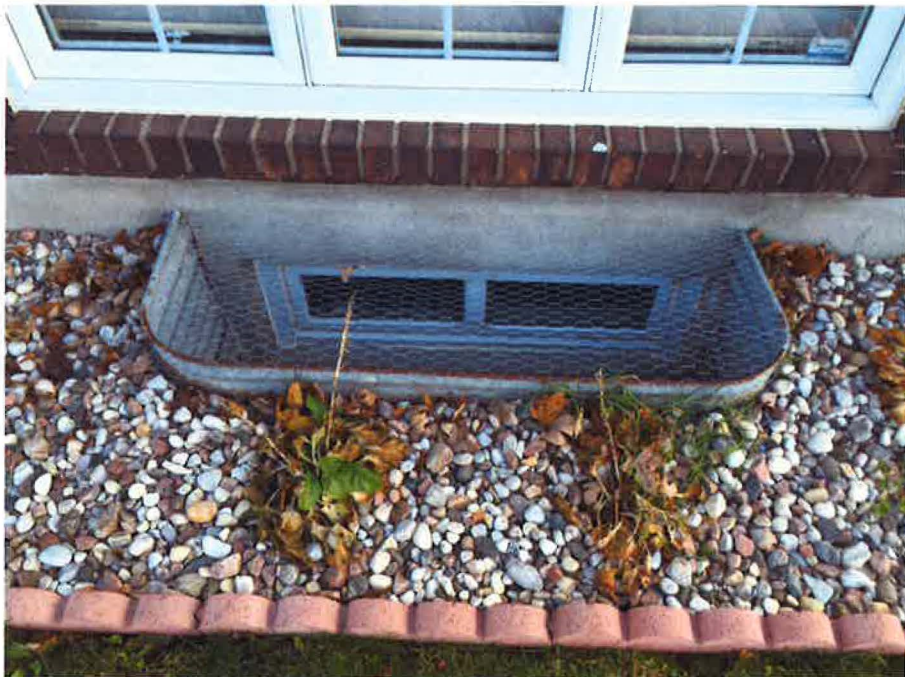
The galvanized sheet metal window wells are in fair to satisfactory condition and should provide many more years of service. Replacement of the metal window wells should be carried out on an as-required basis. As such, an allowance of \$10,000 has been budgeted in fiscal year 2025/26 and every 10 years thereafter.

6 Showing a galvanized sheet metal window well

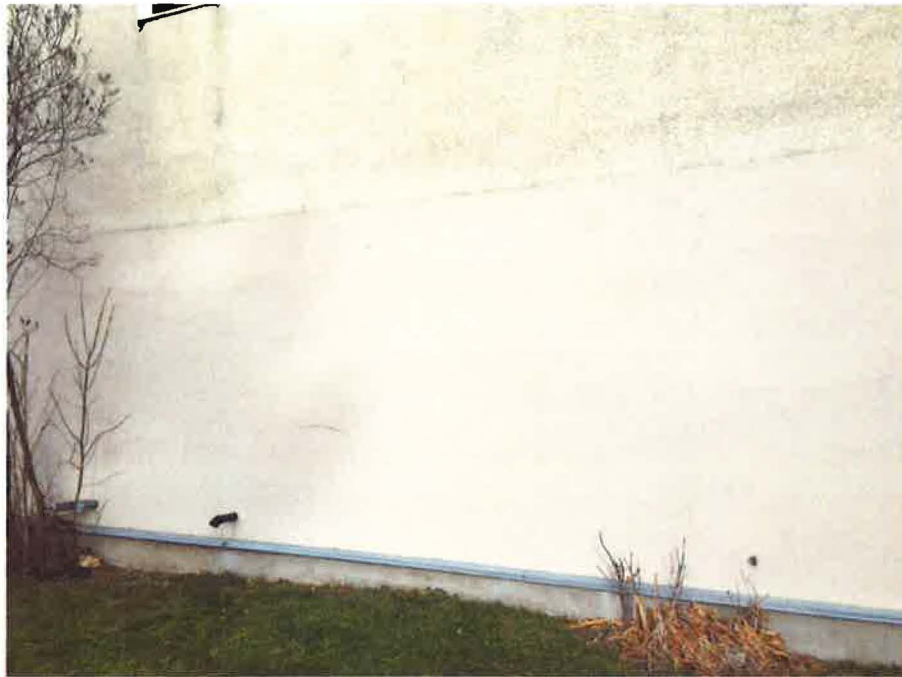
The stucco is in fair condition for its age and it should provide many more years of service. Isolated sections of the stucco veneer have had an additional stucco coating applied and it was common to see cracking in these coatings. According to the information provided by the Board, all the stucco veneer is to be replaced with vinyl siding in the near future. We estimate the replacement of the stucco with vinyl siding to cost \$330,000 and have budgeted this work over a 3-year period beginning in fiscal year 2016/17.

7 Showing existing cracked stucco to be replaced with vinyl siding

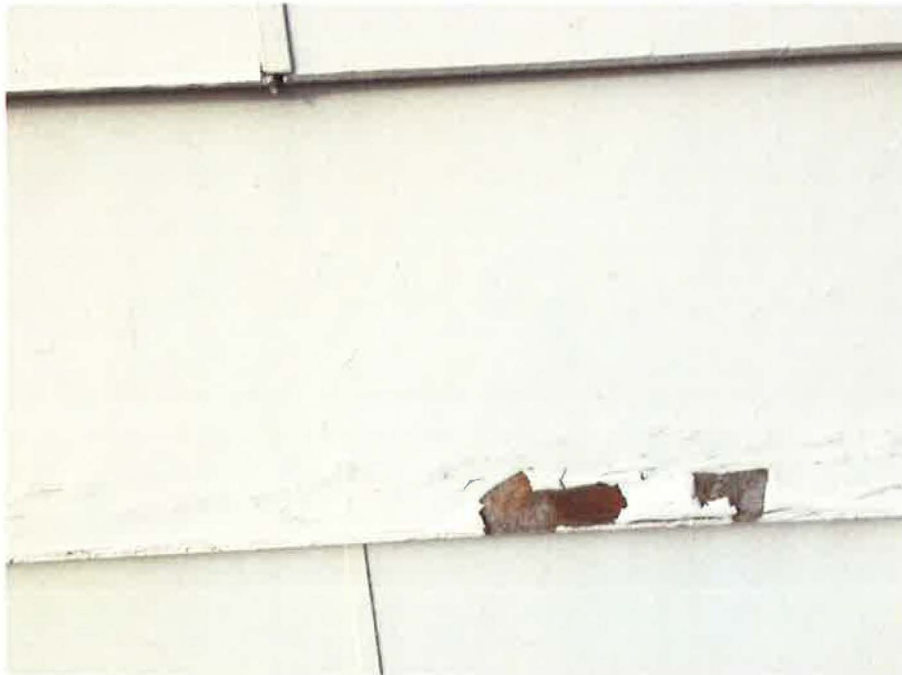
The hardboard siding is in fair condition for its age and should provide many more years of service before requiring replacement. Peeling paint and minor deterioration was observed at isolated locations. According to the information provided by the Board, the hardboard siding is to be replaced with vinyl siding in the near future. We estimate the replacement of the hardboard siding with vinyl siding to cost \$30,000 and we have budgeted this work over a 3-year period beginning in fiscal year 2016/17.

8 Showing existing hardboard siding to be replaced with vinyl siding

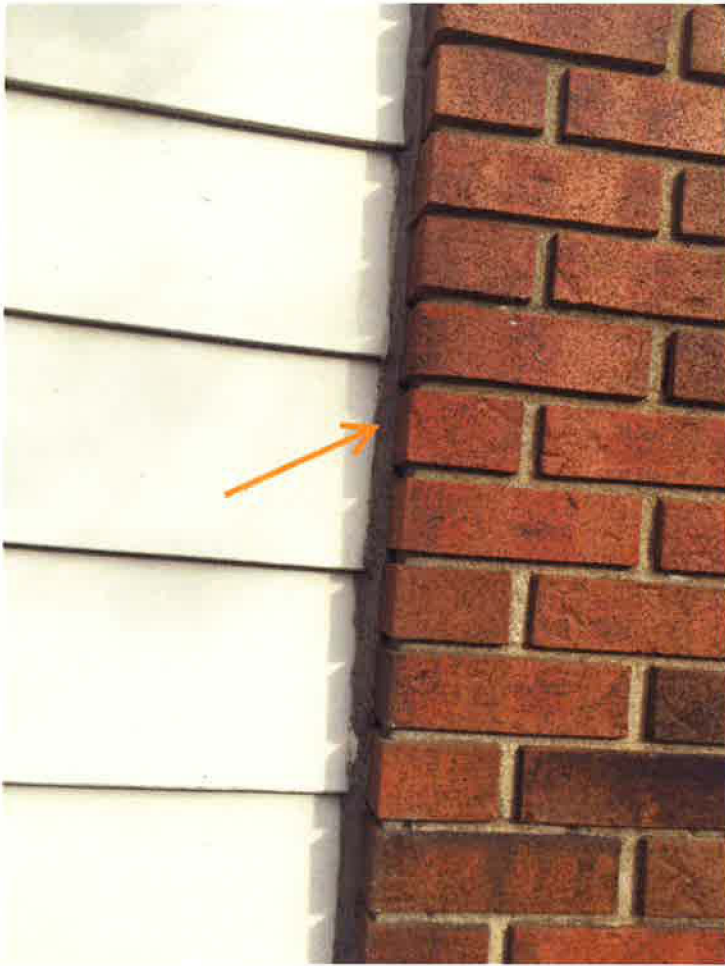
The condition of the caulking varies throughout the complex as caulking replacements have occurred at various times. In general, the caulking is in poor to fair condition and should be replaced in the near future. As the windows and doors are classified as a "unit owner responsibility" the caulking around them is also not the condominiums responsibility. Caulking replacement is scheduled for fiscal year 2018/19 and every 12 years thereafter, in conjunction with exterior painting work, at an estimated cost of \$15,000.

9 Showing typical condition of the caulking throughout the complex

When caulking is replaced, only high quality materials should be used and all old caulking should be removed before applying the new caulking. Caulking should be inspected regularly and the necessary repair work carried out by a qualified contractor. Minor repairs should be paid for out of the operating budget. Complete re-caulking will likely be required every 12-15 years.

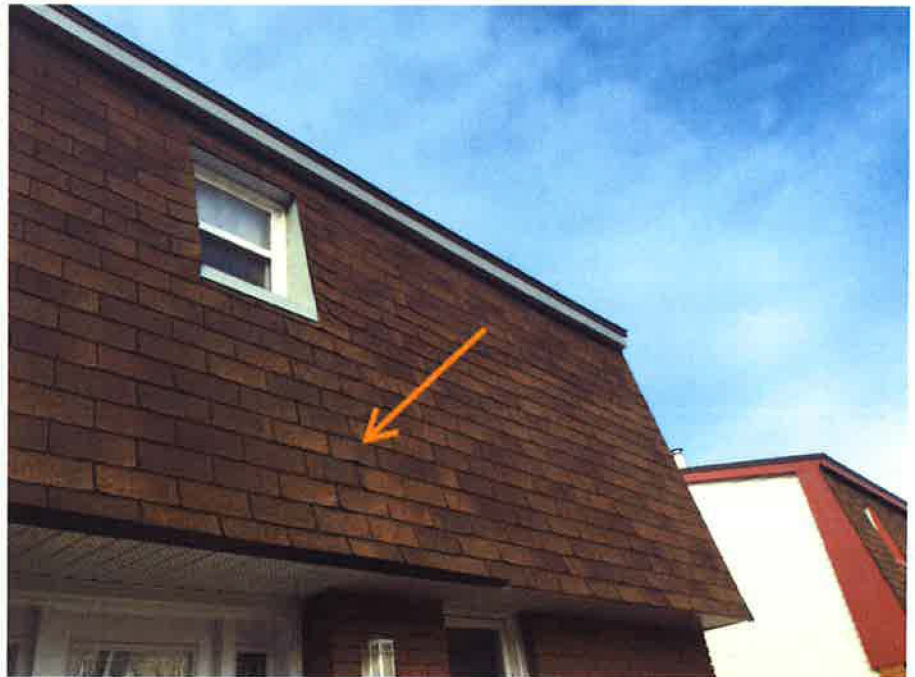
The asphalt shingle mansards throughout the complex are in fair condition. Isolated shingle uplifting and deterioration was observed. We expect these mansard roofs will require replacement within the next 5 years. As such, we have budgeted \$135,000 in 2019/20 and every 20 years thereafter for this work.

10 Showing typical condition of the asphalt shingle mansard roofs. Note minor uplift.
