## **BOARD of DIRECTORS - OCSCC1009**

#### **APPENDIX D: DEFICIENCIES TRACKING SUMMARY**

The purpose of the performance audit is to identify performance deficiencies of the common elements of the Condominium that may give rise to a warranty claim under the builder's warranty.

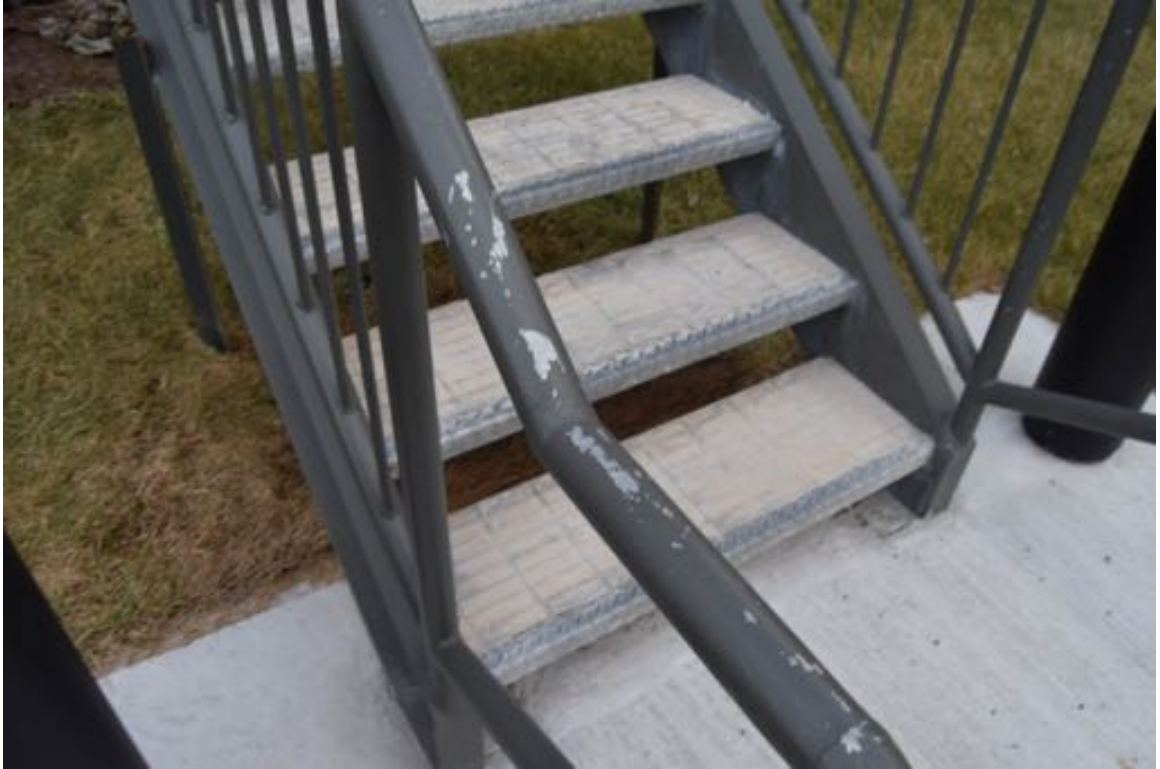
*Photo 5: Paint is peeling on the south staircase railings and risers.*

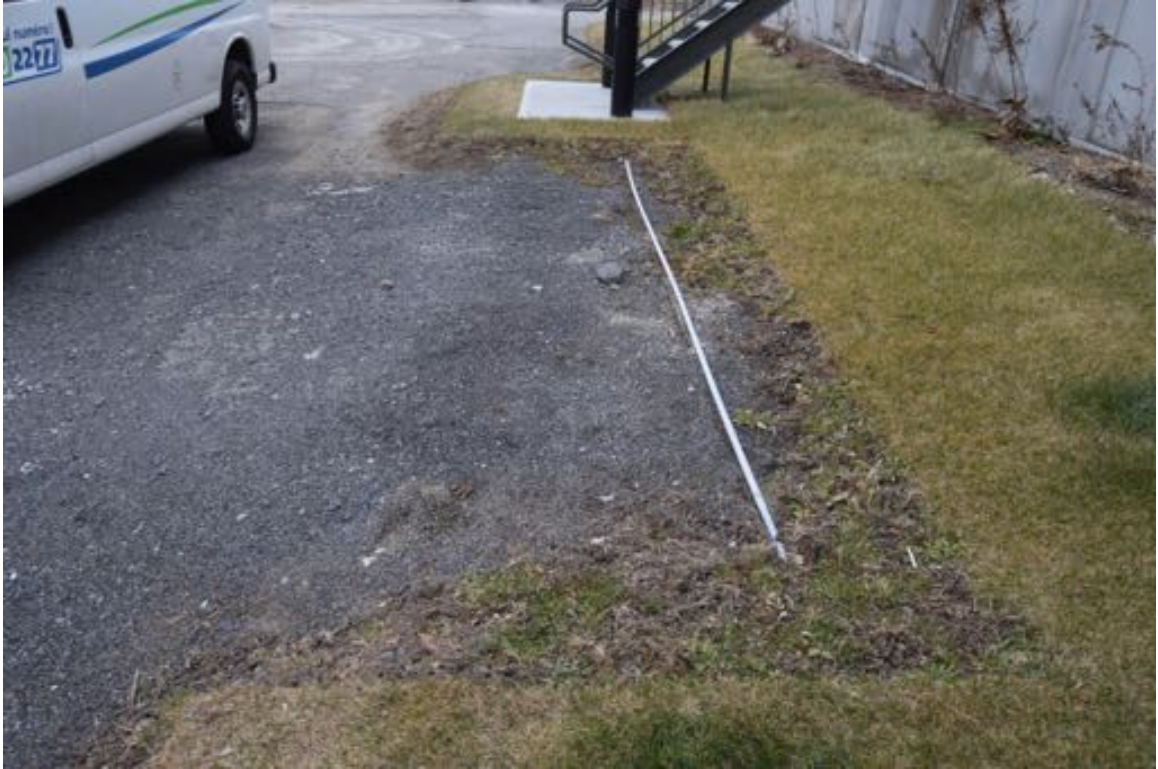
- (3) No access to water on the exterior of the building (103).
- (4) No exterior water faucets (101).
- (5) East elevation, planters are missing from under the two columns at the garage entrance, specified in not as-built architectural drawings.
- (6) Sodded areas are incomplete at the rear west-end of the building, not as per provided drawings. Refer to Photo 9.
- (7) There are areas of dry grass patches. Refer to Photo 10.
- (8) Sod areas adjacent to entrance ramp have sod missing. Refer to Photo 11.

*Photo 9: Sodded areas are incomplete at the rear west-end of the building, not as per provided drawings.*

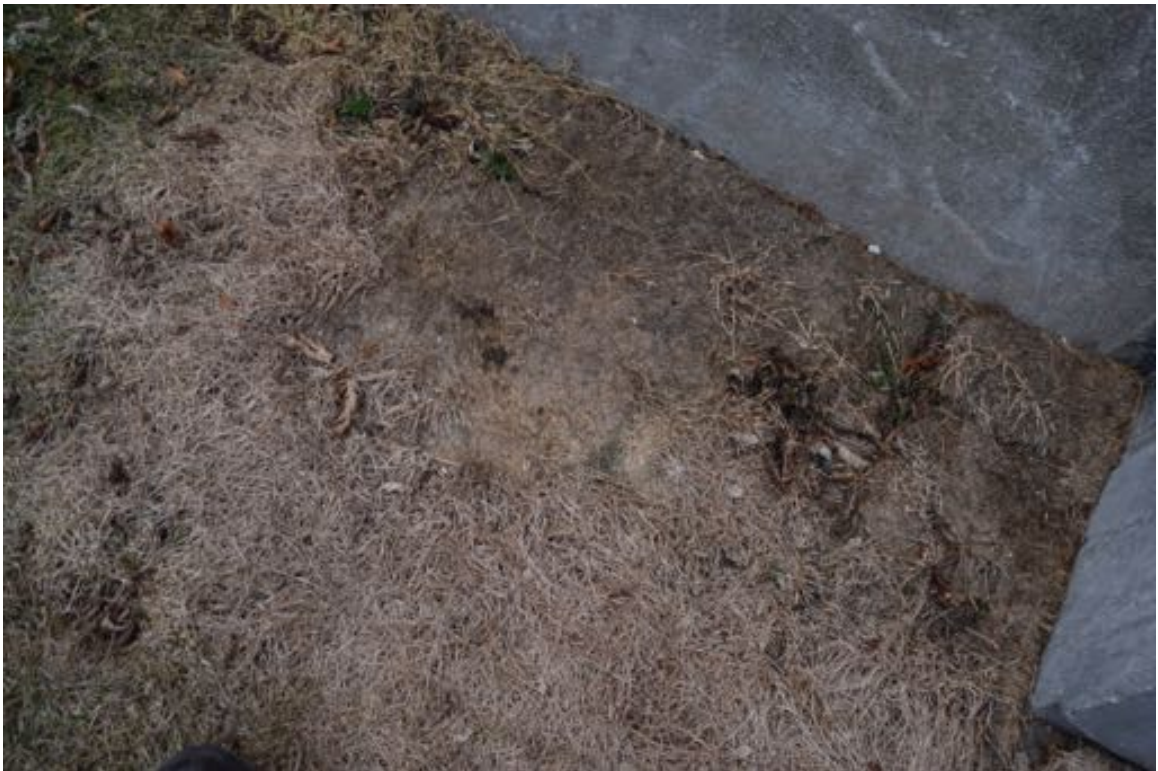
*Photo 10: Areas of dry grass patches.*

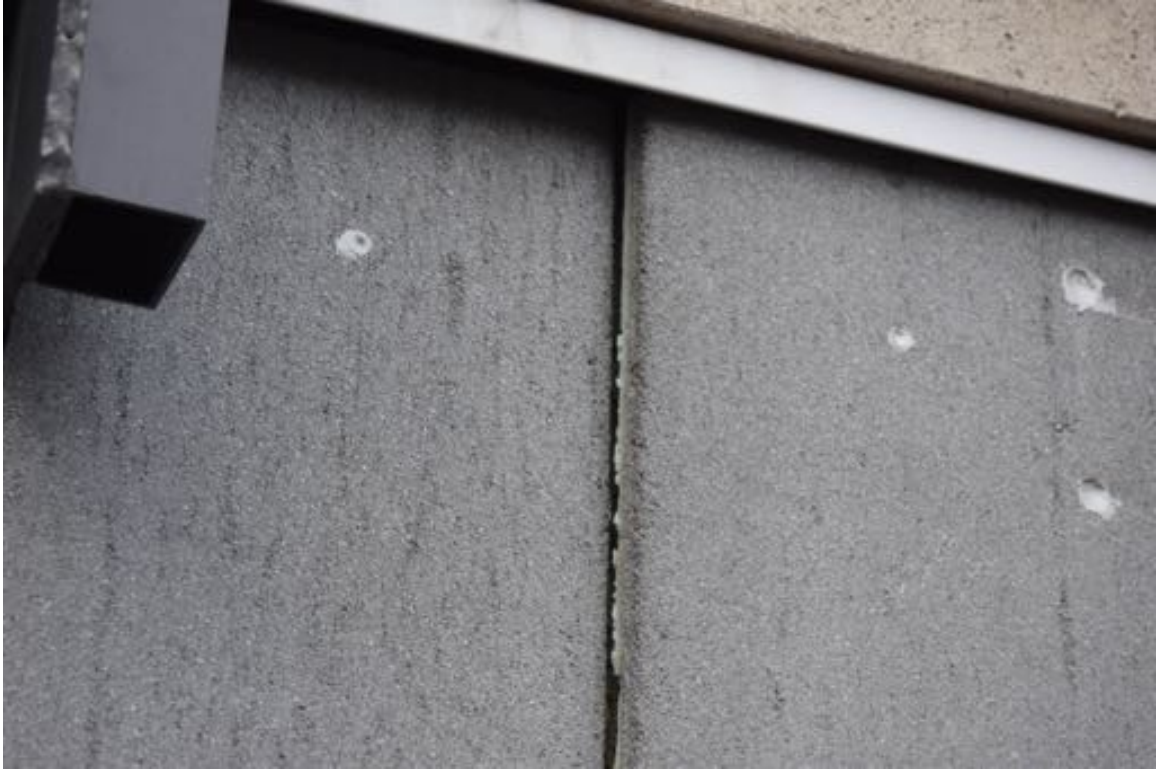
- (21) There is major foundation wall damage on backyard walls under stairs (302).
- (22) An insulation panel is dislodged at the southwest corner of the building. Refer to Photo 43.

*Photo 43: An insulation panel is dislodged at the southwest corner of the building.*

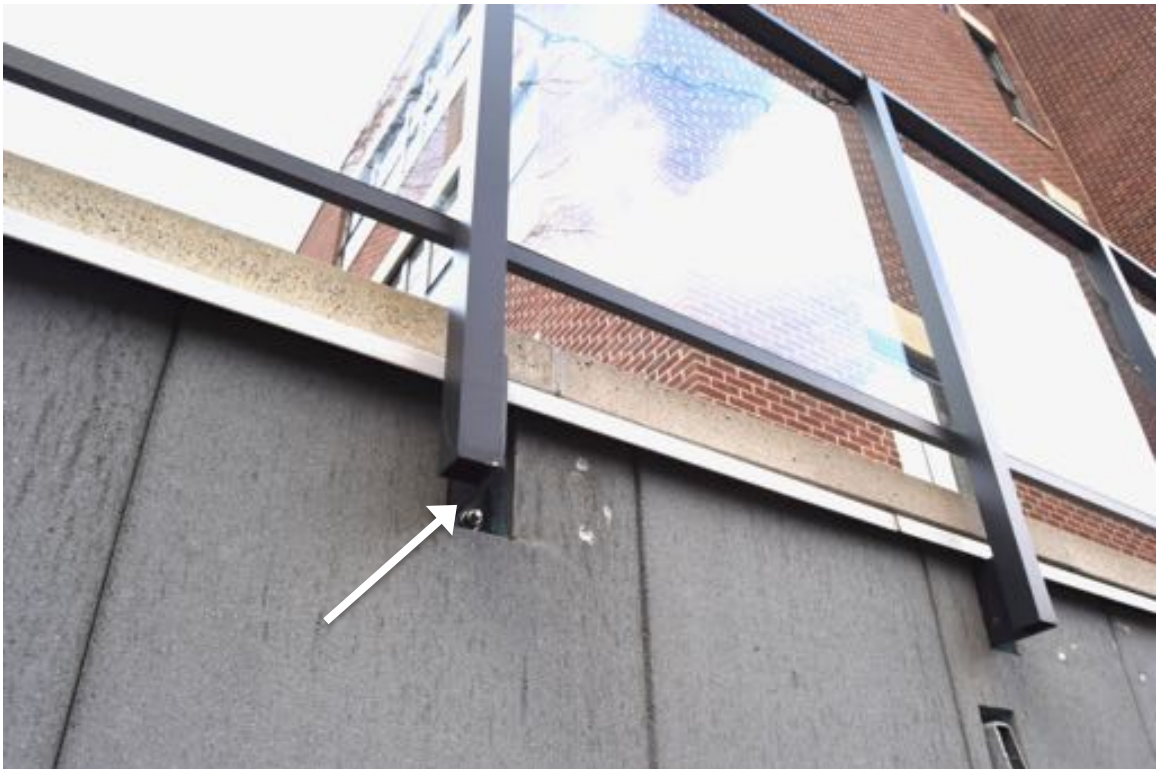
- (23) At multiple locations, the insulation is exposed at the connection points of the terrace aluminum guardrails. Refer to Photo 44.
- (24) At the west elevation, multiple scuppers for terrace drains do not extend far enough beyond the cement insulation panels, causing heavy staining, ice build-up, and deterioration of the panels. Refer to Photo 45 and Photo 46.

*Photo 44: At multiple locations, the insulation is exposed at the connection points of the terrace aluminum guardrails.*

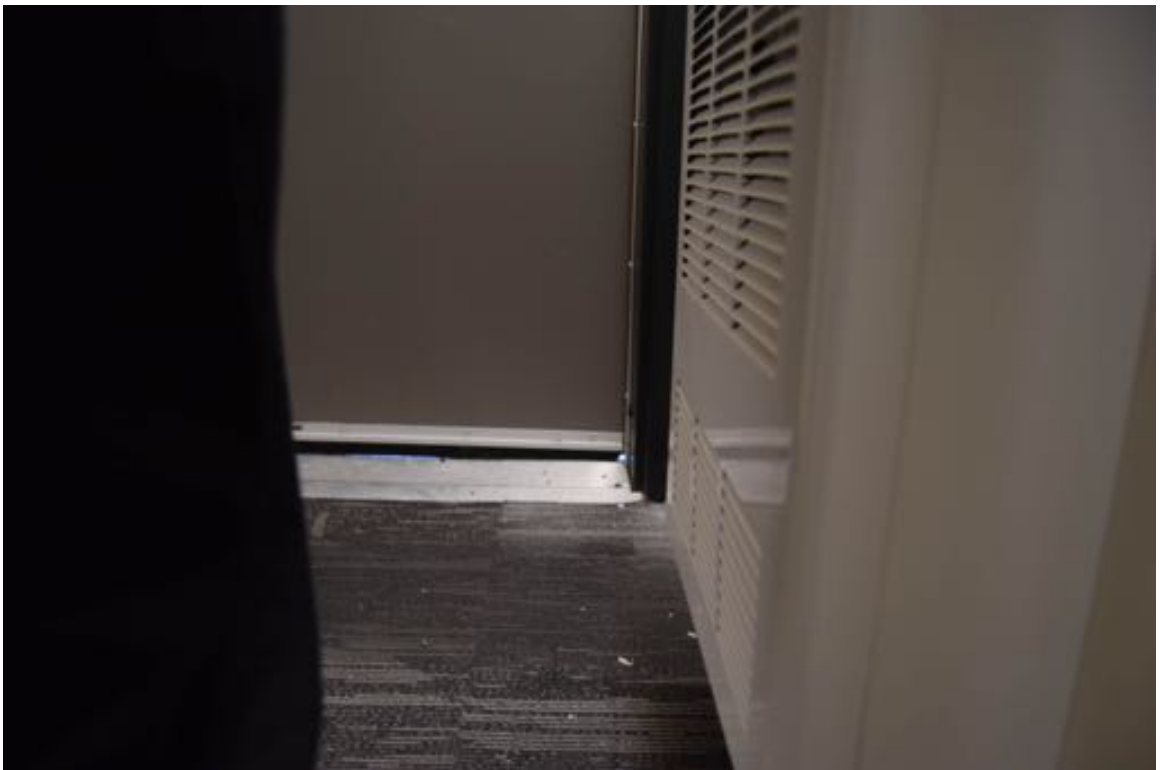
- (3) The side entrance doors did not slam the lock properly, and that is seems to be fixed now (303).
- (4) Stairwell C, there is a gap at the bottom of the door to the common fourth floor terrace. Refer to Photo 54.
- (5) Northeast exterior door to stairwell D, a cap piece is missing. Refer to Photo 55.

*Photo 54: Stairwell C, there is a gap at the bottom of the door to the common fourth floor terrace.*

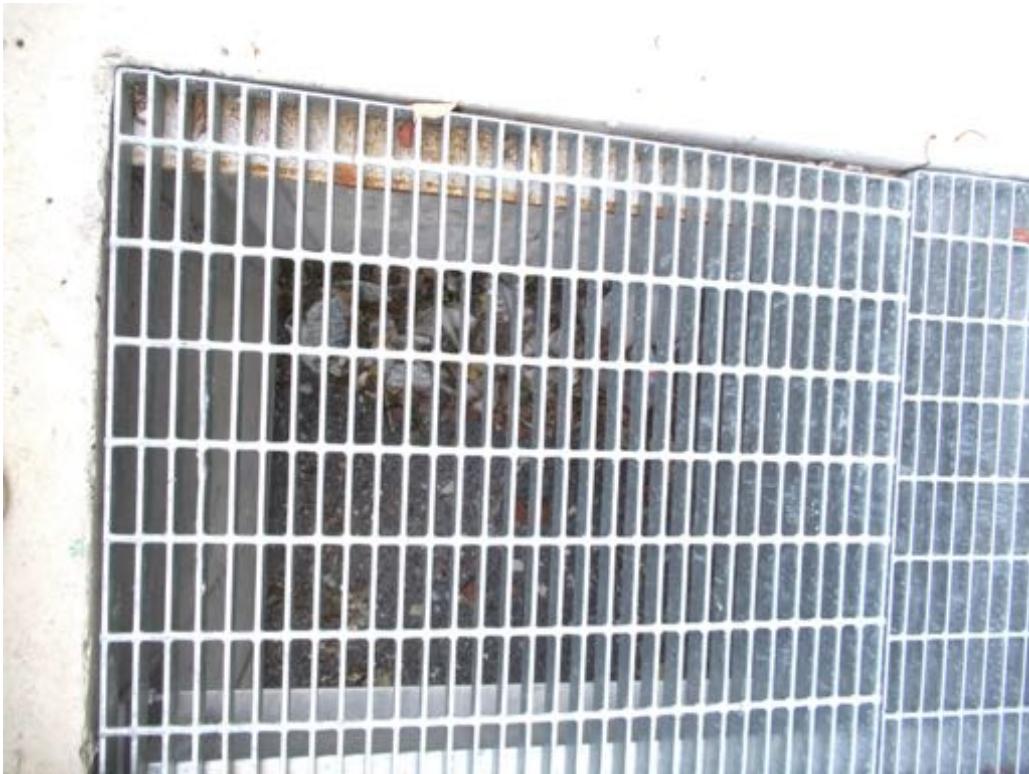
- (1) Construction debris/garbage should be cleaned out from the louvre shaft. Refer to Photo 70.

*Photo 70: Construction debris/garbage should be cleaned out from the louvre shaft.*

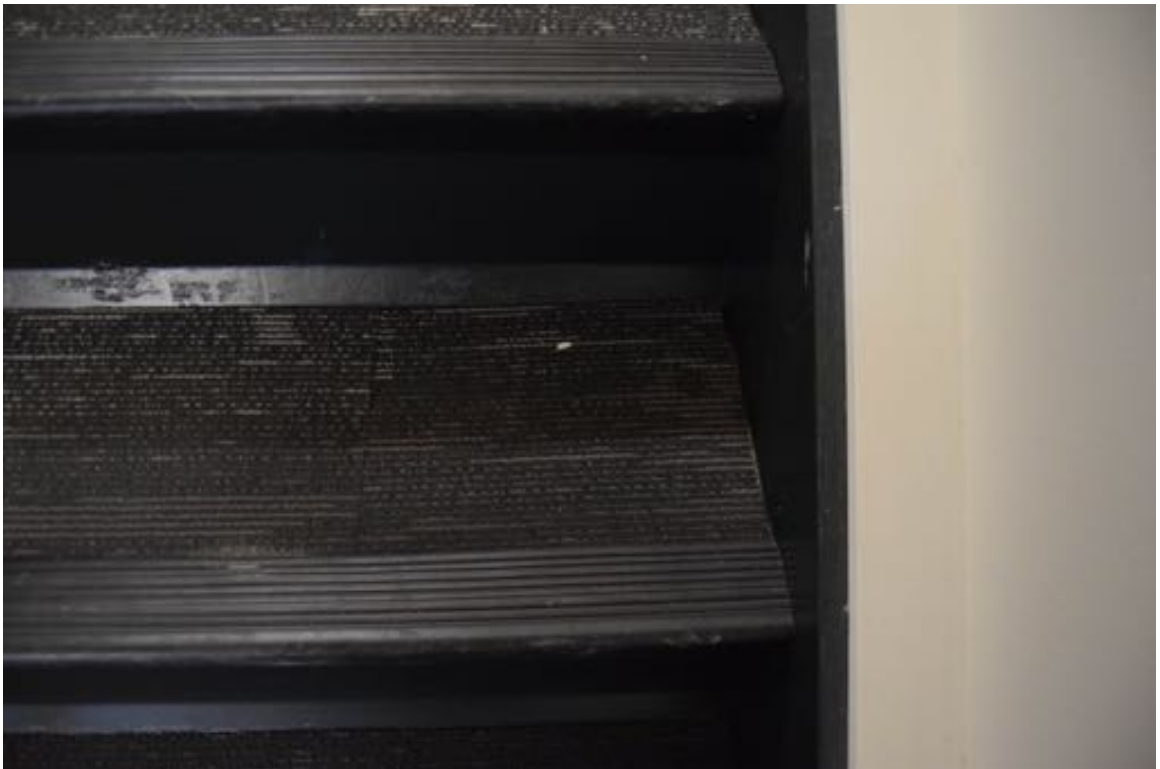
- (1) There is salt corrosion at stairwell sills (101).
- (2) The carpet tiles in stairwells B and C are lifting, that the stair nose guards are also coming loose (103).
- (3) The stairwell B and C flooring is uneven, carpet lifting/gaps, step nose guards lifting/gaps, walls uneven/lumpy, all stairwell drywall & painting is unfinished (101).
- (4) Multiple areas where the carpeted treads appear uneven. Refer to Photo 76.

*Photo 76: Multiple areas where the carpeted treads appear uneven.*

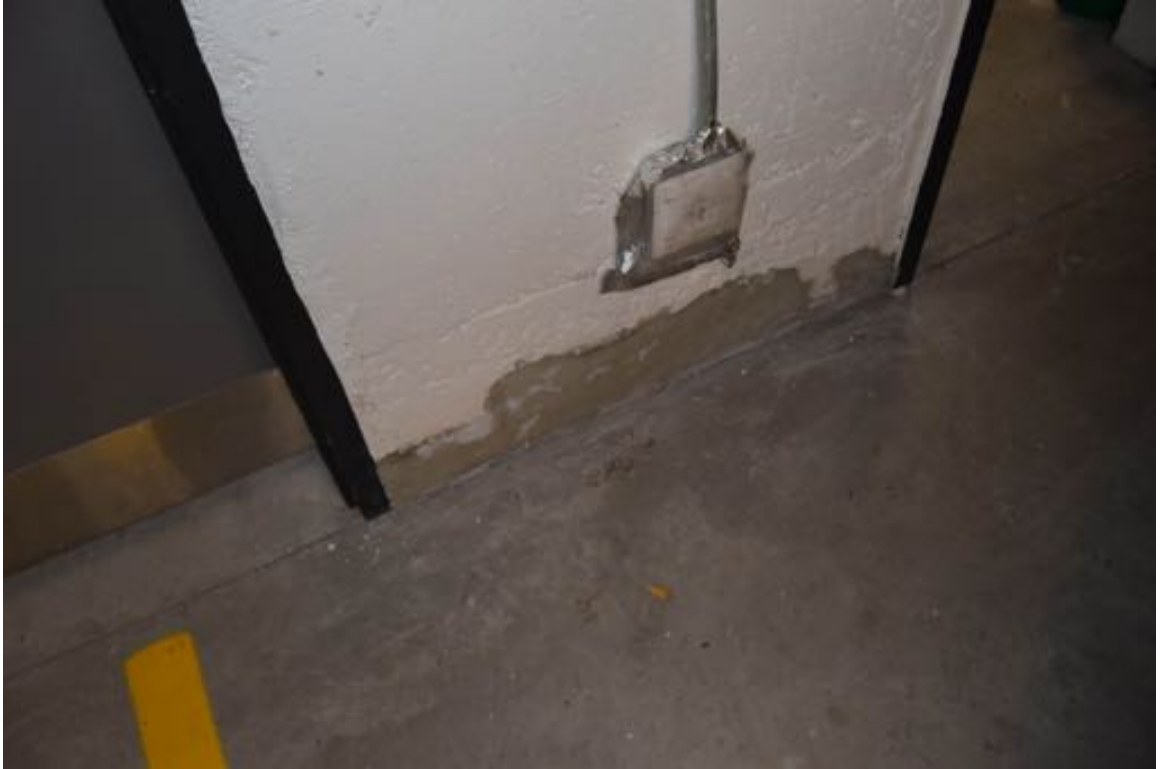
- (7) The walls require painting in a number of locations in the parking lot lever. Refer to Photo 77 and Photo 78.
- (8) A number of areas where the walls require painting in the stairwells. Refer to Photo 79.
- (9) In a number of areas, there are open gaps in the ceilings, particularly around pipe and conduit penetrations. Refer to Photo 80.
- (10) There is an open cutout section in a ceiling. Refer to Photo 81.
- (11) Multiple ceiling areas above the unit heaters are not painted. Refer to Photo 82.
- (12) Ceiling panels near the unit heaters have gaps, with interior ceiling structure visible. Refer to Photo 83.
- (13) One of the ceiling panels near the unit heater is detaching. Refer to Photo 84.
- (14) The wall finishes behind the door in the electrical room are poor. Refer to Photo 85.

*Photo 77: The walls require painting in a number of locations.*

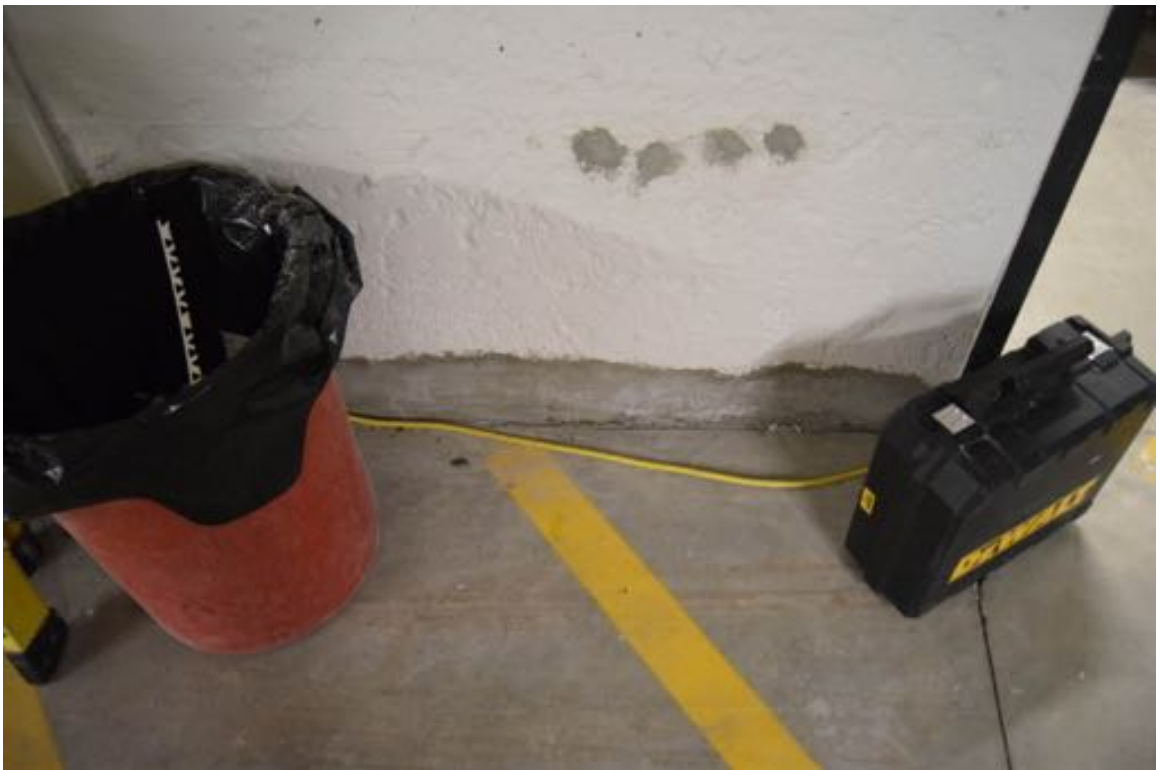
*Photo 78: The walls require painting in a number of locations.*

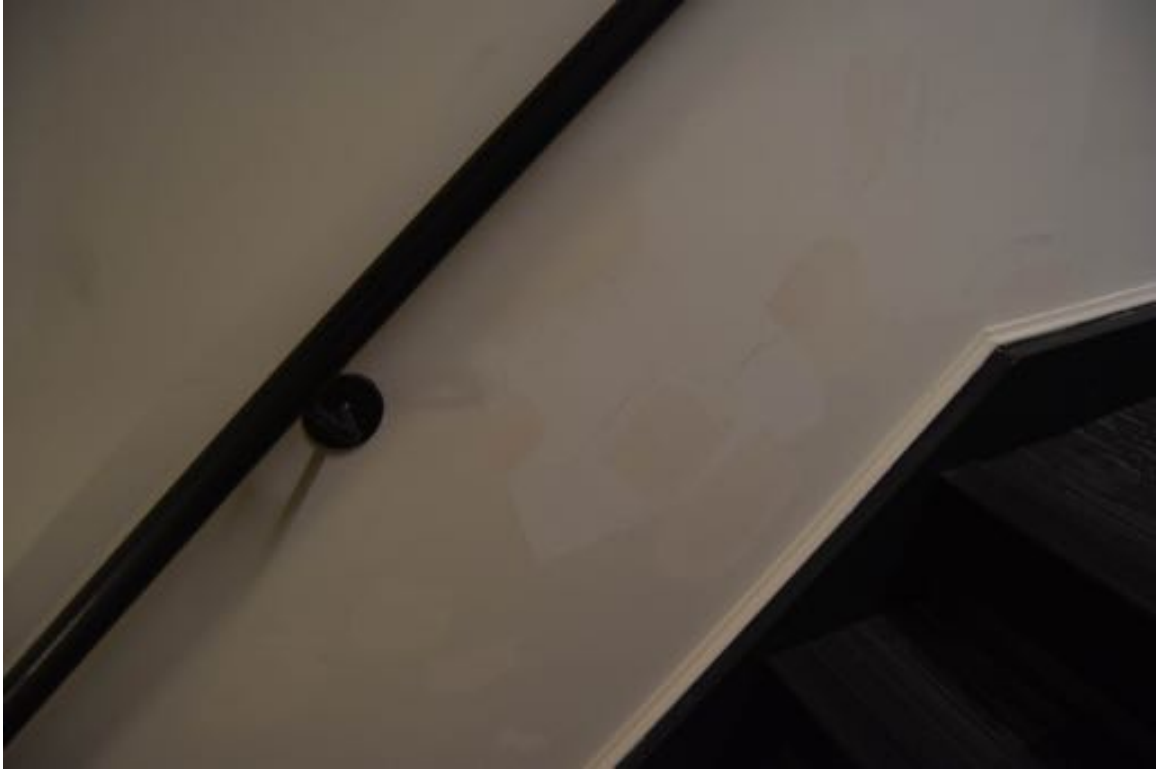
*Photo 79: A number of areas where the walls require painting in the stairwells.*

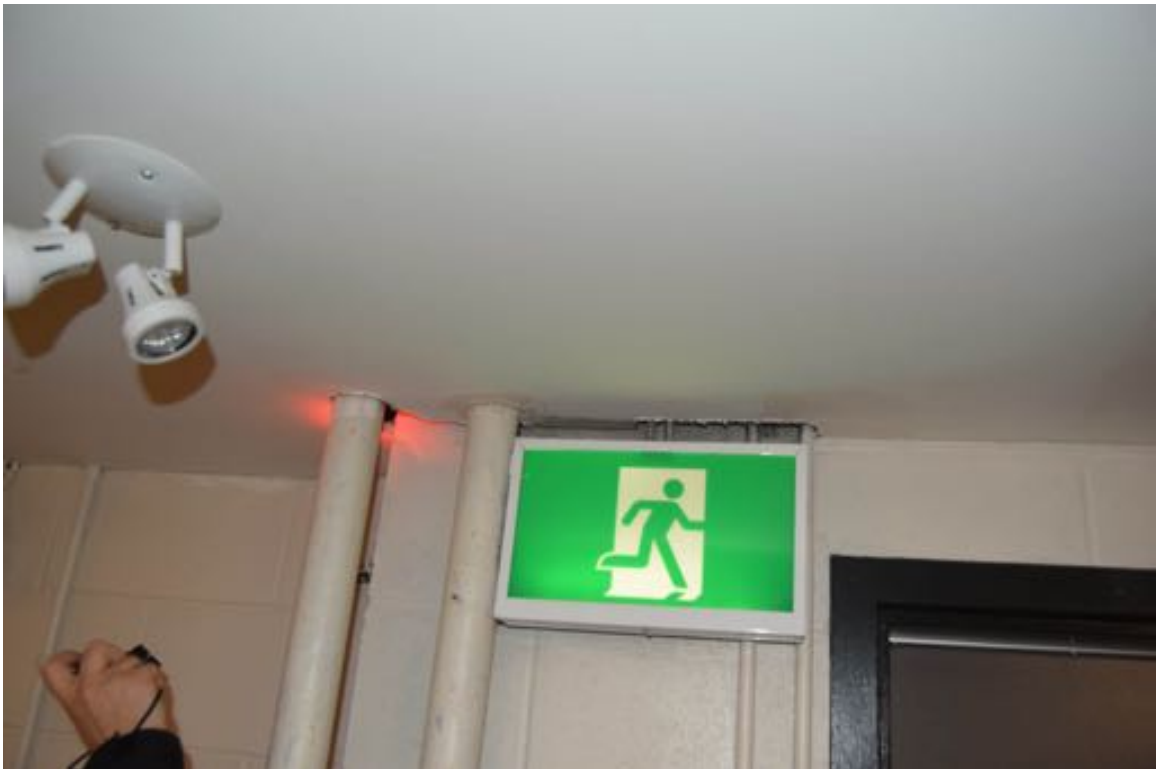
*Photo 80: In a number of areas, there are open gaps in the ceilings, particularly around pipe and conduit penetrations.*

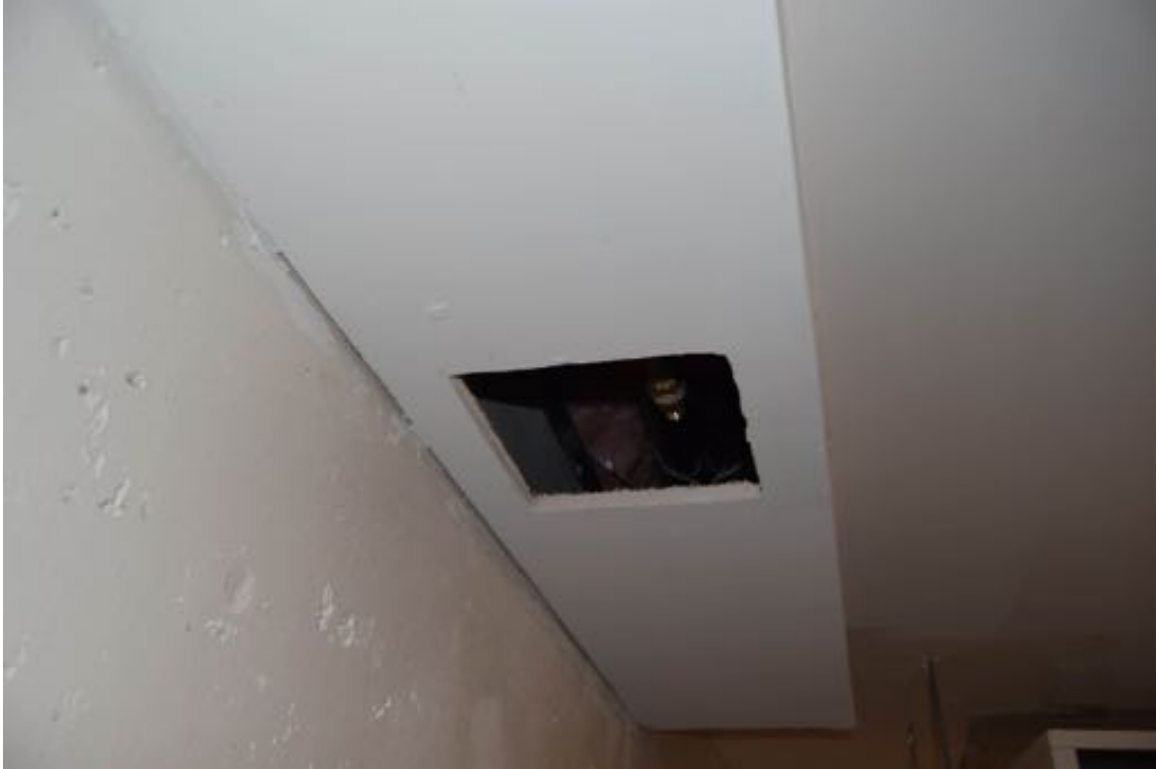
*Photo 81: There is an open cutout section in a ceiling.*

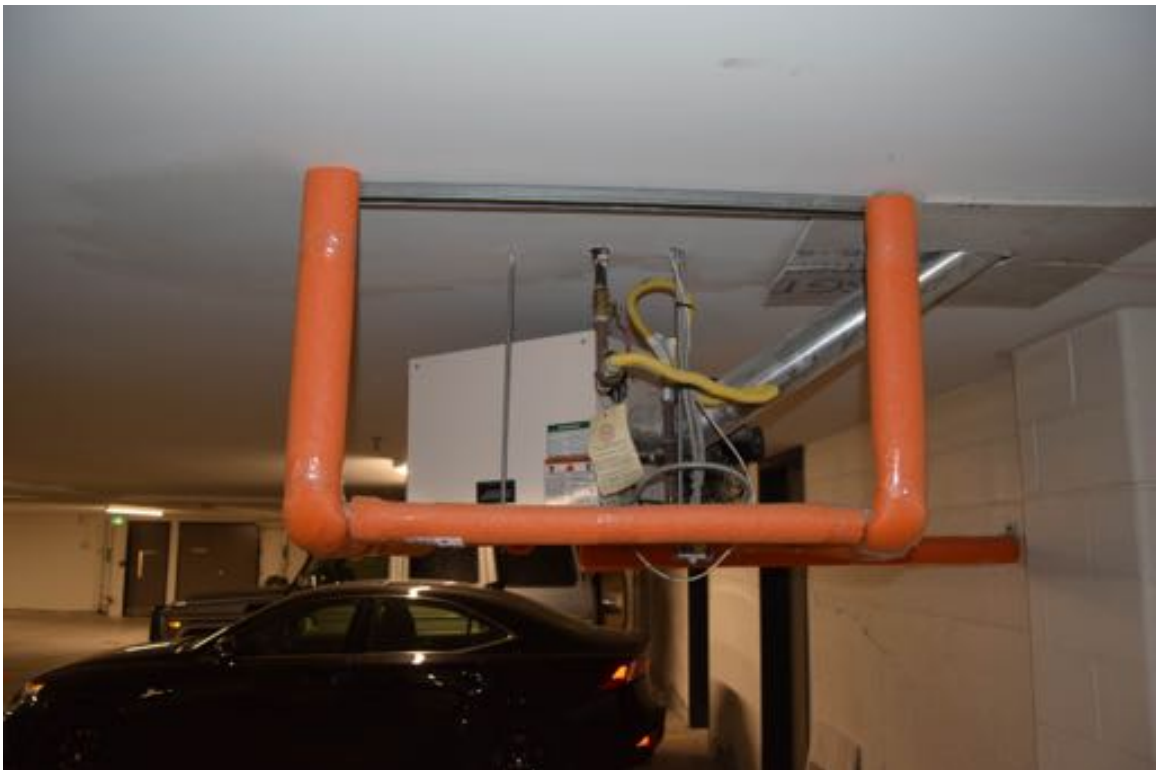
*Photo 82: Multiple ceiling areas above the unit heaters are not painted.*

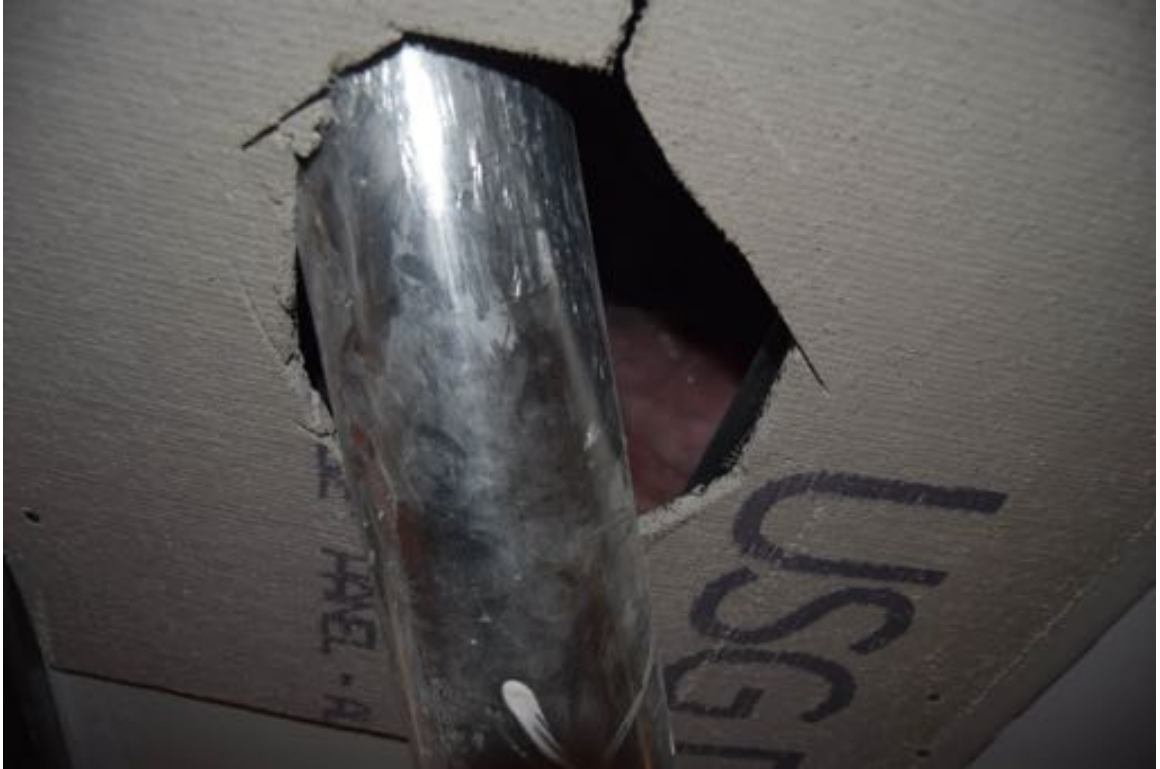
*Photo 83: Ceiling panels near the unit heaters have gaps, with interior ceiling structure visible.*

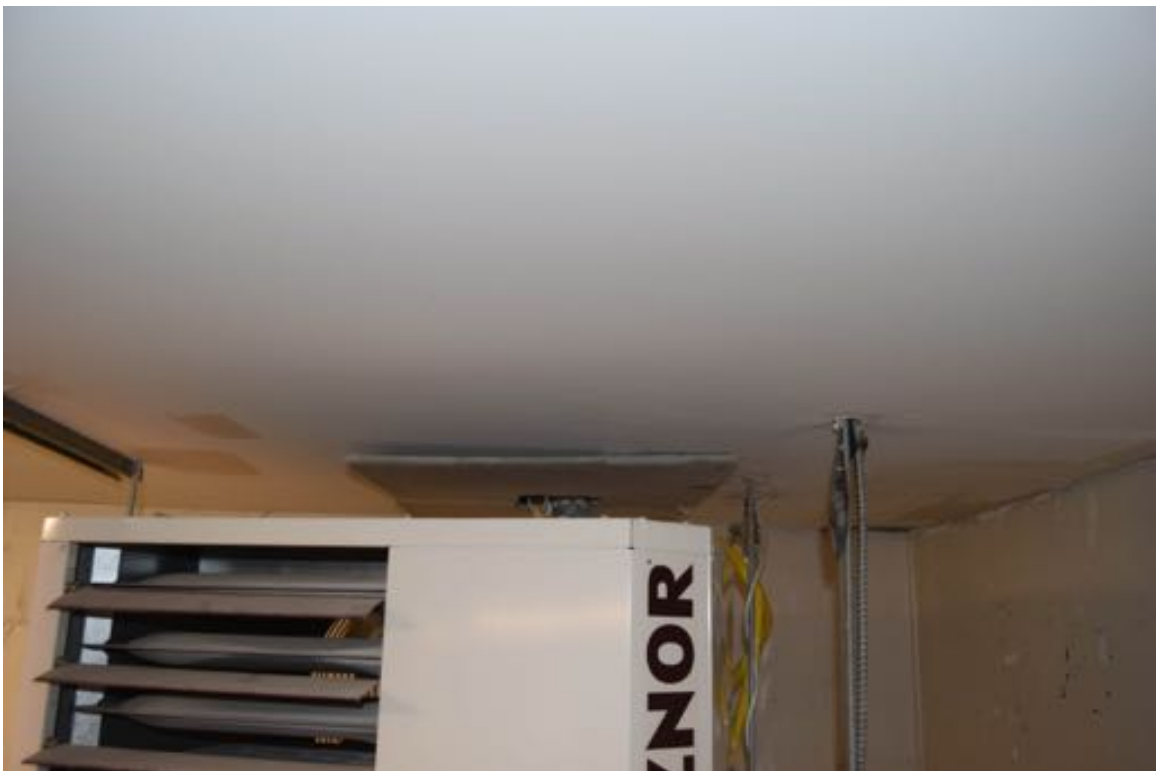
*Photo 84: One of the ceiling panels near the unit heater is detaching.*

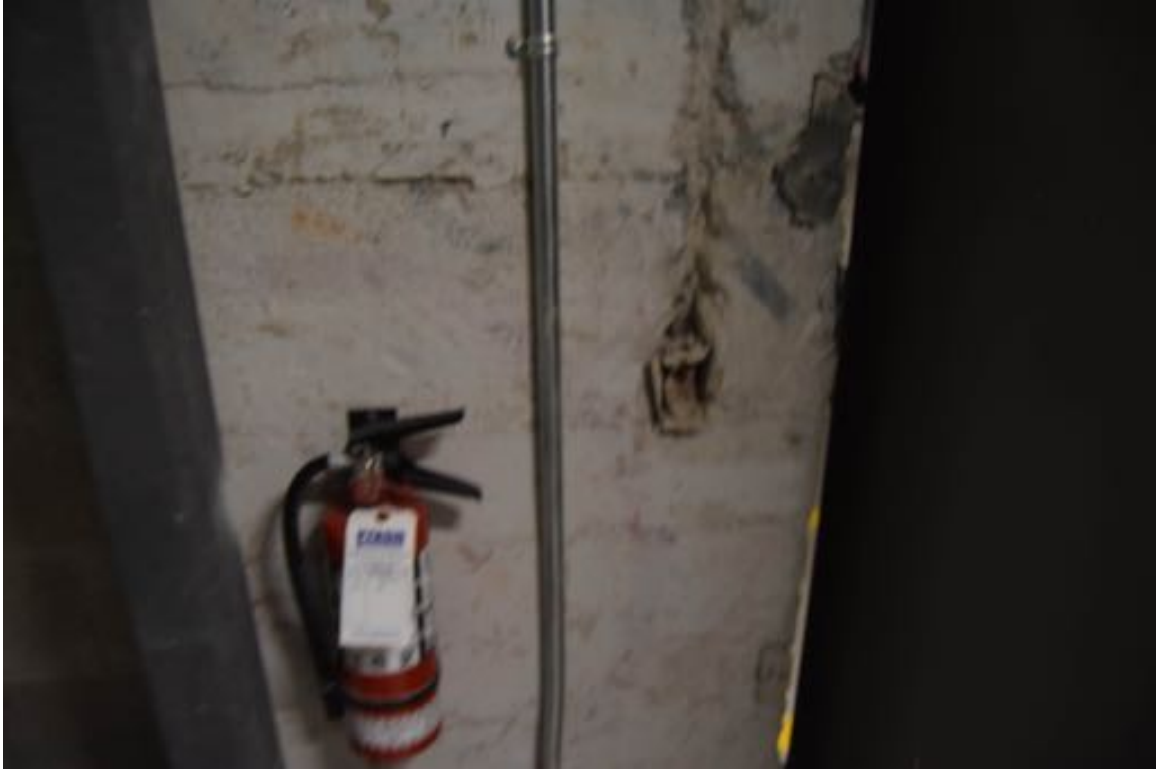
*Photo 85: The wall finishes behind the door in the electrical room are poor.*
